## Lower Eel River – Historical Survey

River Planform changes from 1922 to 2017 documented using aerial photographs from USGS , Belcher's Humboldt County Atlas, and GPS survey.

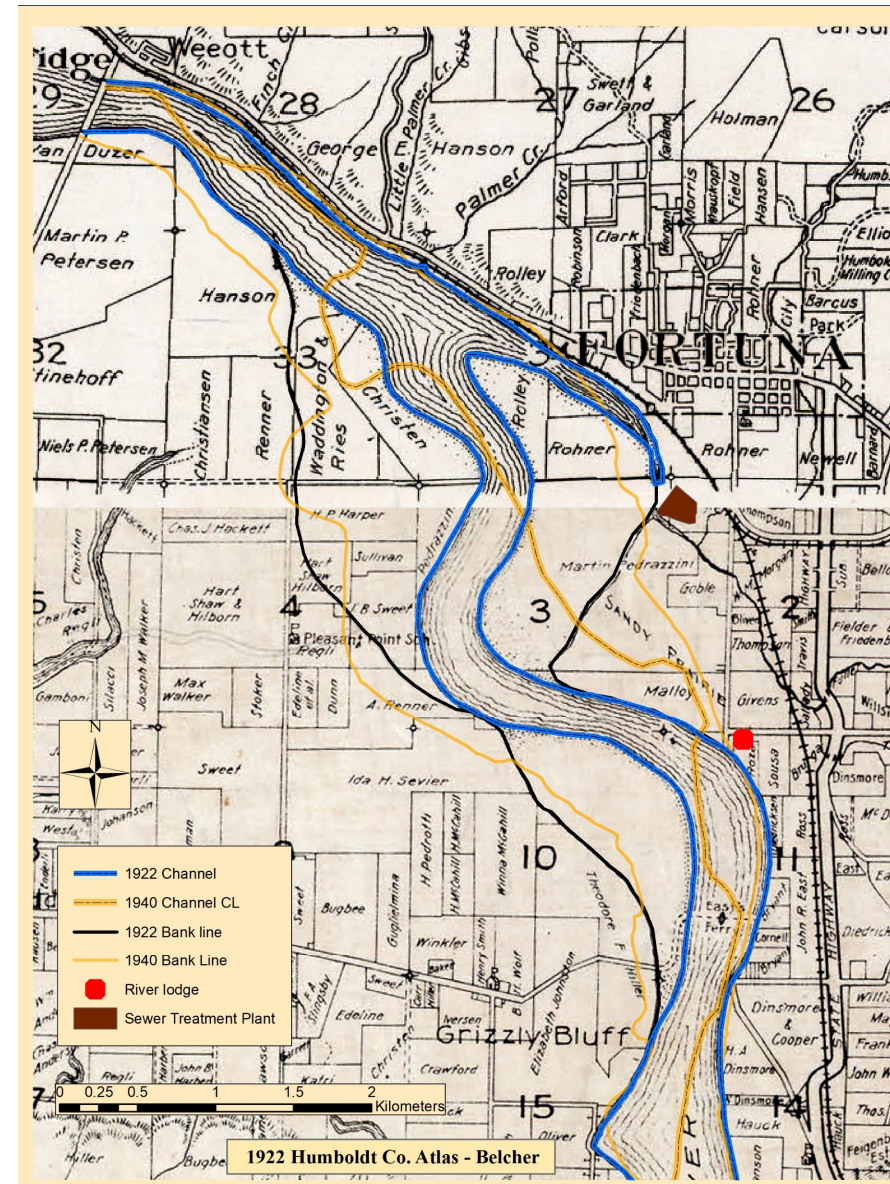
- 1) Erosion of the meander between Pleasant Point and Sandy Prairie Point
  - ends with construction of Fortuna levee 1959
  - 1940 image shows loss of Sandy Prairie Point and Pleasant point

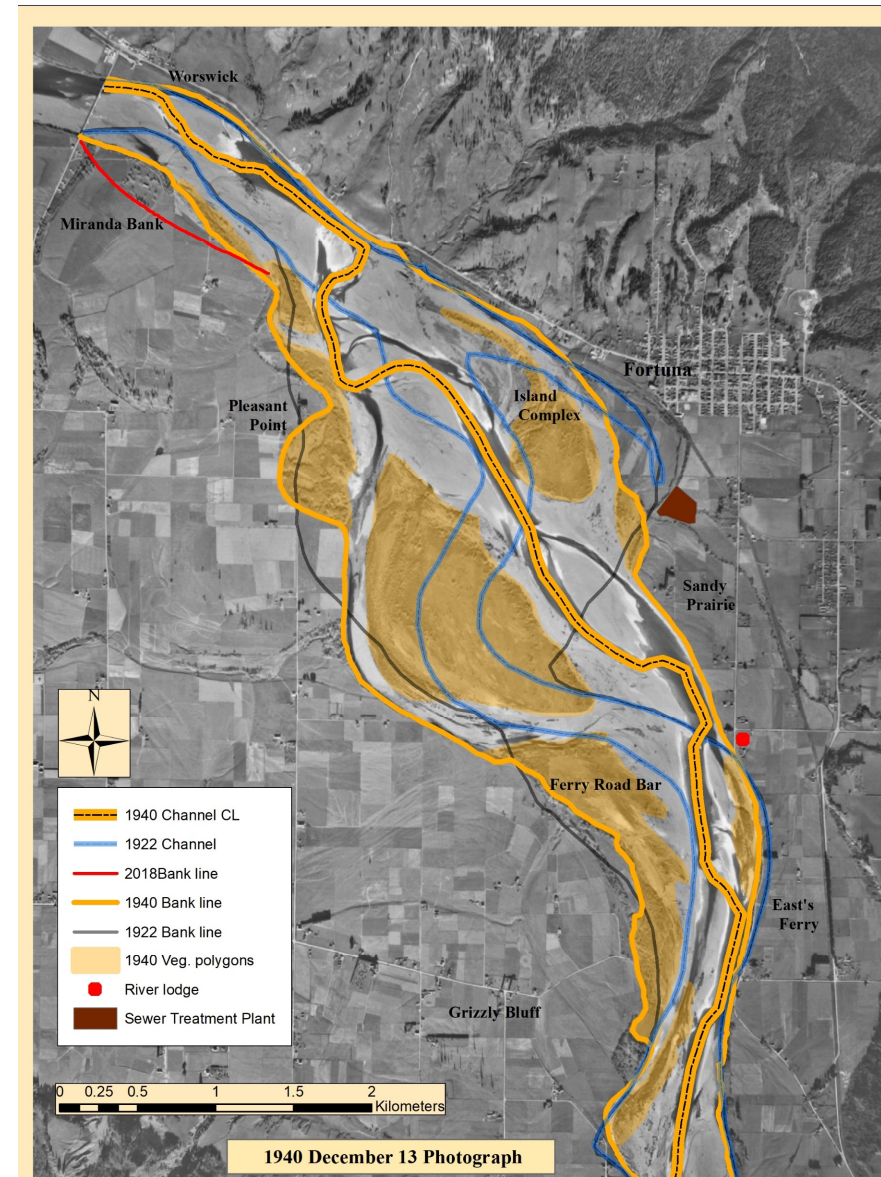
- 1) Erosion of the meander between Pleasant Point and Sandy Prairie Point
  - ends with construction of Fortuna levee 1959
  - 1940 image shows loss of Sandy Prairie Point and Pleasant point
  - 1956 image shows erosion of Fortuna Bank

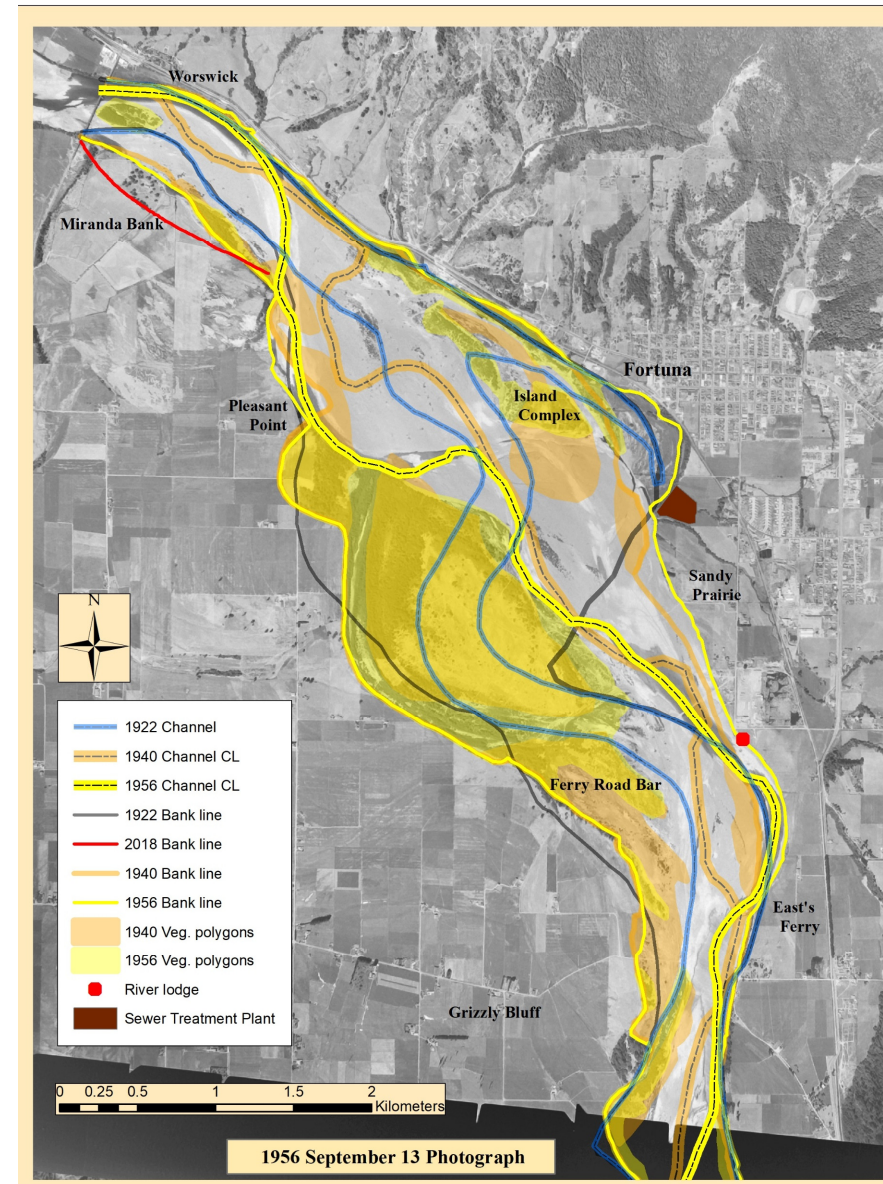
- 1) Erosion of the meander between Pleasant Point and Sandy Prairie Point
  - ends with construction of Fortuna levee 1959
  - 1940 image shows loss of Sandy Prairie Point and Pleasant point
  - 1956 image shows erosion of Fortuna Bank
- 2) The second era goes through the mid 1970's as the river chokes with sediment from the 1964 and subsequent events
  - The channel is highly braided
  - The channel gradually moved to the outside of the bend

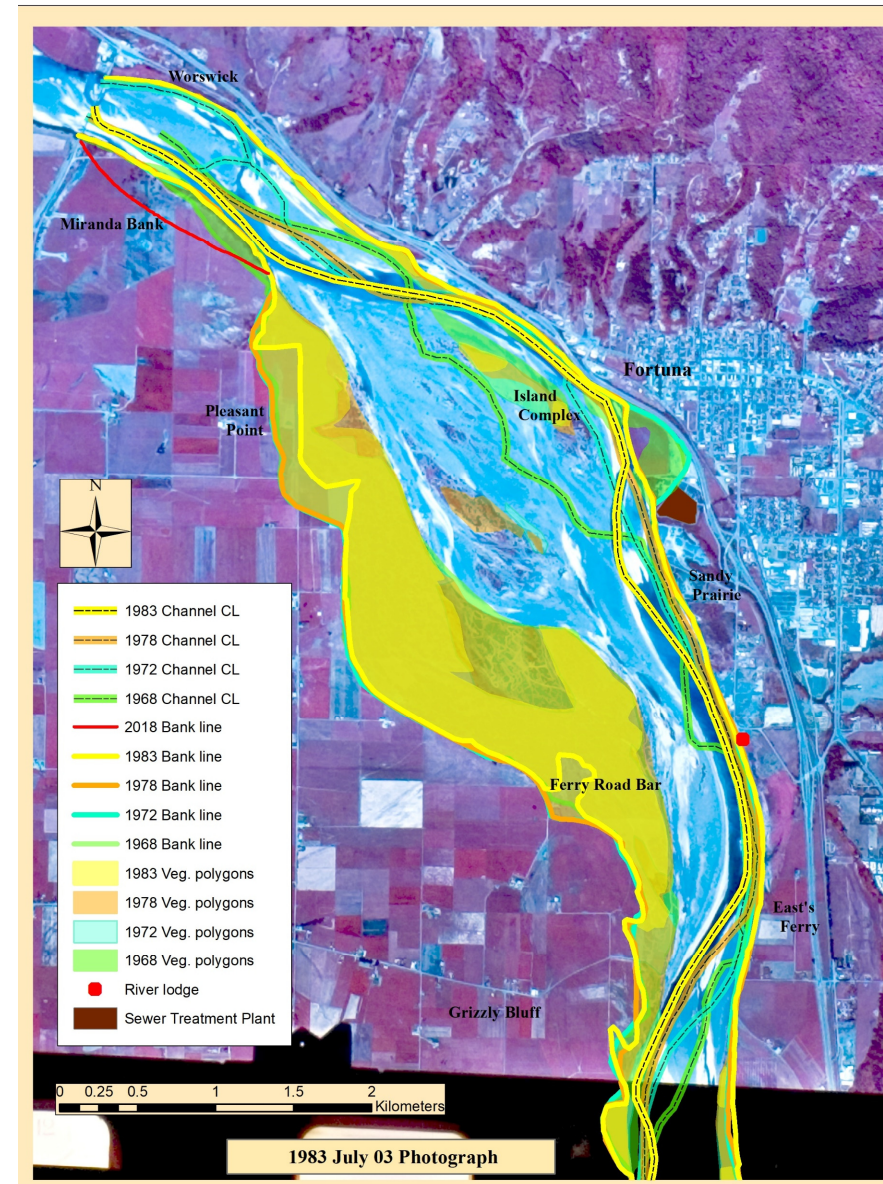
- 1) Erosion of the meander between Pleasant Point and Sandy Prairie Point
  - ends with construction of Fortuna levee 1959
  - 1940 image shows loss of Sandy Prairie Point and Pleasant point
  - 1956 image shows erosion of Fortuna Bank
- 2) The second era goes through the mid 1970's as the river chokes with sediment from the 1964 and subsequent events
  - The channel is highly braided
  - The channel gradually moved to the outside of the bend
- 3) The final era continues to the present with the river settled into its new configuration
  - The Miranda bank is eroded

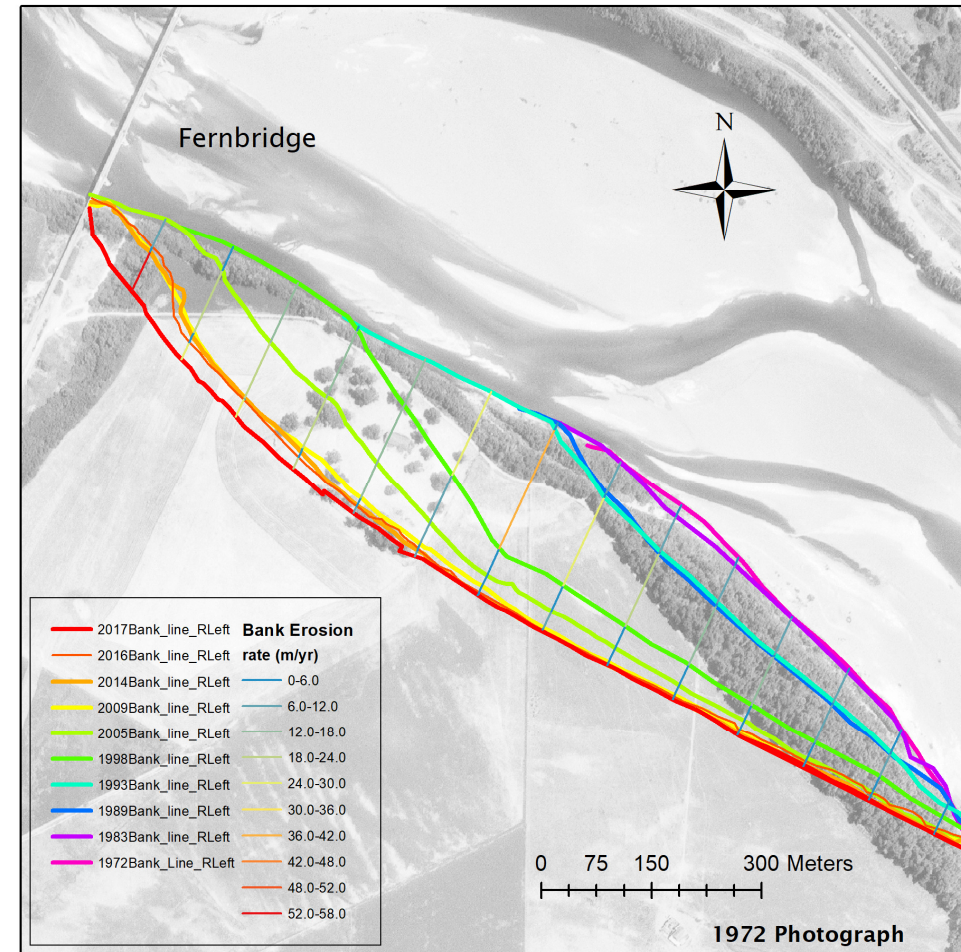
- 1) Erosion of the meander between Pleasant Point and Sandy Prairie Point
  - ends with construction of Fortuna levee 1959
  - 1940 image shows loss of Sandy Prairie Point and Pleasant point
  - 1956 image shows erosion of Fortuna Bank
- 2) The second era goes through the mid 1970's as the river chokes with sediment from the 1964 and subsequent events
  - The channel is highly braided
  - The channel gradually moved to the outside of the bend
- 3) The final era continues to the present with the river settled into its new configuration
  - The Miranda bank is eroded
  - The Worswick Bar grows into a point bar

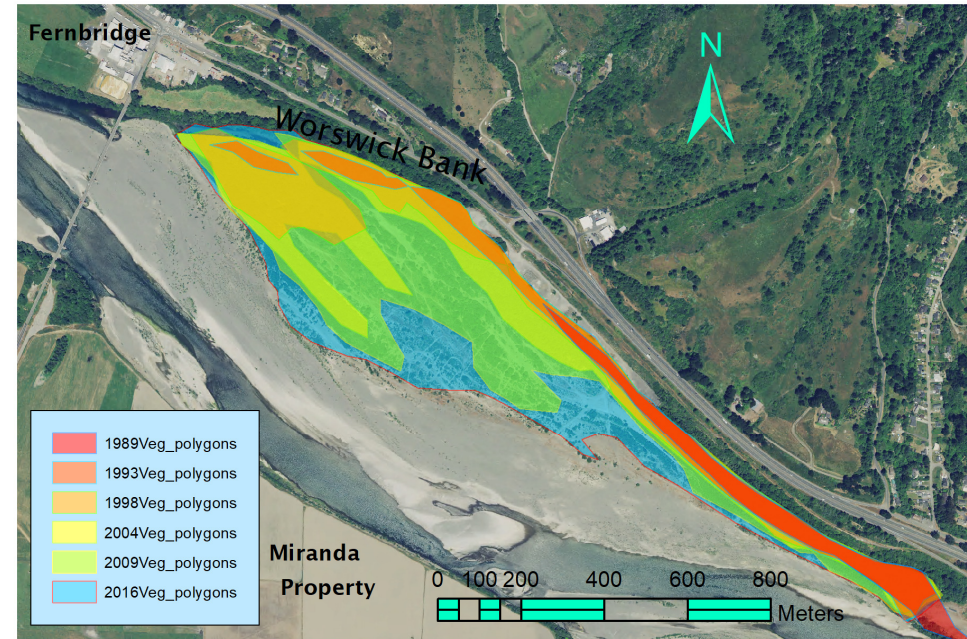
- 1) Erosion of the meander between Pleasant Point and Sandy Prairie Point
  - ends with construction of Fortuna levee 1959
  - 1940 image shows loss of Sandy Prairie Point and Pleasant point
  - 1956 image shows erosion of Fortuna Bank
- 2) The second era goes through the mid 1970's as the river chokes with sediment from the 1964 and subsequent events
  - The channel is highly braided
  - The channel gradually moved to the outside of the bend
- 3) The final era continues to the present with the river settled into its new configuration
  - The Miranda bank is eroded
  - The Worswick Bar grows into a point bar
  - The Island complex expands the north end of the Ferry Road Bar

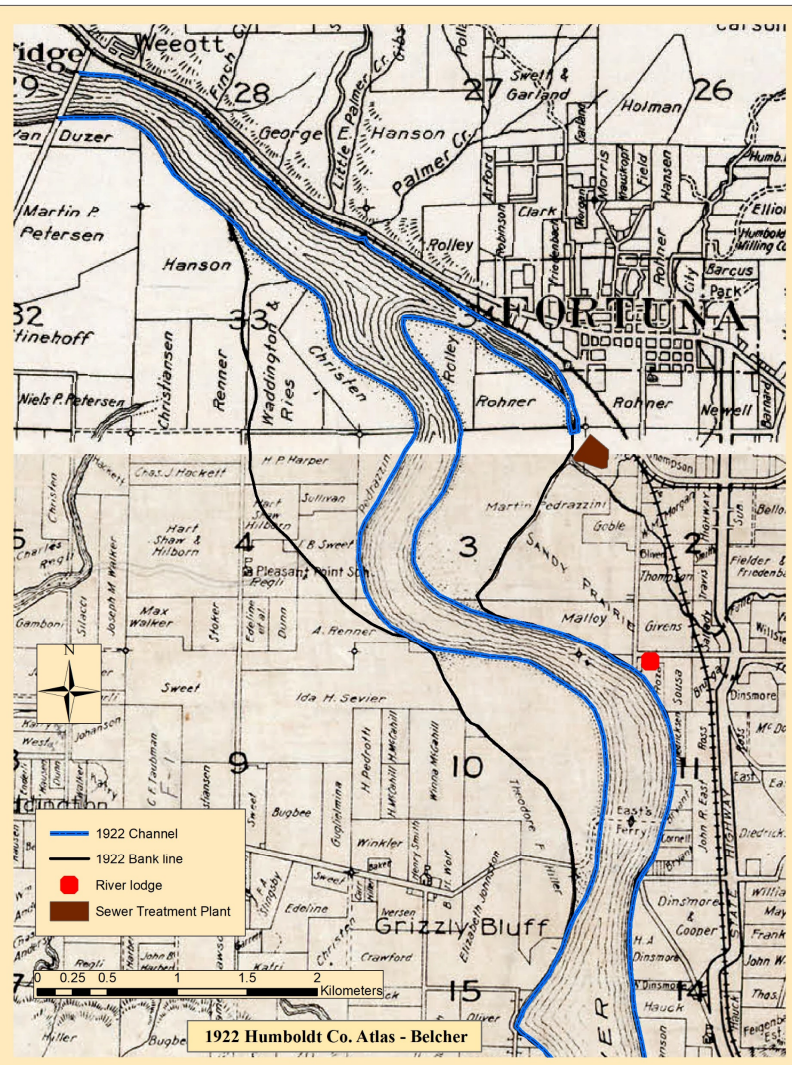
Here we are today:

- 1) The Miranda Bank continues to erode.
- 2) On the Worswick Bar and the Island Complex the riparian vegetation continues to expand in area and density.
- 3) The sediment plug in the lower river has filled all the holding water for migrating fish between tide water and the 12<sup>th</sup> street pool.
