**Assessment of Southern California Steelhead Trout  
On the Cleveland National Forest**

Jason M. Wilcox  
Acting Fisheries Biologist, Cleveland NF  
September 21, 2012

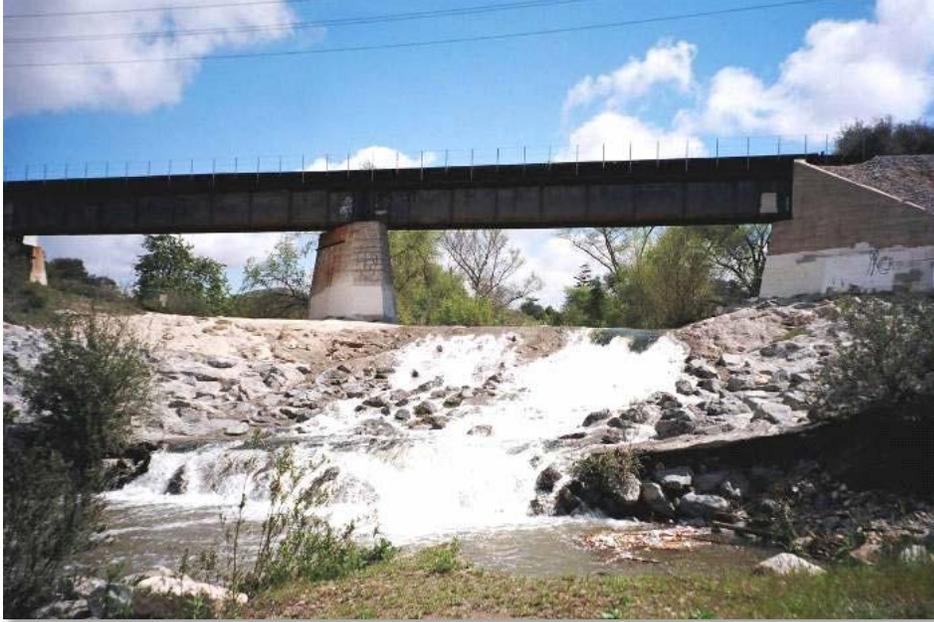
**Figure 2.** Metrolink rail crossing concrete and aggregate structure (looking upstream) on Trabuco Cr. several miles downstream of CNF land in San Juan Capistrano, CA. This approximately 30-foot tall structure is a barrier to all life stages of southern steelhead trout. The barrier height is increasing due to continual vertical scour at the base of this large artificially hardened streambed structure. Photo from CDM, et al. 2007.

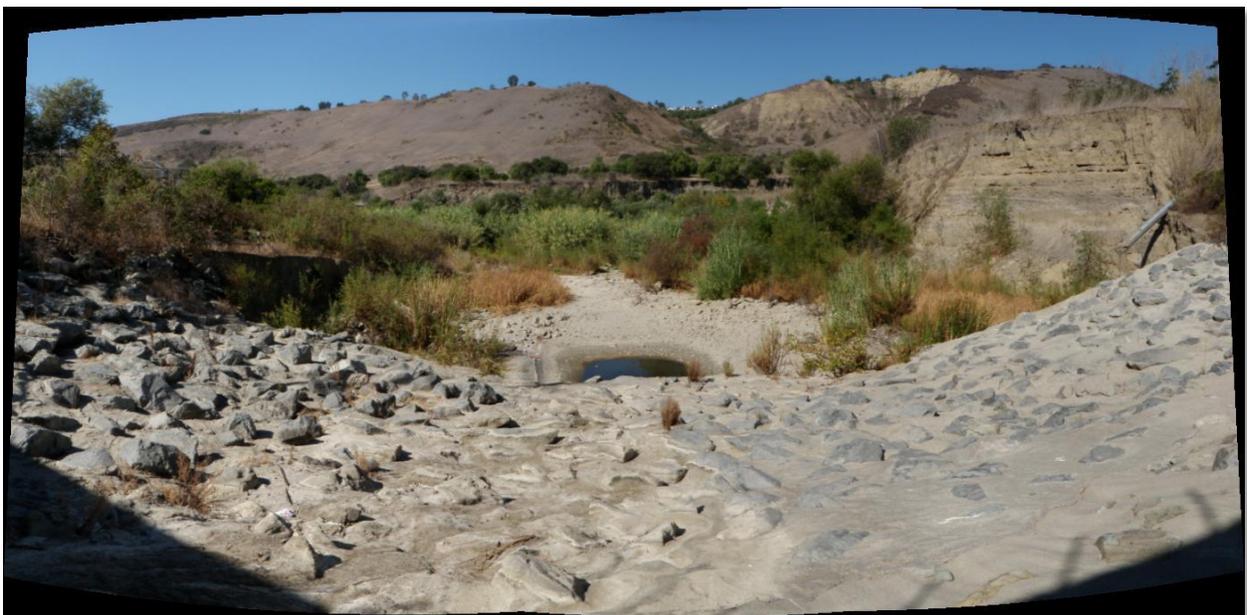
**Figure 3.** Metrolink rail crossing concrete and aggregate structure (looking downstream) on Trabuco Cr. several miles downstream of CNF land in San Juan Capistrano, CA. This approximately 30-foot tall structure is a barrier to all life stages of southern steelhead trout. Photo from author, September 7, 2012.

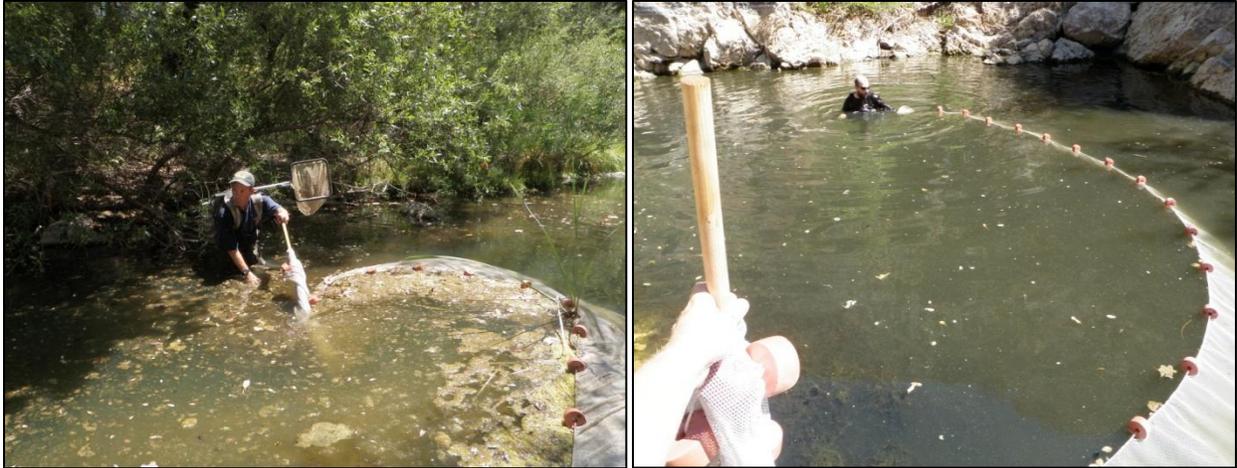
**Figure 5.** Seine and hand netting was the primary survey methodology selected for aquatic inventory due primarily to poor water clarity.

Electroshocking was applied in Trabuco Creek in conjunction with CDFG biologists, where genetic tissue samples of suspected hatchery *O. mykiss* were collected for forwarding to a current CDFG trout genetics testing program (Figure 5).

No suspected steelhead have been observed to date. Over two dozen *O. mykiss* were electroshocked in Trabuco Cr., a tributary of San Juan Cr. (Figure 5). The genetic tissue sampling results of these fish are going to be processed by CDFG in the coming months and are expected to confirm they are of either direct hatchery origin, or progeny of hatchery-derived fish due to a current hatchery resident rainbow trout stocking program in Trabuco Cr.

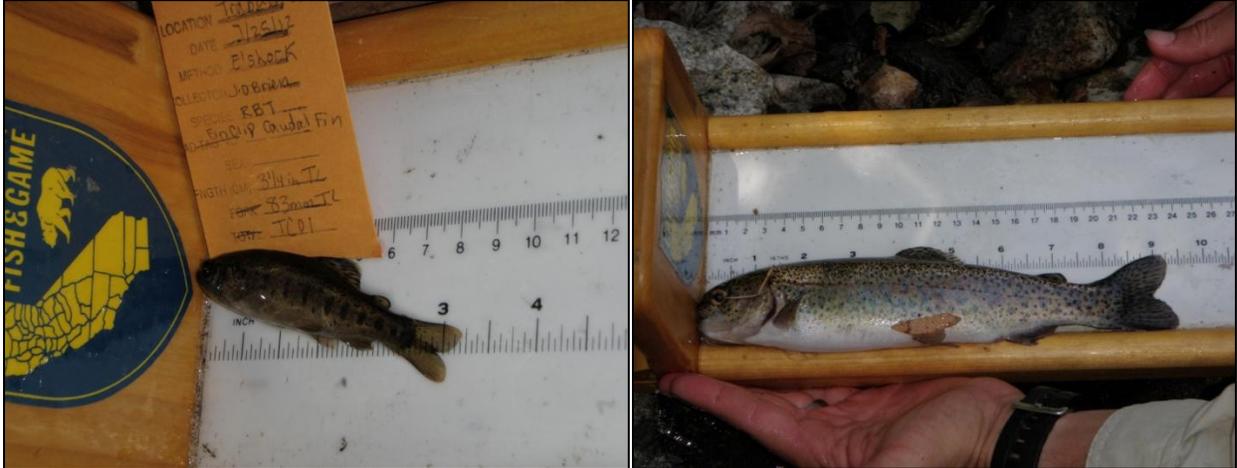
**Figure 6.** Rainbow trout were electroshocked by CDFG in Trabuco Cr. to confirm the extent of hatchery stocking influence on the local *O. mykiss* population. Distinctly different size classes were captured, confirming the presence of natural reproduction in the wild, though a current hatchery stocking program by CDFG is thought to be the source of all *O. mykiss* in Trabuco Cr.

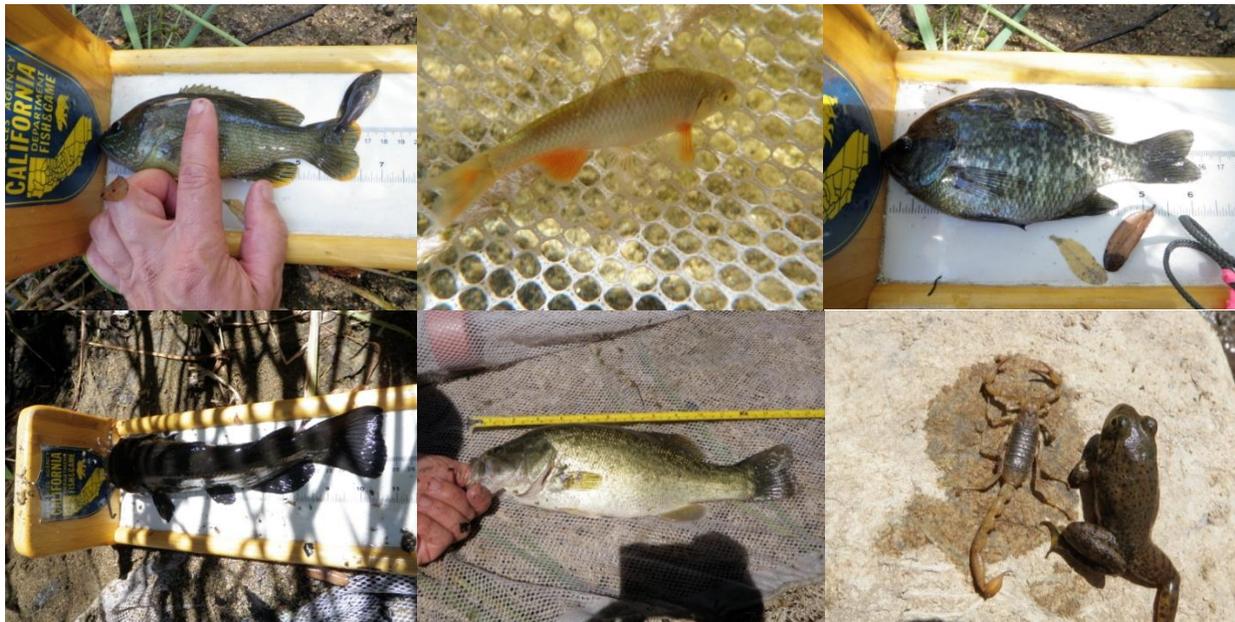
**Figure 7.** Introduced non-native aquatic species were common in mainstem San Juan Cr., relatively few in Trabuco Cr., and infested San Mateo Cr. Species in clockwise order from upper left: Green sunfish, Golden shiner, Bluegill sunfish, Bullfrog, Largemouth bass, Black bullhead.

Introduced non-native aquatic species including Green Sunfish (*Lepomis cyanellis*), Black Bullhead (*Ameiurus melas*), Golden Shiner (*Notemigoneus crysoleucas*), Bluegill (*Lepomis macrochirus*), Largemouth bass (*Micropterus salmoides*), Mosquitofish (*Gambusia affinis*), American Bullfrog (*Rana catesbeiana*), and Red Swamp Crayfish (*Procambarus clarkia*) were documented at infestation levels in the surveyed segment of San Mateo Cr. (Figures 7 and 8). Golden shiner, Mosquitofish and Red Swamp Crayfish were found to be prolific in portions of San Juan Cr. All non-native aquatic species were removed from watered habitats and killed as encountered. One native fish species, Arroyo chub (*Gila orcutti*), was documented as commonplace in mainstem Trabuco and San Juan Creeks (Figure 8).

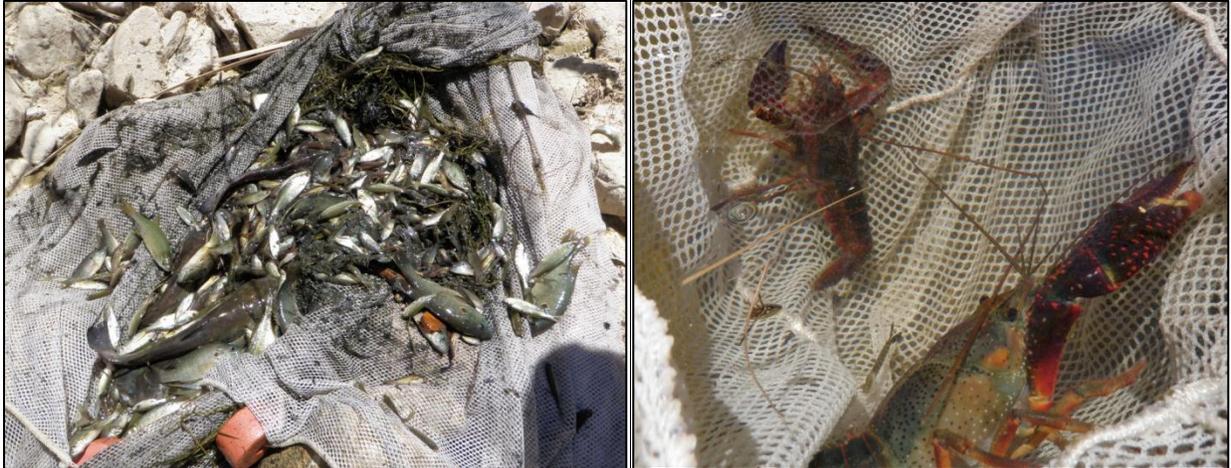
**Figure 8.** Introduced non-native aquatic species were prolific and broadly distributed in all surveyed waters of the San Mateo watershed. Green sunfish and golden shiner were the most common fish, while American bullfrog and Red Swamp Crayfish were also found in very high densities more appropriately measured by weight in aggregate than via population enumeration.

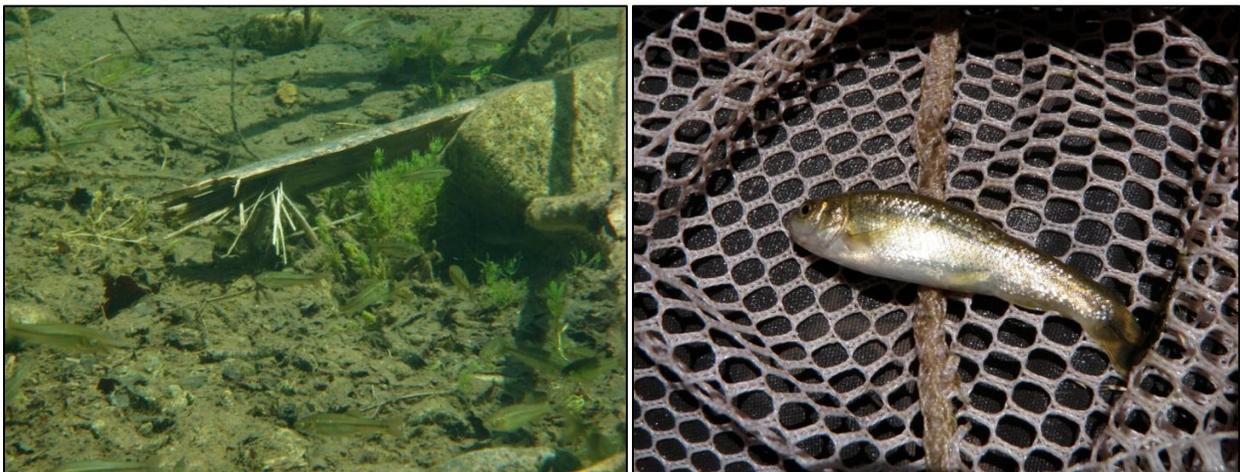
**Figure 9.** Arroyo chub (*Gila orcutti*) was the only confirmed native fish species observed during the aquatic inventory. This species was not noted in the San Mateo drainage, but was present in mainstem San Juan and Trabuco creeks.

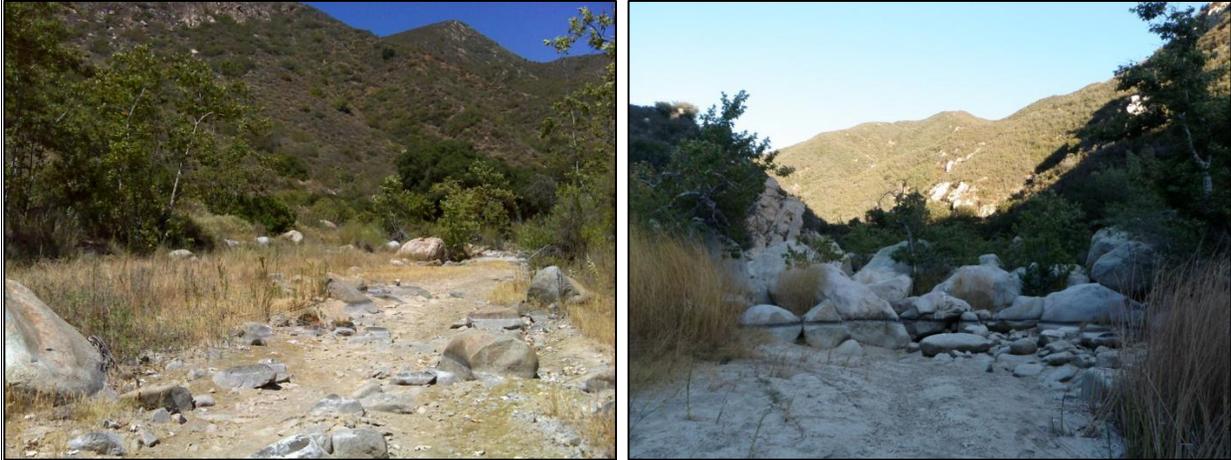
**Figure 10.** San Juan (left) and San Mateo (right) were predominantly dry by early September 2012.

Approximately three-quarters of the mainstem drainage network inventoried for steelhead in San Mateo Cr. lacked visible surface water by early September, with approximately 90% dry stream bed conditions in San Juan Cr. mainstem at this time (Figure 10). Trabuco Cr. was the most perennially watered channel, with surface water along the majority of the lower two stream miles on the CNF.

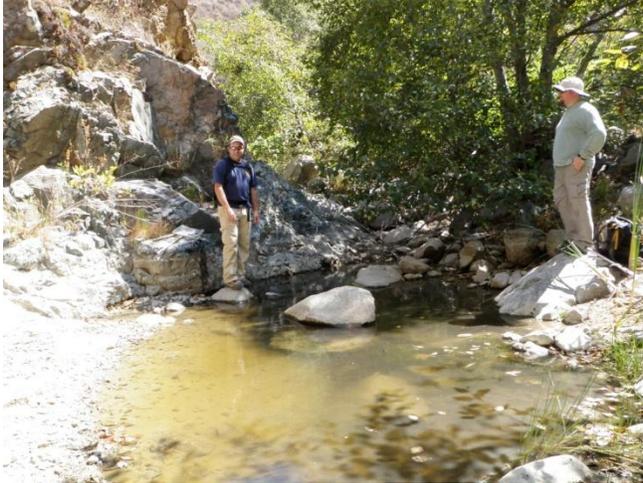
**Figure 13.** Tim Hovey of CDFG (left) and Mike Rouse of USMC Camp Pendleton (right) at the pool marking the upstream extent of steelhead documented (by Tim in December 2003) in Devils Canyon Cr. on CNF land, a tributary to San Mateo Cr. Photo taken by author 9/17/2012.

The most likely location for steelhead to occupy CNF lands appears to be in the Devils Canyon tributary of San Mateo Cr., since they were last observed there in winter of 2003 by Tim Hovey of CDFG (Figure 13). According to Tim, there are periodic high flow freshets that result in large numbers of non-native warmwater fishes washed up on the beach at the mouth of San Mateo Cr., whereas the Devils Canyon tributary has a naturally aggraded bedload barrier at its confluence with San Mateo Cr. that he believes prevents infestation of this stream reach, thereby supporting observed adult steelhead and their progeny (pers. comm). It is possible that non-native species that are inclined to lentic habitats are not able to migrate up into Devils Canyon due to a discharge velocity barrier, whereas steelhead have this capability. If this is the case, this may support the concern that the source of the invasive species in San Mateo Cr. is in the headwaters, resulting in downstream flushing and redistribution of these species during higher flow conditions. He also surmises that the Devils Canyon tributary may have slightly cooler water temperatures than mainstem San Mateo Cr., further supporting steelhead.
