Appendices

Appendix A

Infrastructure

A.1 Existing Conditions

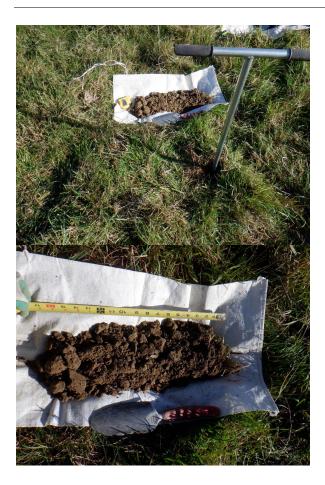
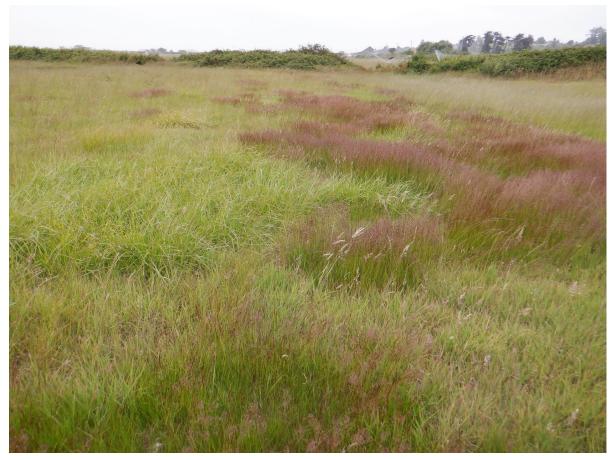
Figure C-1. Photographs at wetland Data Point 02 illustrating conditions in a palustrine seasonally flooded-saturated persistent emergent wetland associated with historic flow paths of Swain Slough and other drainages throughout agricultural pasture lands within the valley floor in Planning Area 1.

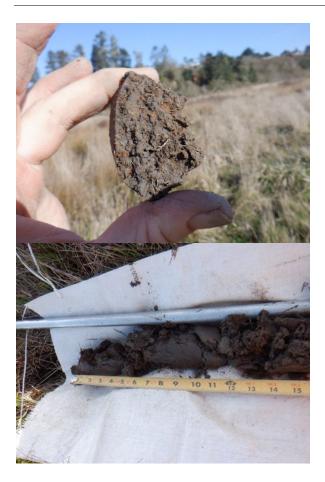
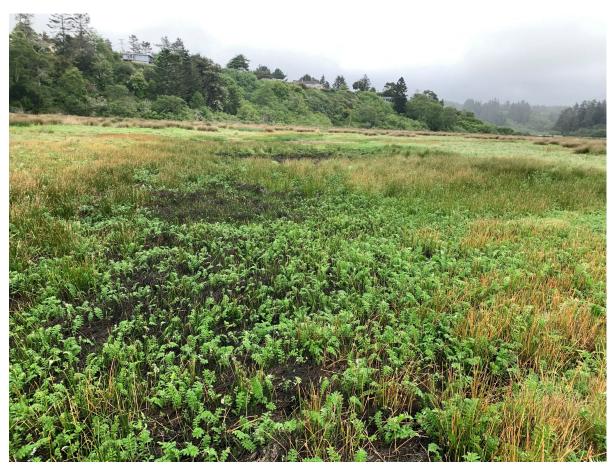
Figure C-2. Photographs at wetland Data Point 205 illustrating conditions in palustrine seasonally flooded-saturated persistent emergent wetlands adjacent to estuarine wetlands within the tidally influenced parcel near Swain Slough in Planning Area 1.

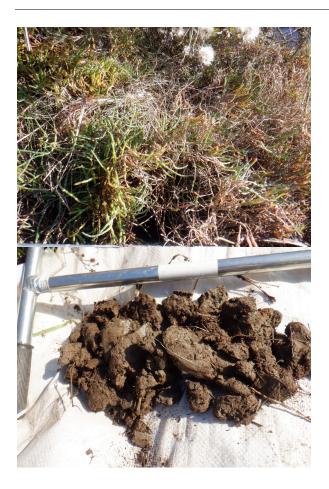
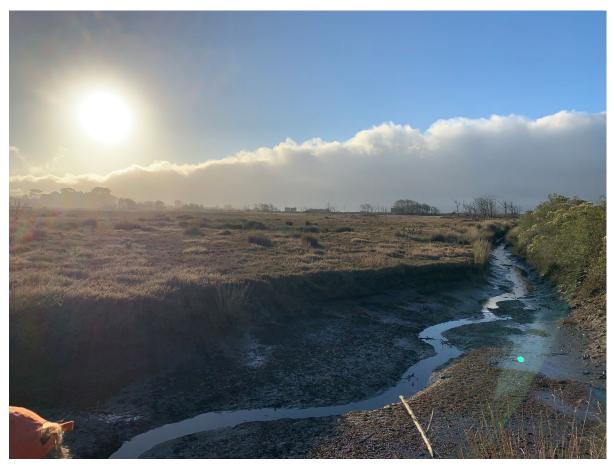
Figure C-3. Photographs at Data Point 108 illustrating conditions in tidally influenced estuarine irregularly flooded persistent emergent wetlands adjacent to an unconsolidated bottom intertidal drainage (i.e., estuarine tidal Other Waters of the U.S) in the Elk River Wildlife Area in Planning Area 1.

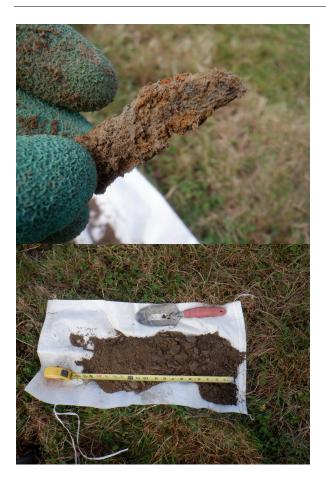
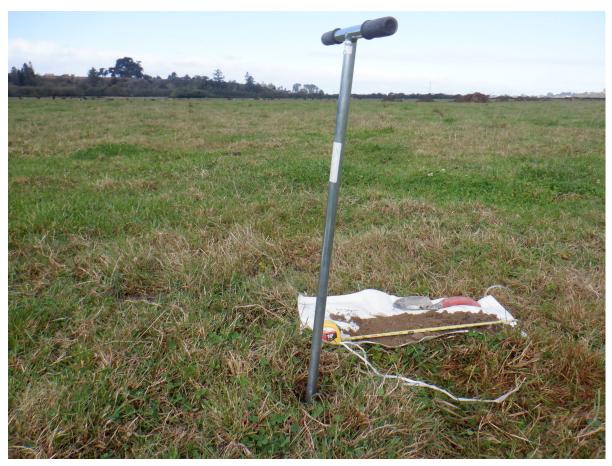
Figure C-4. Photographs at Data Point 02 illustrating conditions in the palustrine seasonally flooded persistent emergent wetlands documented throughout agricultural pasture lands within the valley floor in Planning Area 1.

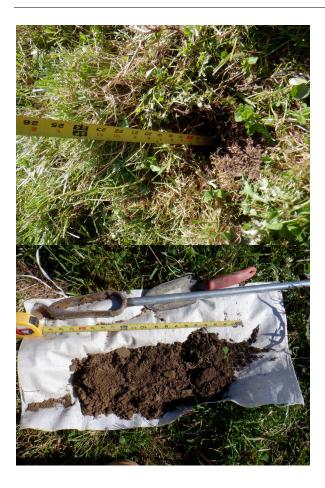
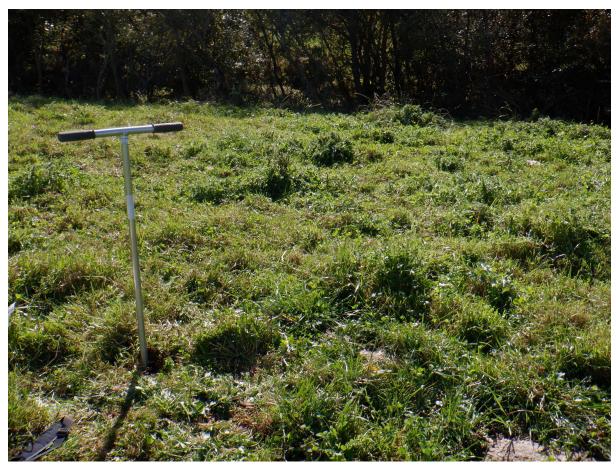
Figure C-5. Photographs at Data Point 05 illustrating conditions in the delineated uplands associated with the elevated raised berm surrounding the right bank of Elk River through much of the valley bottom in Planning Area 1.

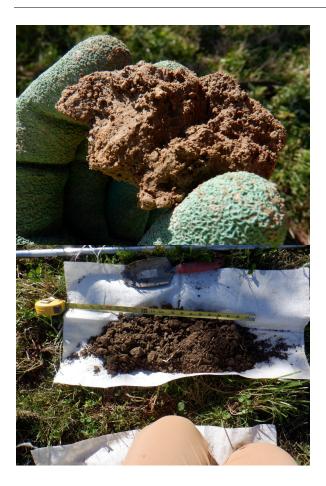
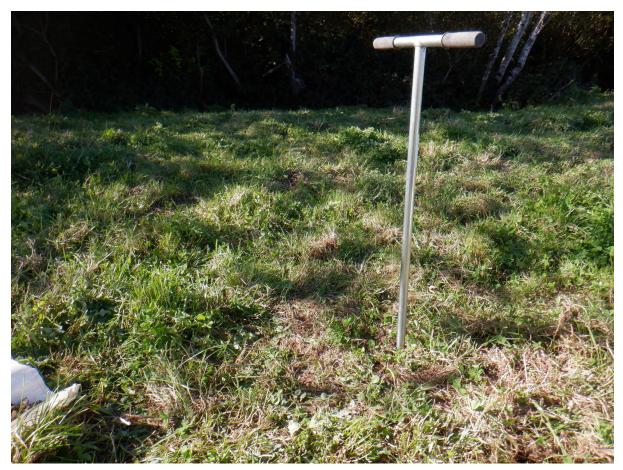
Figure C-6. Photographs at Data Point 03 illustrating another example of conditions in the delineated uplands associated with elevated raised berm surrounding the right bank of Elk River through much of the valley bottom in Planning Area 1 (note the extent of this upland stops at the riparian corridor where broadleaved deciduous wetland types are delineated).

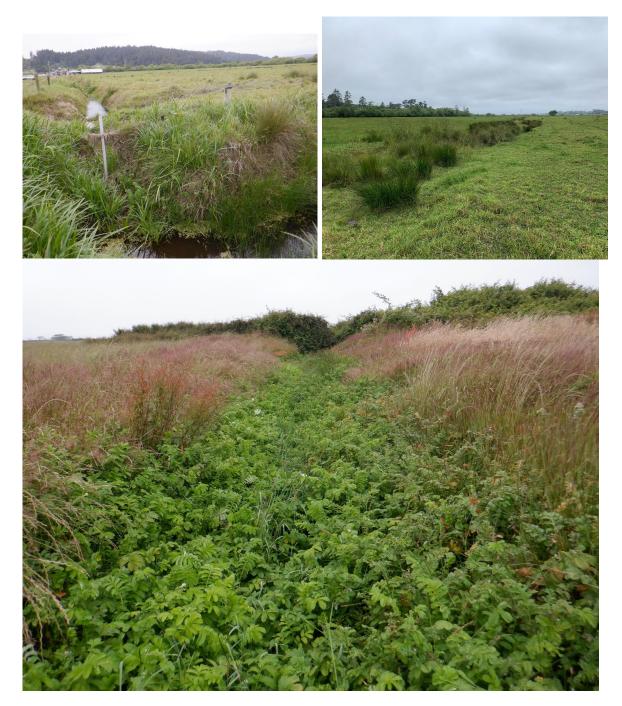
Figure C-7. Photographs illustrating conditions in the delineated palustrine semipermanently flooded persistent wetlands associated with vegetated drainages in agricultural pasturelands. Dominant emergent vegetation includes *Scirpus microcarpus* (small-fruited bulrush) (top left), San Francisco rush (top right), and Pacific cinquefoil (bottom).

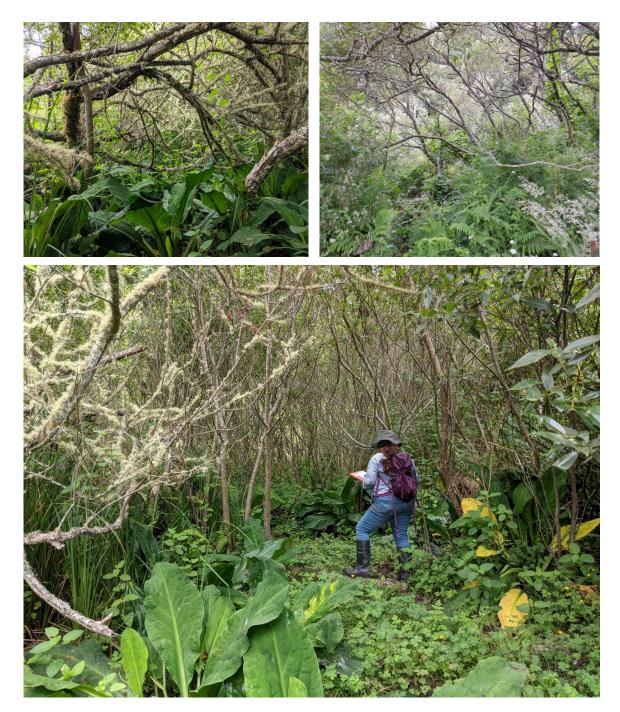
Figure C-8. Photographs illustrating conditions in the delineated palustrine broadleaved deciduous scrub-shrub and forested wetlands throughout the valley floor in Planning Area 1.

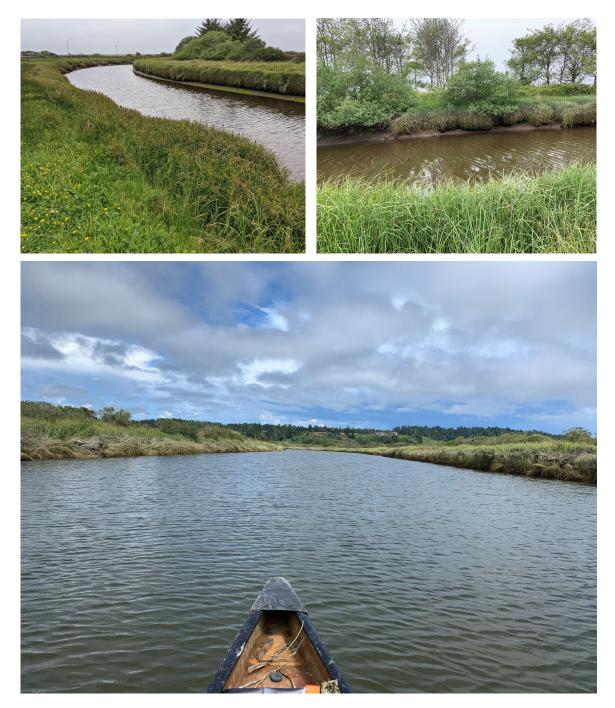
Figure C-9. Photographs of Elk River, a listed navigable water of the U.S. within Planning Area 1. Mean high water line delineated at transition from unconsolidated shore to intertidal estuarine wetlands (visible in upper left and right photographs).

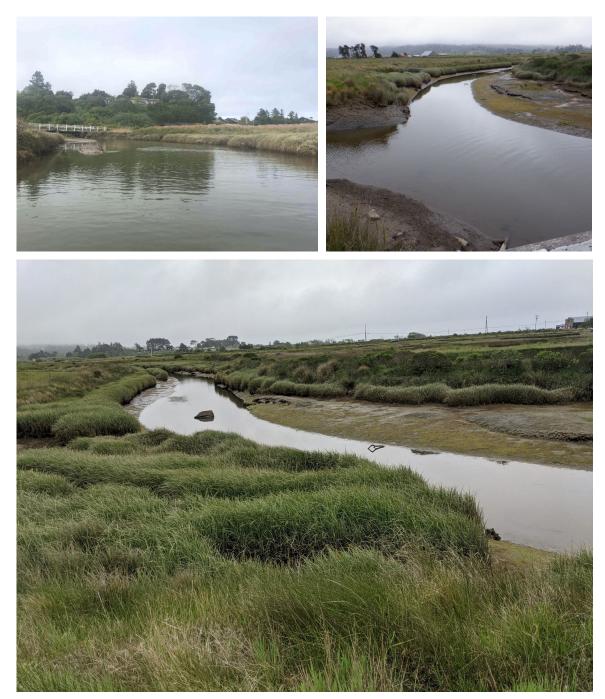
Figure C-10. Photographs of Swain Slough (estuarine tidal Other Waters of the U.S.) within Planning Area 1. Waters delineated to transition from unconsolidated shore to intertidal estuarine wetlands (visible in bottom photograph) since the HTL includes estuarine wetlands.

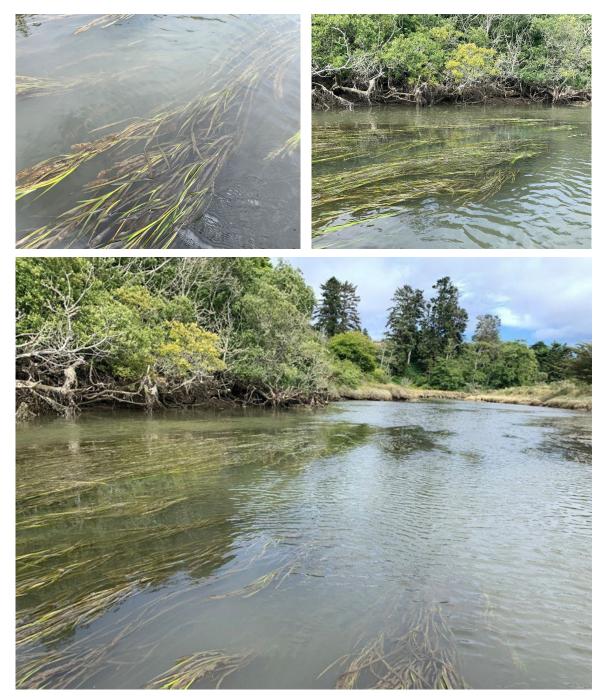
Figure C-11. Photographs of the intertidal aquatic eelgrass bed delineated in the Swain Slough channel within Planning Area 1.

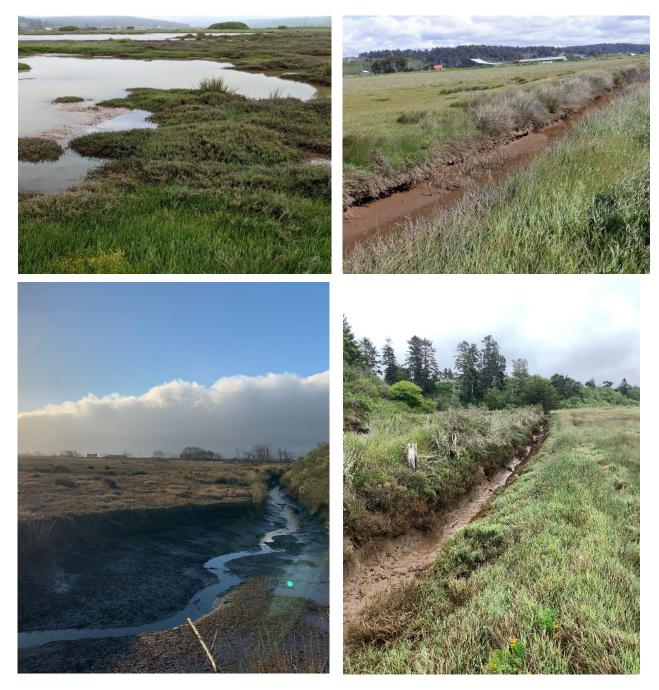
Figure C-12. Photographs illustrating conditions of estuarine tidal drainages (Other Waters of the U.S.) with unconsolidated bottom associated with Swain Slough and Elk River in Planning Area 1.

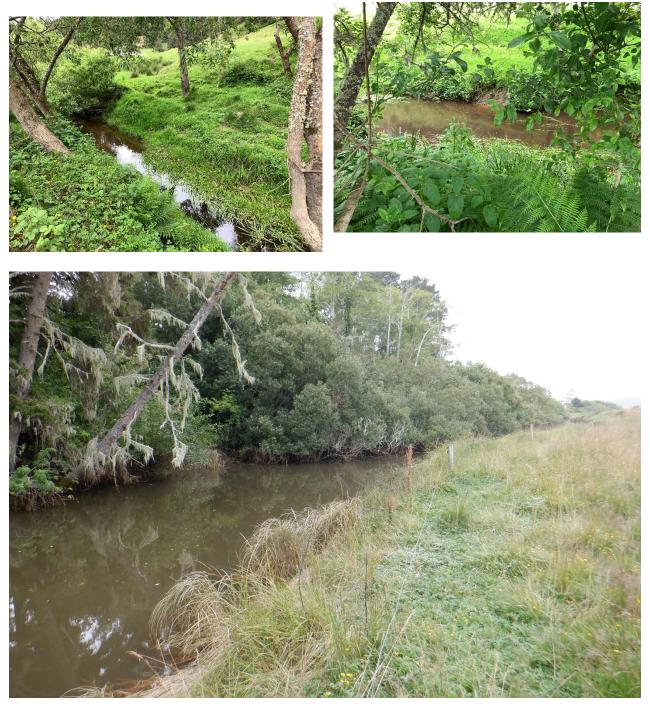
Figure C-13. Photographs illustrating conditions of estuarine and riverine tidal waters of Elk River (Other Waters of the U.S.) in Planning Area 1. Where riparian woody vegetation was noted within the HTL/OHWM it was defined as Vegetated -Other Waters of the U.S.

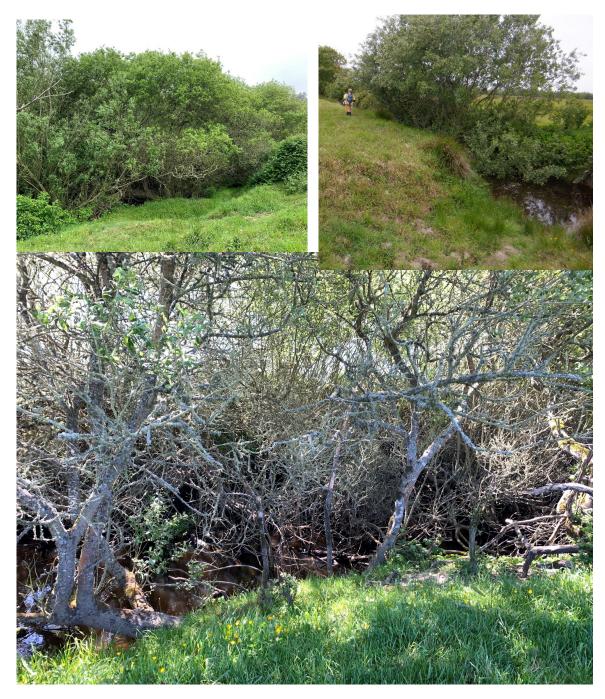
Figure C-14. Photographs illustrating conditions of palustrine broadleaf deciduous scrub/shrub wetlands rooted below HTL/OHWM associated with Vegetated - Other Waters of the U.S in Planning Area 1.
