FINAL REPORT • MAY 2023

Elk River Planning Area 1: 10% Design Report

Northern Hydrology and Engineering
P.O. Box 2515
McKinleyville, CA 95519

Stillwater Sciences
850 G Street, Suite K
Arcata, CA 95521

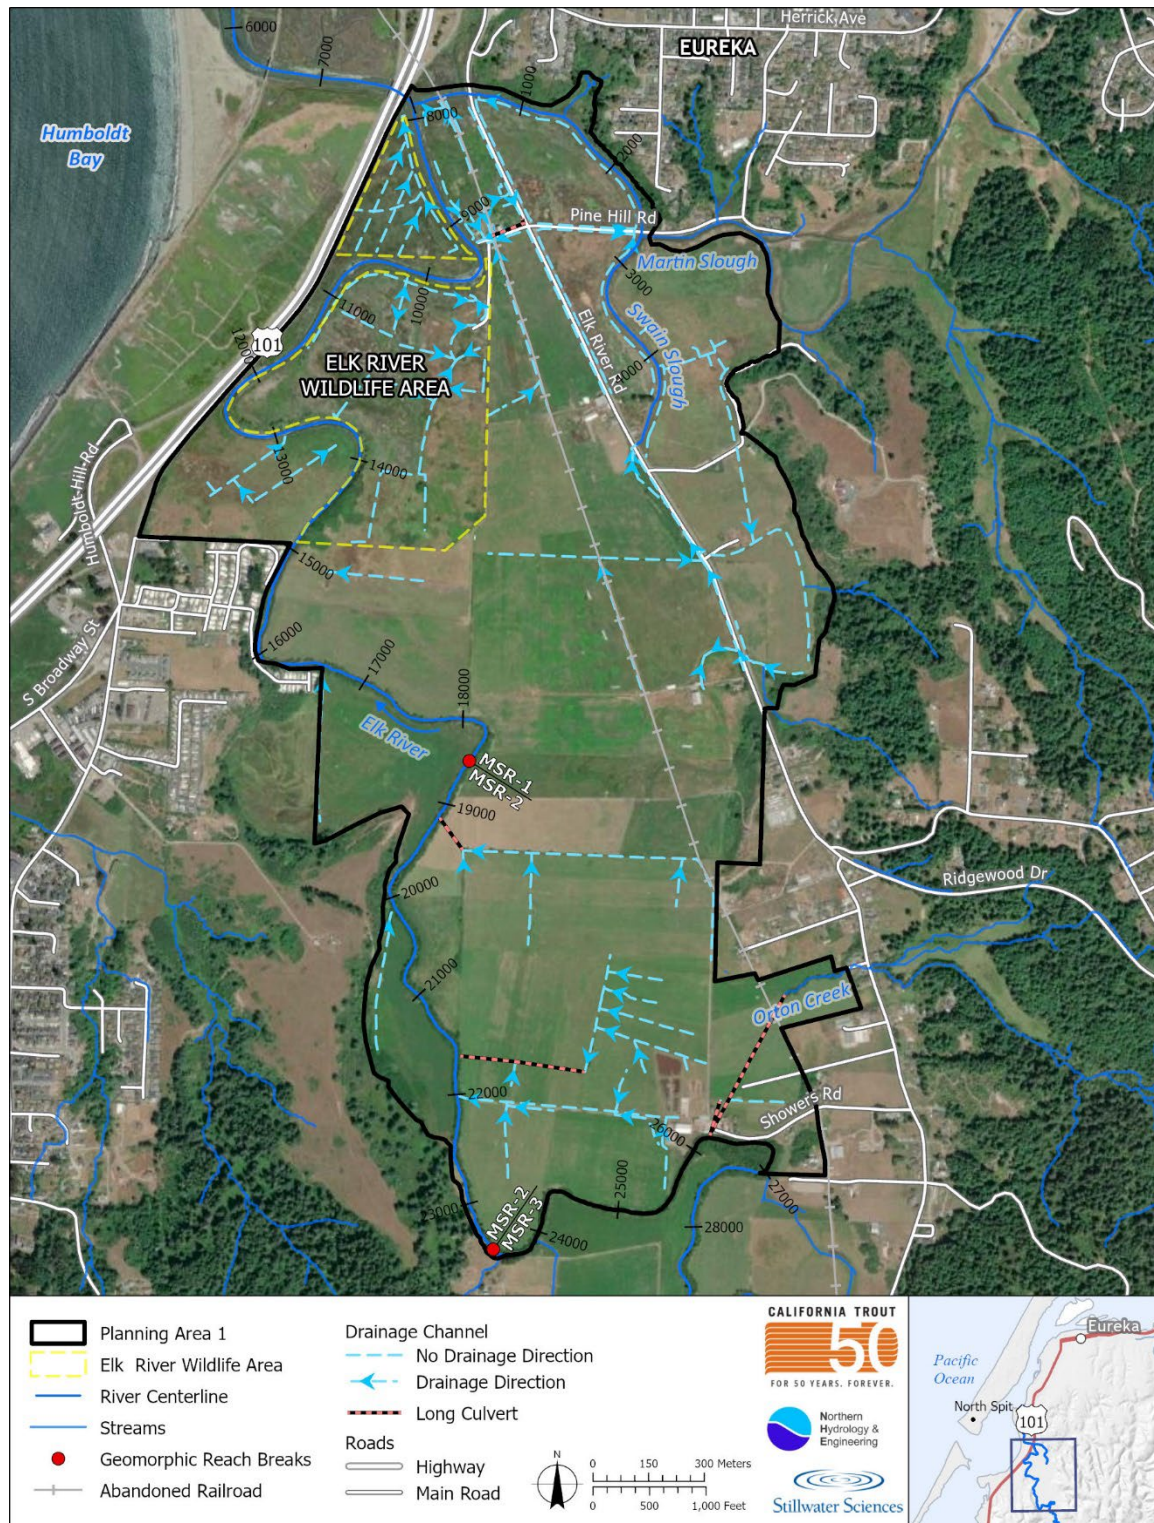
Figure 1-2. Map of Elk River Planning Area 1. River stationing represents the distance (ft) upstream from the Humboldt Bay confluence.

PA-1 is generally bounded to the south-west by the Elk River itself and to the north-east by Swain Slough and Elk River Road. The Elk River – Swain Slough confluence is at the very downstream end of PA-1, just upstream of HWY 101 at Sta. 7800; PA-1 extends up the sinuous Elk River to Showers Road. The total length of the channel, including Elk River and Swain Slough is 20,500 feet [ft] or 3.8 miles. Martin Slough branches off Swain Slough but is not considered part of our Stewardship Area or Recovery Plan.

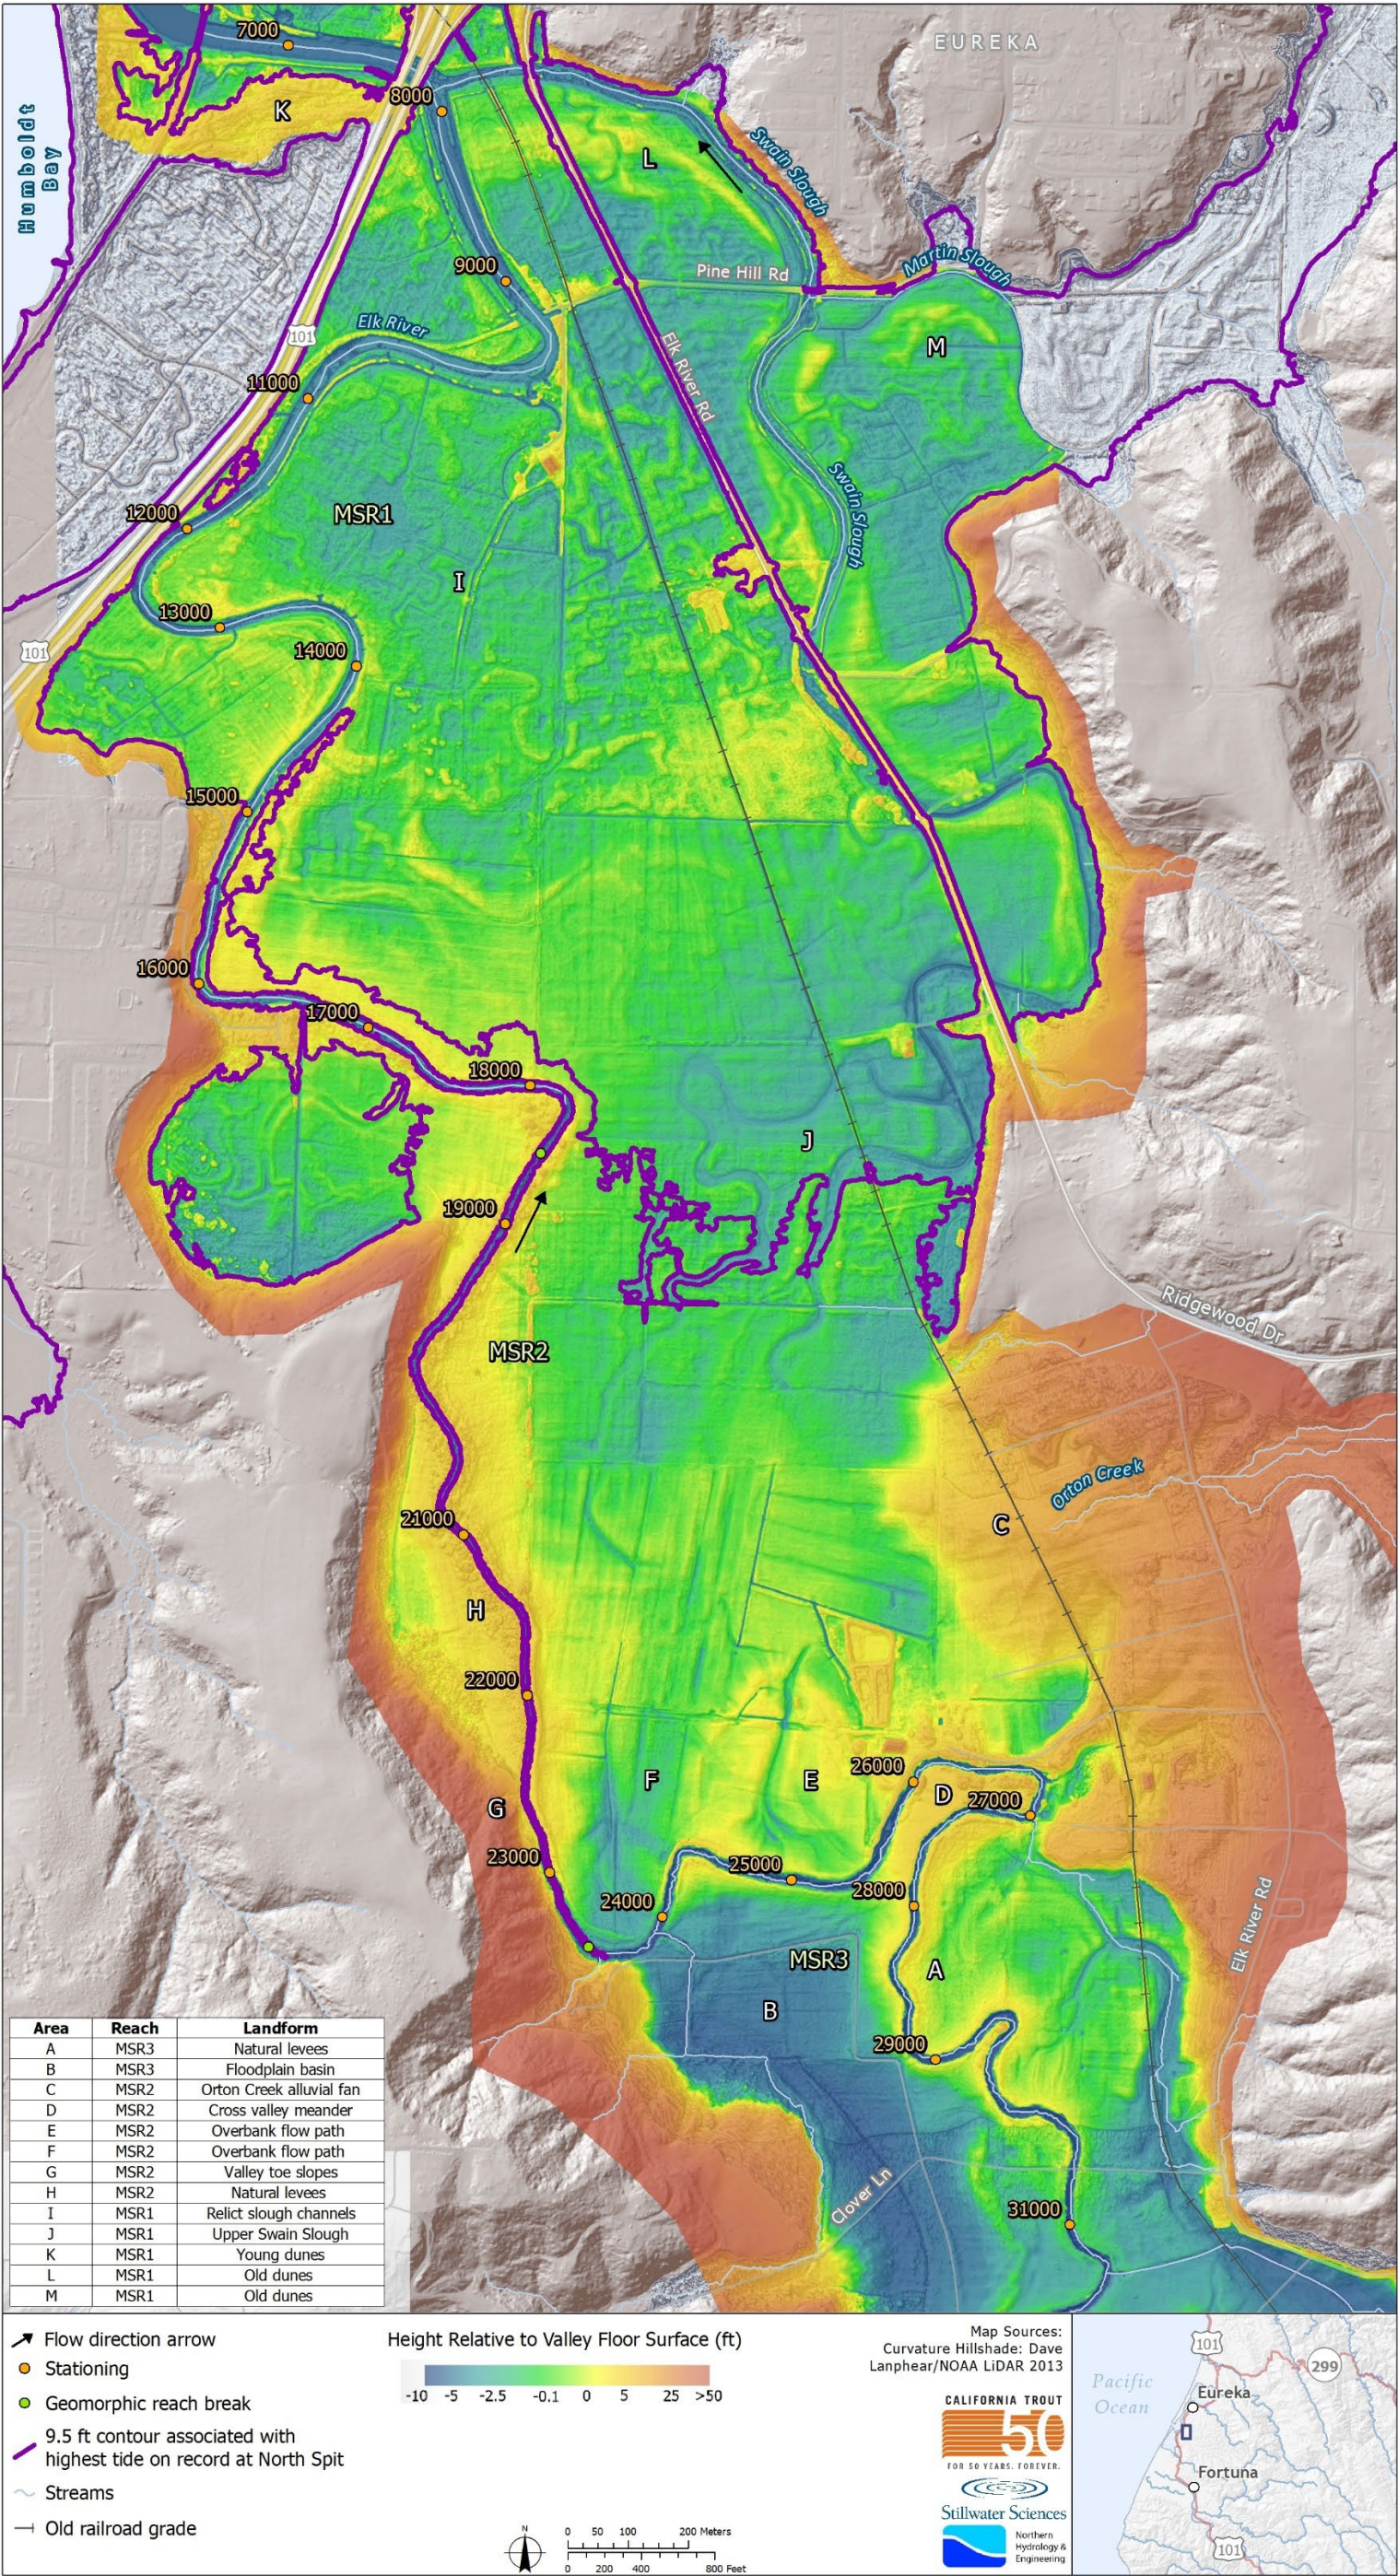
Figure 2-1. Valley bottom landforms.

Two main secondary flow paths (Figure 2-1, Features E and F) convey overbank flow through the relatively high floodplain topography in MSR2 near the end of Showers Road. These channels coalesce down-valley floodplain flow moving across the Elk River channel and convey it through the MSR2 floodplain into the former estuary (MSR1). These secondary flow paths, as well as Orton Creek, form the historical headwaters for Swain Slough.

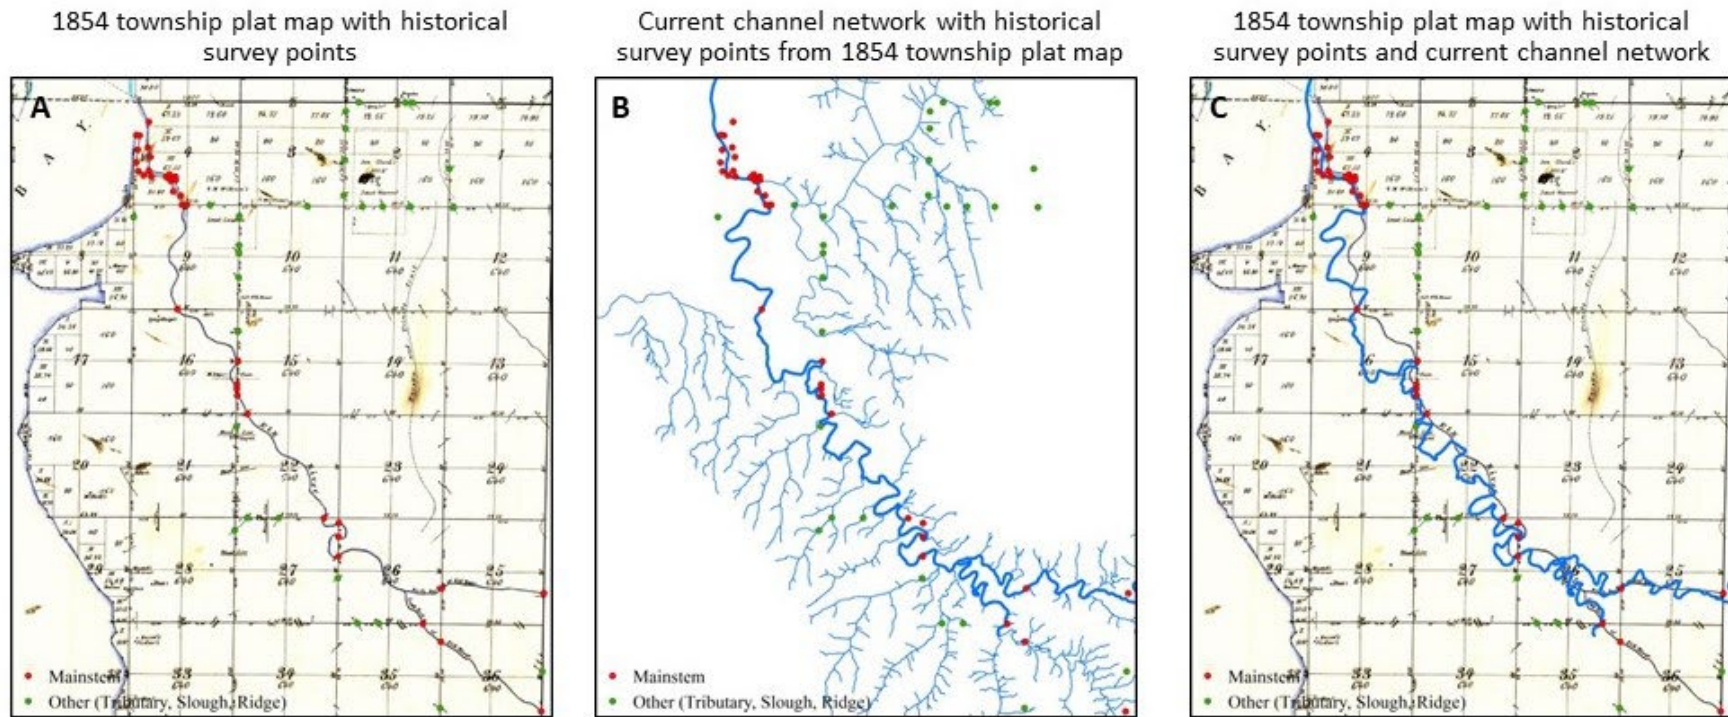
Figure 2-2. Comparison of historical 1854 mainstem Elk River channel planform to current channel conditions.

We used the 1854 Township Plat Map and information from the original surveyors notes to compare the historical mainstem Elk River channel planform to current conditions (Figure 2-2). The primary purpose of the 1854 plat map surveys was to document property information rather than information about the terrain, and as such, the standard surveying procedures involved traversing the Township and Range lines, typically recording observations about the topography and vegetation only at the intersections of major channels. The channels represented on the 1854 plat map therefore are qualitatively interpreted between the points of intersection and are often depicted in much simplified form relative to the actual channel planform. The points of intersection from the 1854 surveys were digitized, rubber-sheeted, and overlaid onto existing LiDAR-derived hydrography to assess the degree of correspondence between historical and current mainstem Elk River channel planform (Figure 2-2). The results indicate that although the

mainstem channel depicted on the 1854 plat map appears substantially more simplified than current channel conditions, the points of intersection nearly all correspond with current channel planform locations. Although the US Coast and Geodetic Survey maps focus almost exclusively on the Humboldt Bay shoreline and Pacific Coast margin, the earliest map from 1916 also depicts the lower approximately 4.5 miles of the mainstem Elk River channel in nearly the same channel planform as current conditions. We strongly infer from these results that the mainstem Elk River channel has maintained a stable planform throughout Planning Area 1 with little change since at least 1854. The degree of mainstem channel modification prior to 1854 is unknown, however, it is unlikely that large scale, mechanized channel modification (e.g., relocation of mainstem channel to the southern edge of the valley) occurred during the period of early Anglo-American settlement prior to 1884.

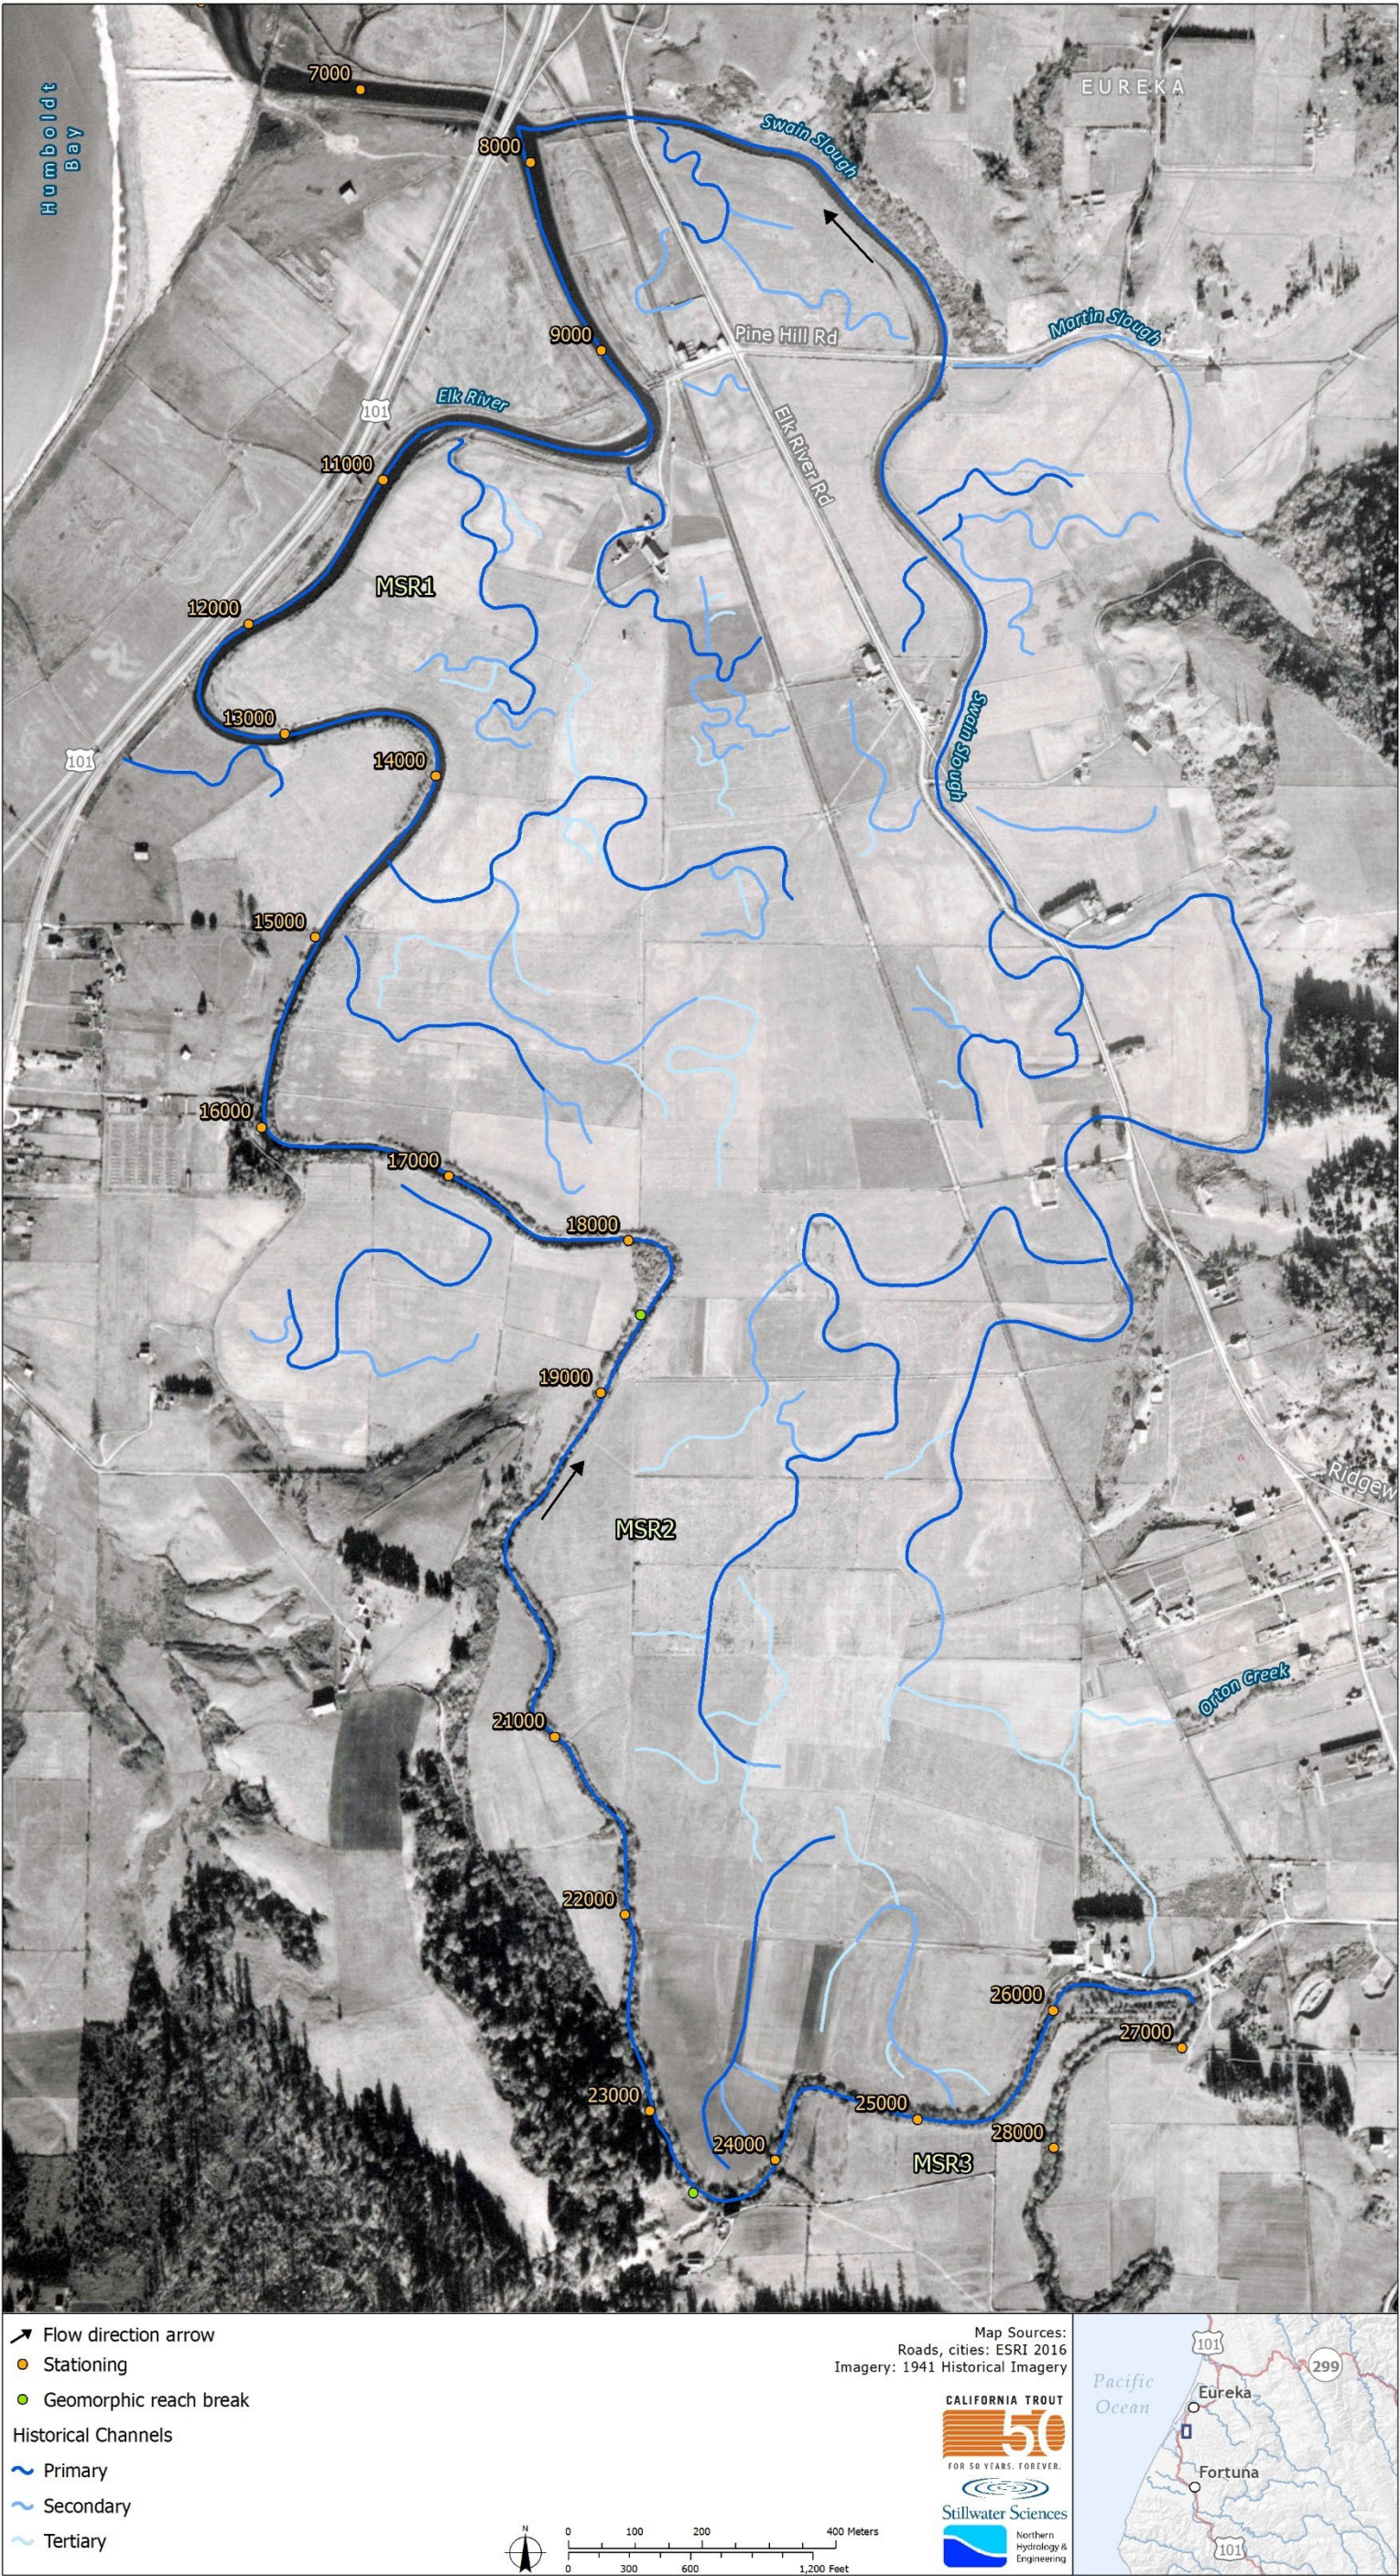
Figure 2-3. Historical tidal slough and tributary channel network shown on aerial imagery from 1941.

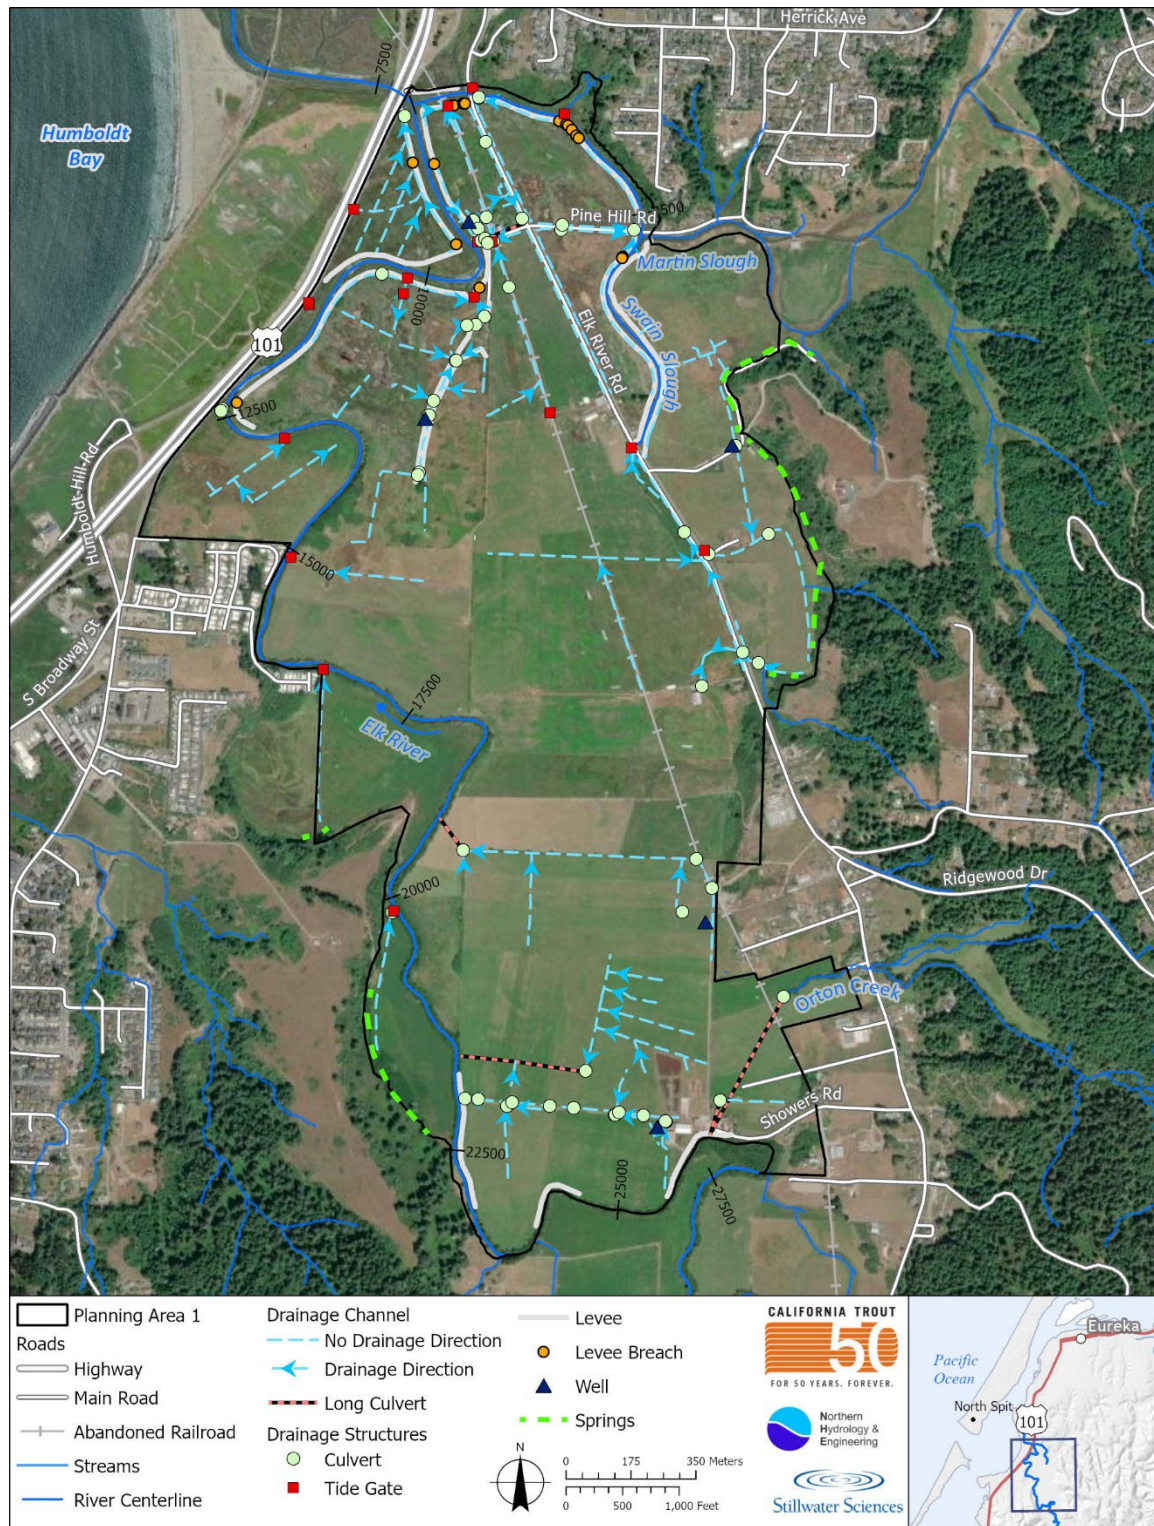
Figure 2-4. Sources of water and drainage infrastructure in Planning Area 1.

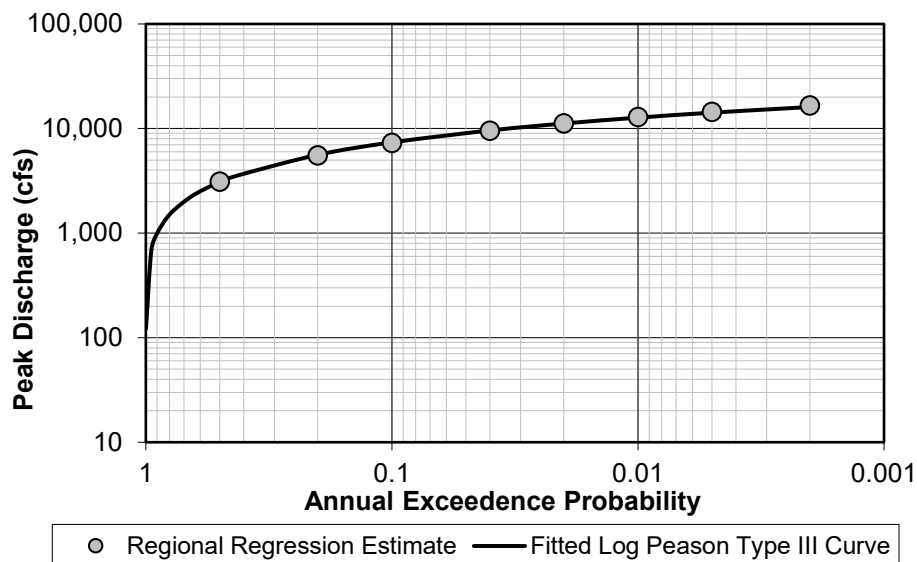
**Figure 2-5.** Example of flood-frequency results for the Elk River at the upstream extent of Planning Area 1; regional regression equation and fitted Log-Pearson III curve.

Peak flows less than the 2-year event were developed by extending the regional equation flood-frequency estimates by fitting a Log Pearson Type III (LP3) curve using LP3 frequency factors (Chow et al. 1988), and the regional skew value for the site. The LP3 fitting technique uses Excel Solver to determine the mean and standard deviation of hypothetical flood values (assuming the regional skew value) that minimizes the difference between the regional equation and LP3 peak flood estimates. Figure 2-5 shows an example of the regional equation peak flood estimates and the fitted LP3 curve determined for the Elk River at the upstream extent of PA-1. Table 2-2 and summarizes the peak flow estimates conducted for the hydraulic analysis.

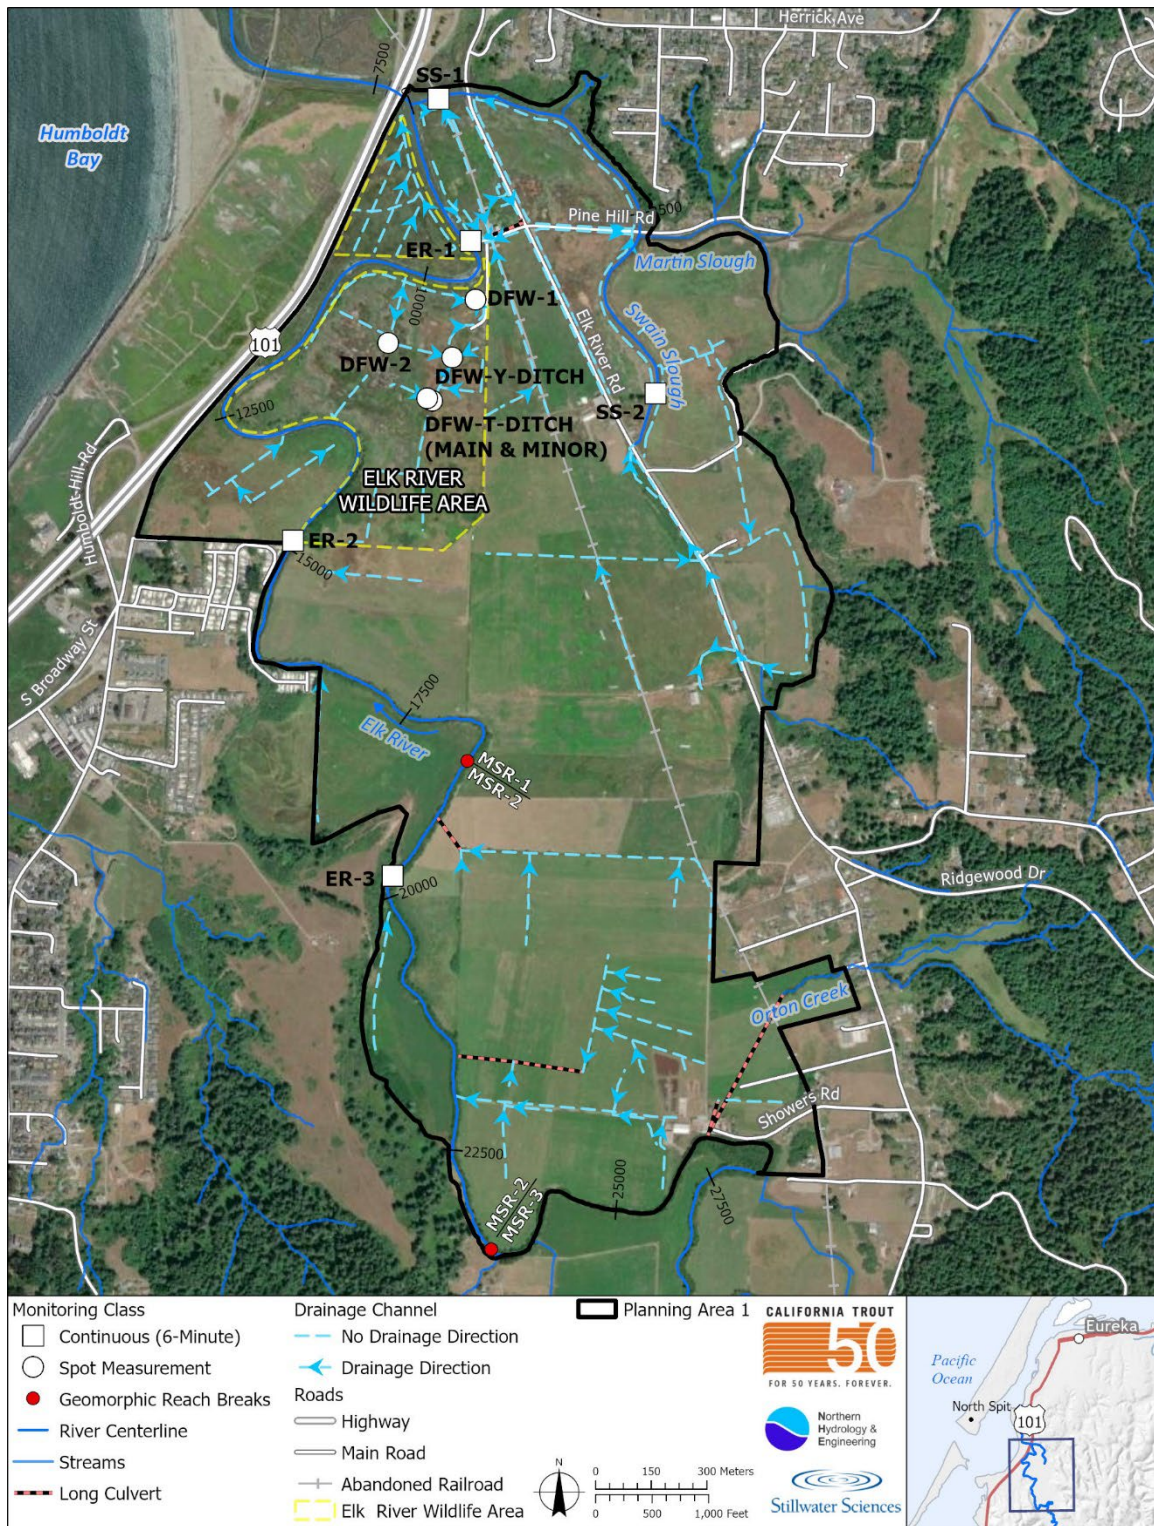
Figure 2-6. Water level, salinity, and temperature monitoring sites in Planning Area 1.

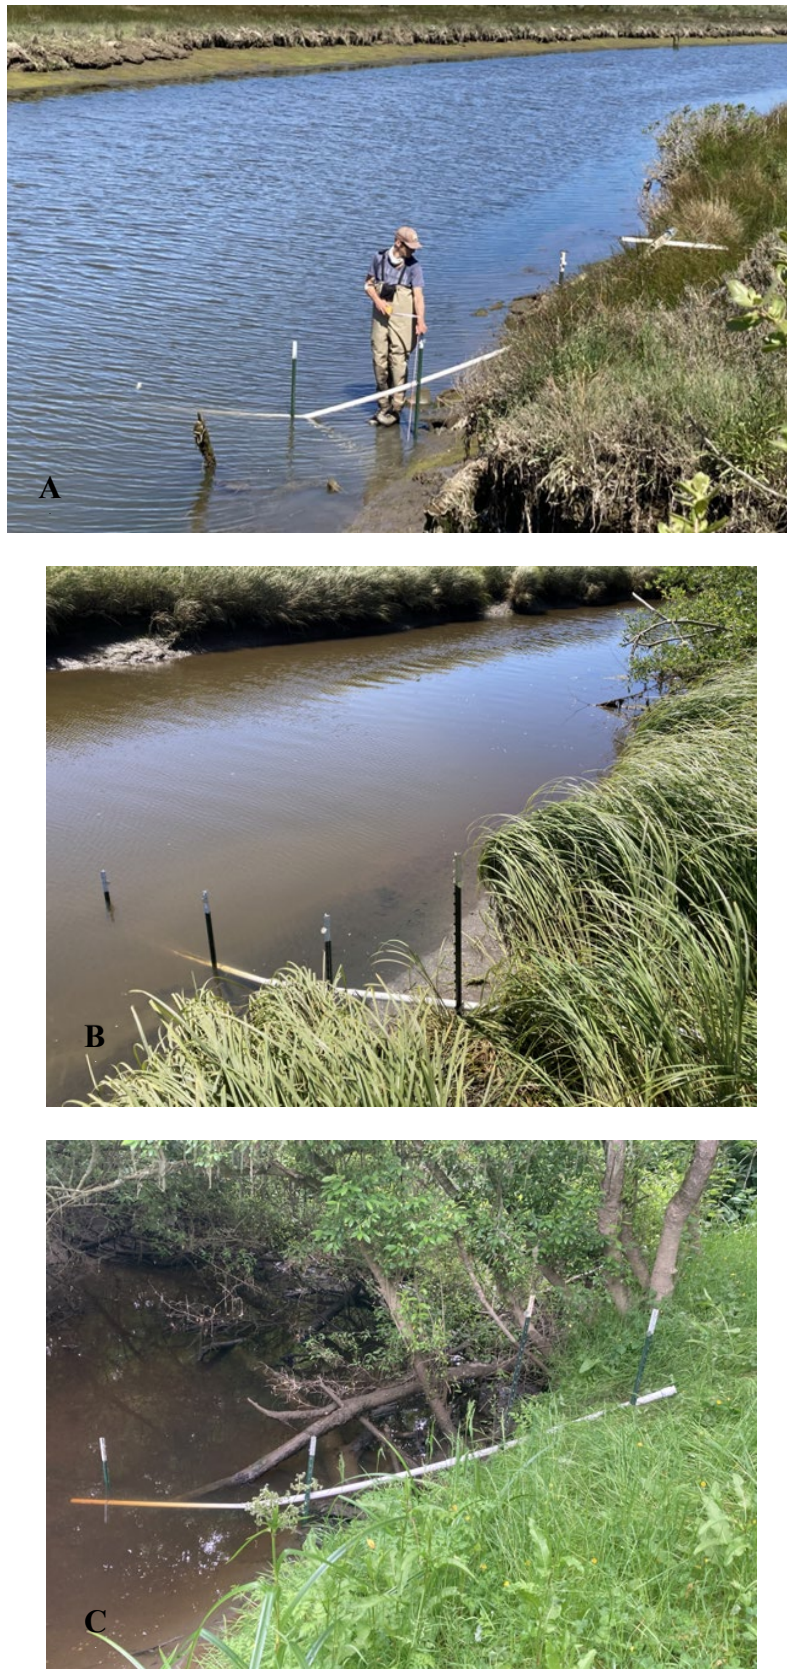
Figure 2-7. Elk River monitoring sites, ER-1 (A), ER-2 (B), ER-3 (C).

Three sites were monitored on the Elk River (Figure 2-6 and Figure 2-7). The downstream most site, ER-1, is located near Pine Hill Road at STA 9,920. ER-1 is 1,350 ft upstream of the confluence with Swain Slough and 430 ft downstream of the primary tide gate controlling water levels in the southern portion of the ERWA. ER-2 is located at STA 14,920, at the southern boundary of the ERWA. ER-3 is located at STA 19,800. The tidal influence extends to about STA 25,000 where the bed elevation of the channel is equal to the highest tide on record.

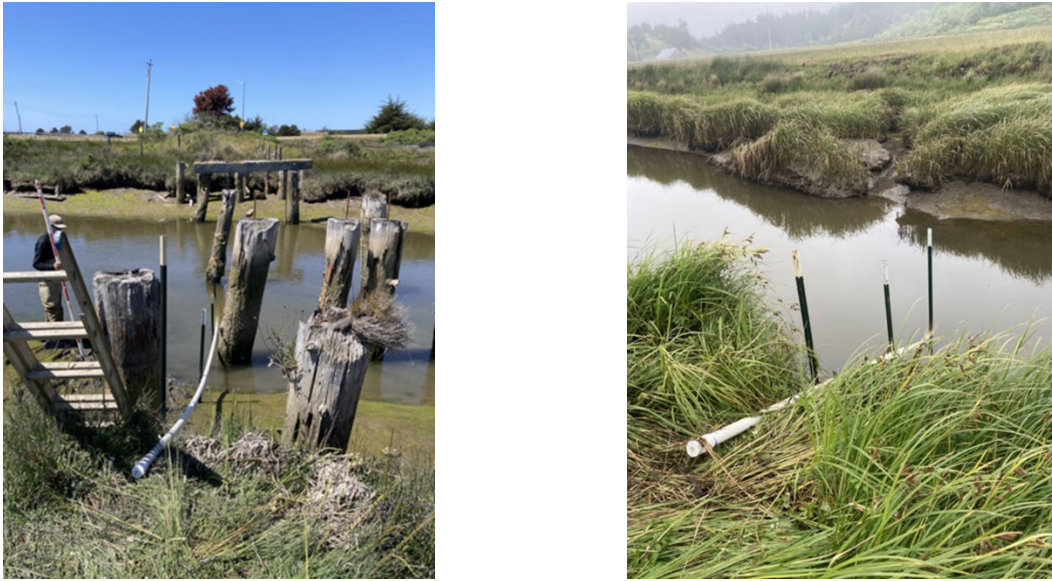
Figure 2-8. Swain Slough monitoring sites, SS-1 (left) and SS-2 (right).

Swain Slough currents extends 4,480 ft from the Elk River at STA 7,870 to a tide gate at Elk River Road (TG-100) (Figure 2-6). Martin Slough, a major slough channel and tributary, enters Swain Slough 2,700 ft upstream of the Elk River. Two sites were monitored on Swain Slough (Figure 2-6 and Figure 2-8). The downstream most site, SS-1 is located at the abandoned railroad crossing (STA 250). The upstream site is located at STA 4,360 which is 1,660 ft upstream of Martin Slough, and 480 ft downstream of the tide gate (TG-100) at Elk River Road.

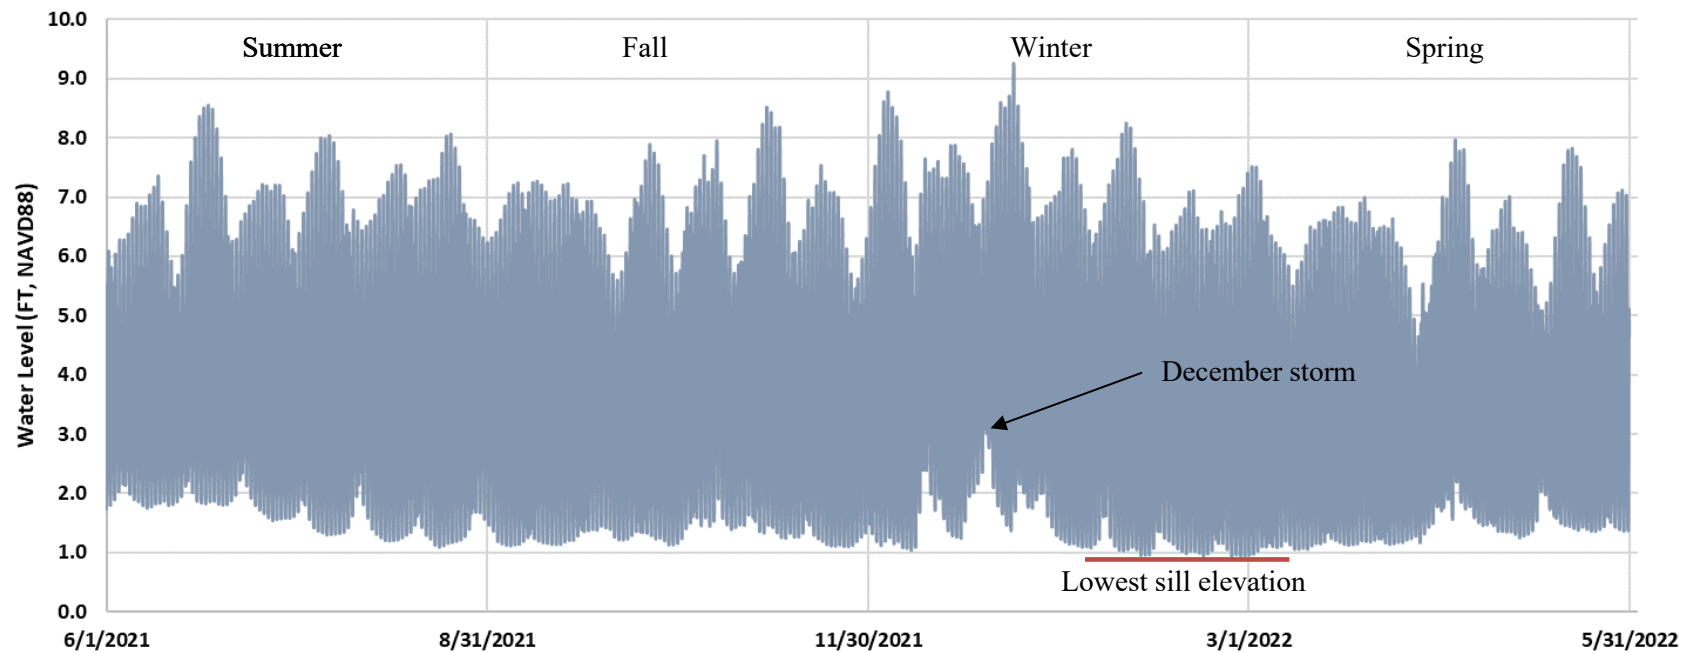
Figure 2-9. Example water level during monitoring period at ER-1. The sill elevation controls the minimum water level at ER-1, ER-2, SS-1 and SS-2.

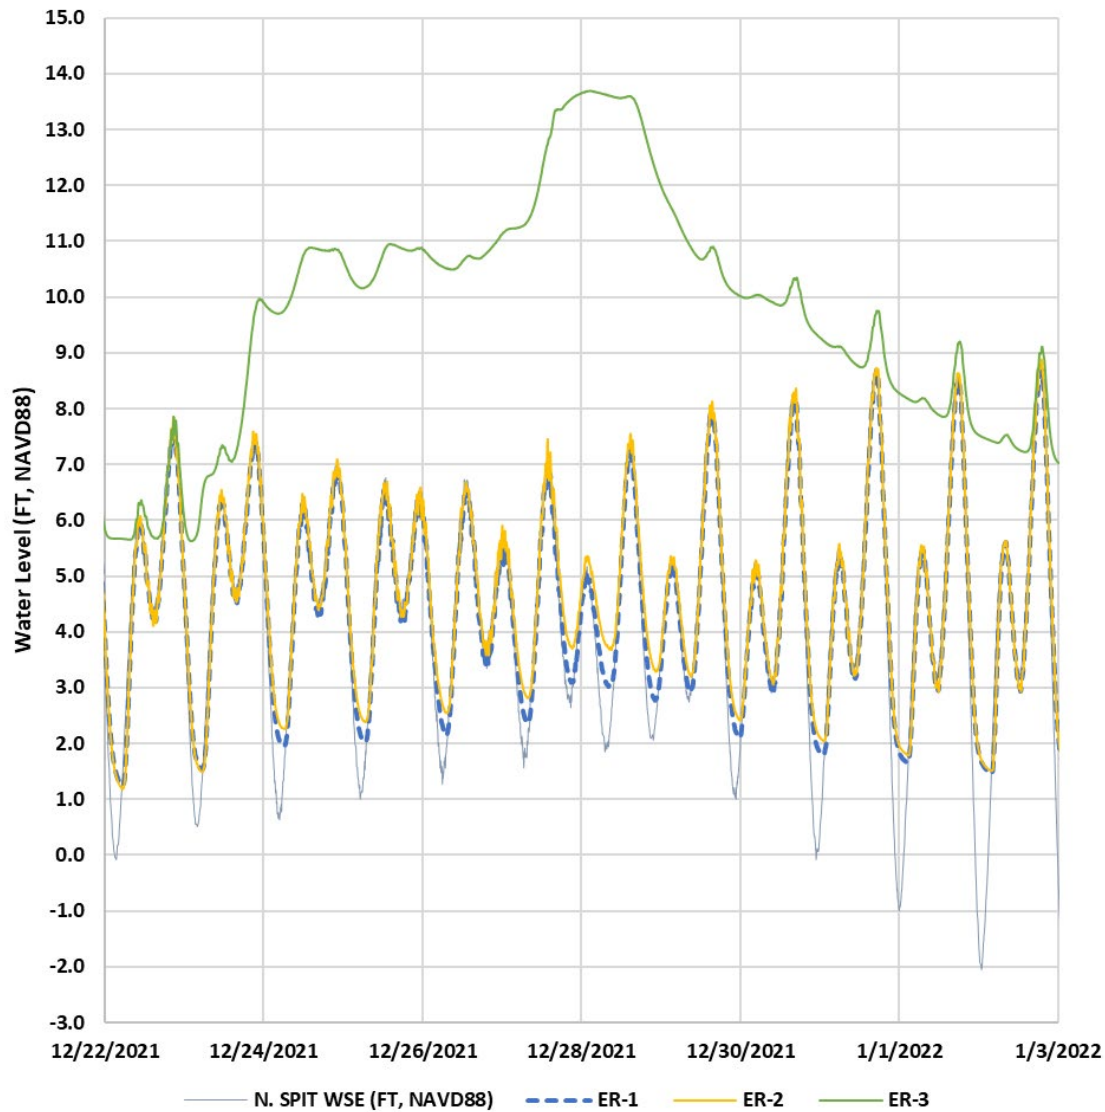
Figure 2-10. Water level at Elk River sites (ER-1, ER-2, ER-3) and North Spit during the December storm.

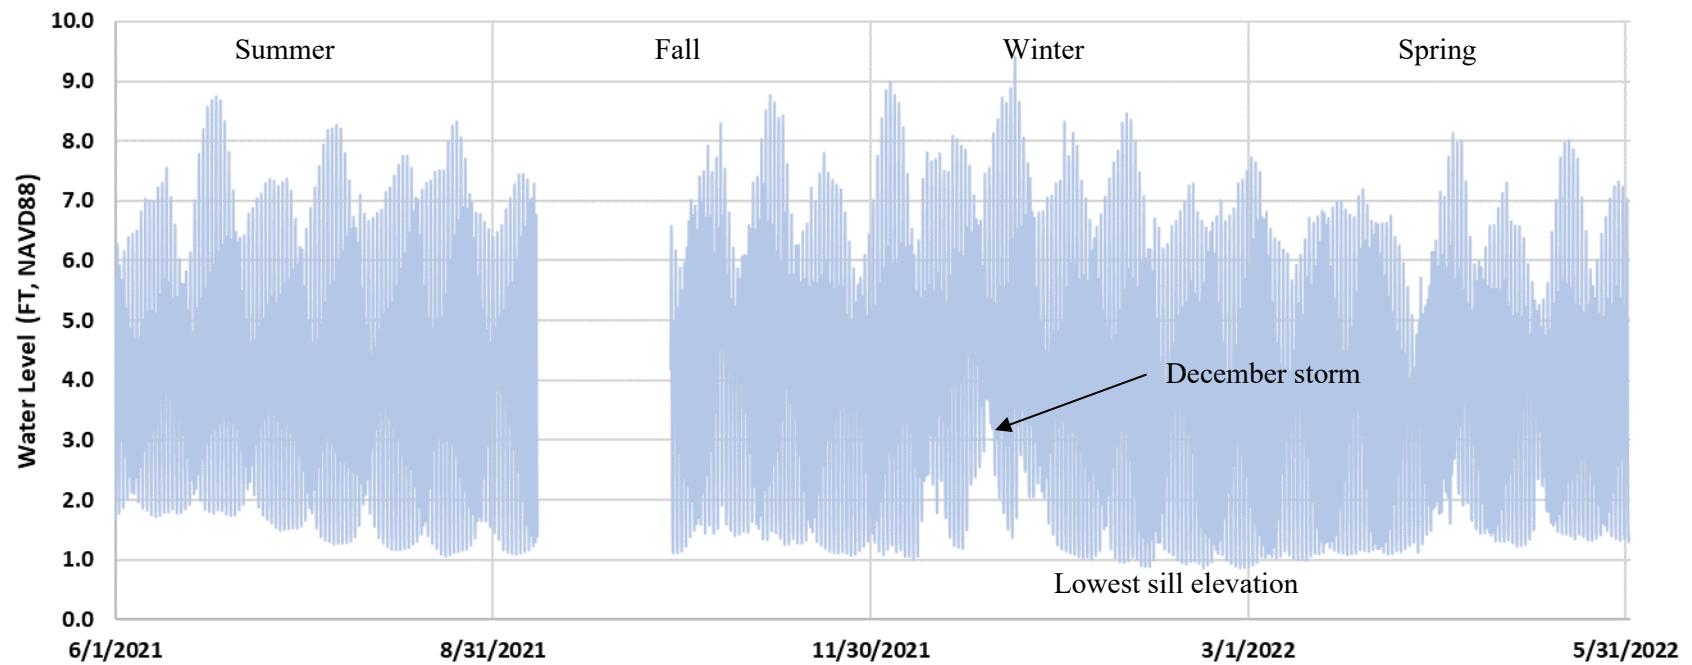
Figure 2-11. Water level during monitoring period at ER-2.

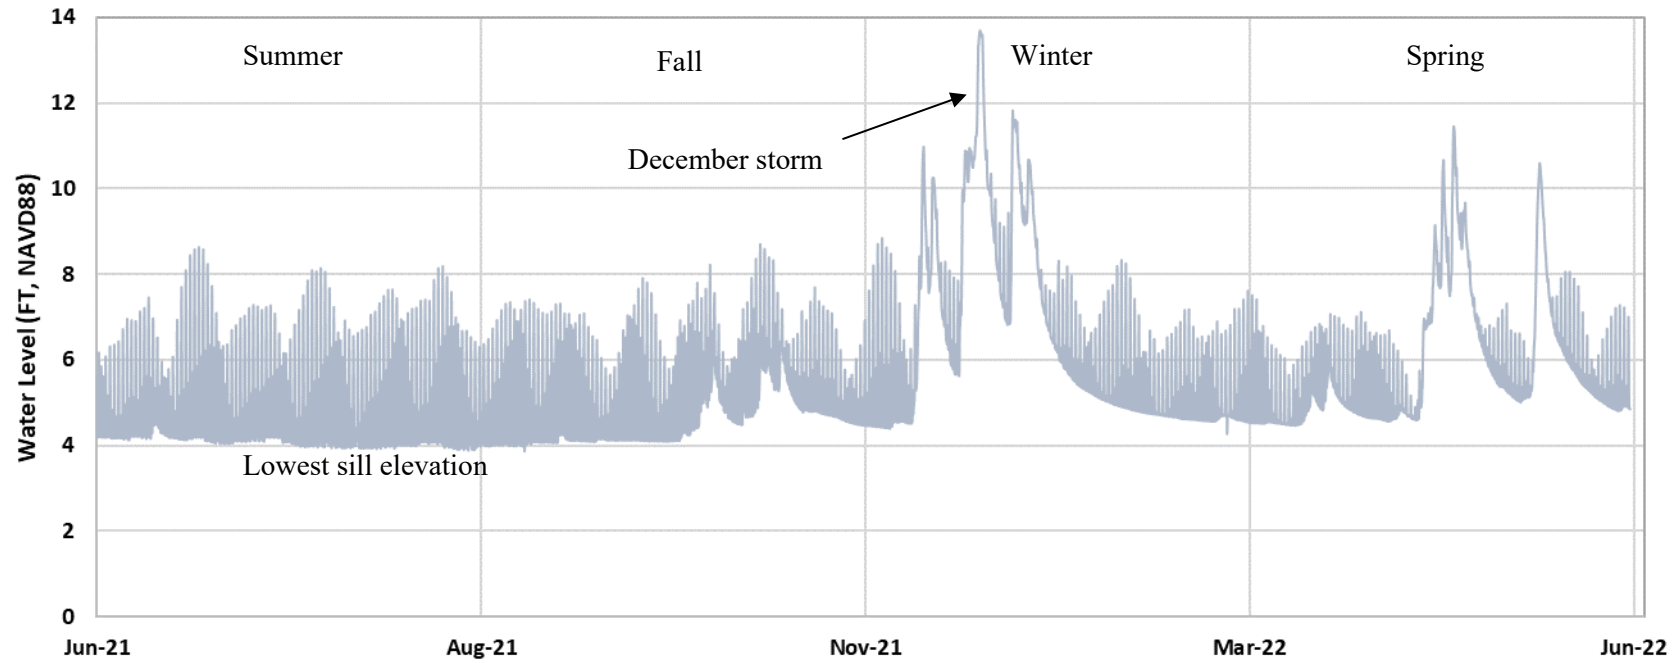
Figure 2-12. Water level during monitoring period at ER-3. A sill elevation of ~4 ft controls the minimum water level during low stream flows.
