FINAL REPORT • MAY 2023

Elk River Planning Area 1: 10% Design Report

Northern Hydrology and Engineering
P.O. Box 2515
McKinleyville, CA 95519

Stillwater Sciences
850 G Street, Suite K
Arcata, CA 95521

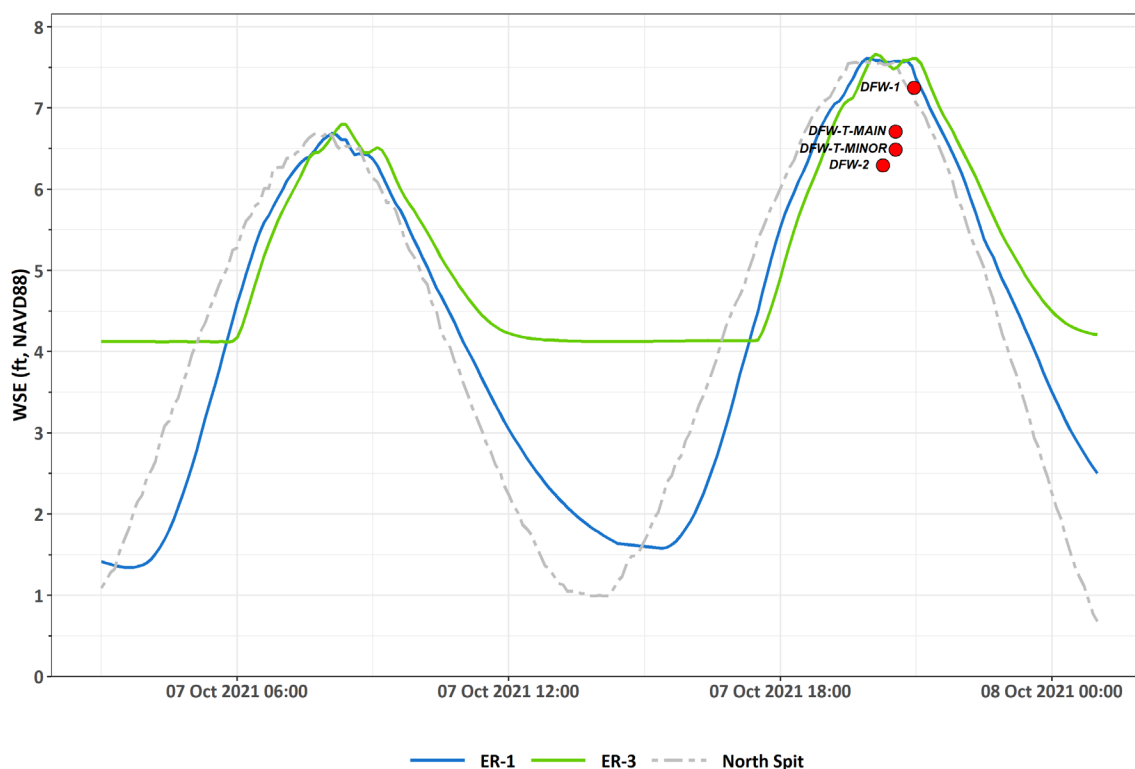
Figure 2-13. Water level at ER-1 and ER-3 and Elk River Wildlife Area monitoring sites compared to North Spit on October 7, 2021.

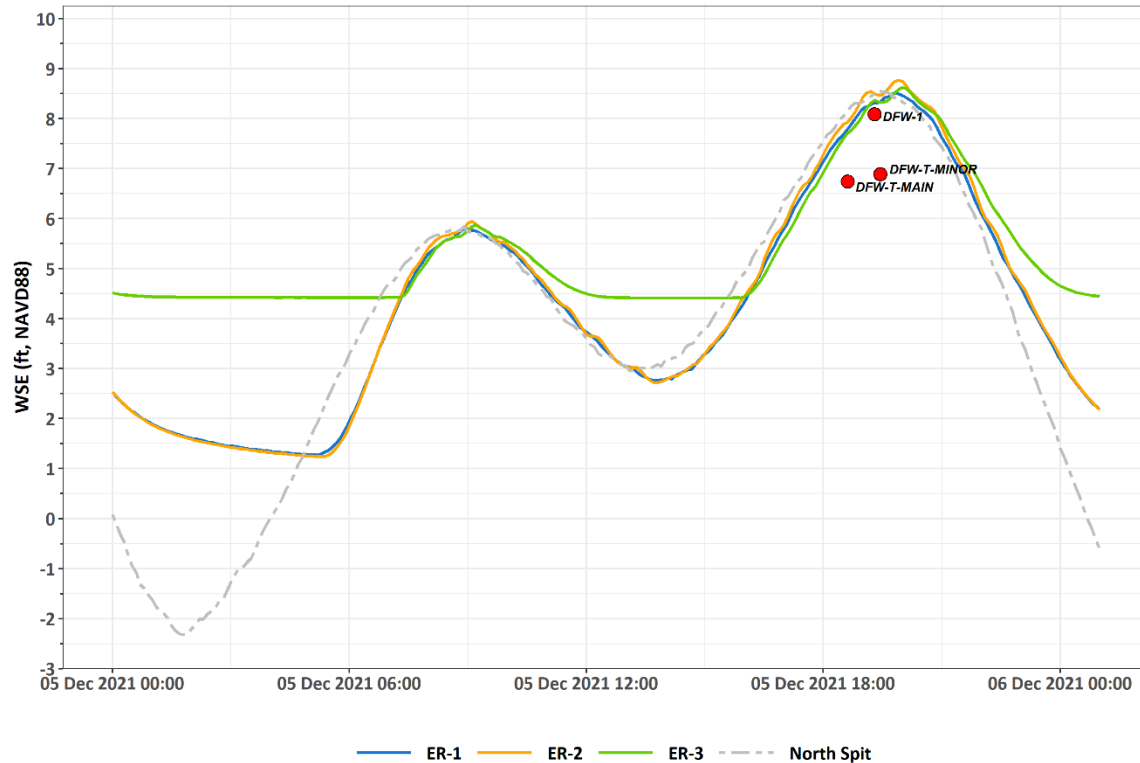
Figure 2-14. Water level within the Elk River Wildlife Area on December 5, 2021.

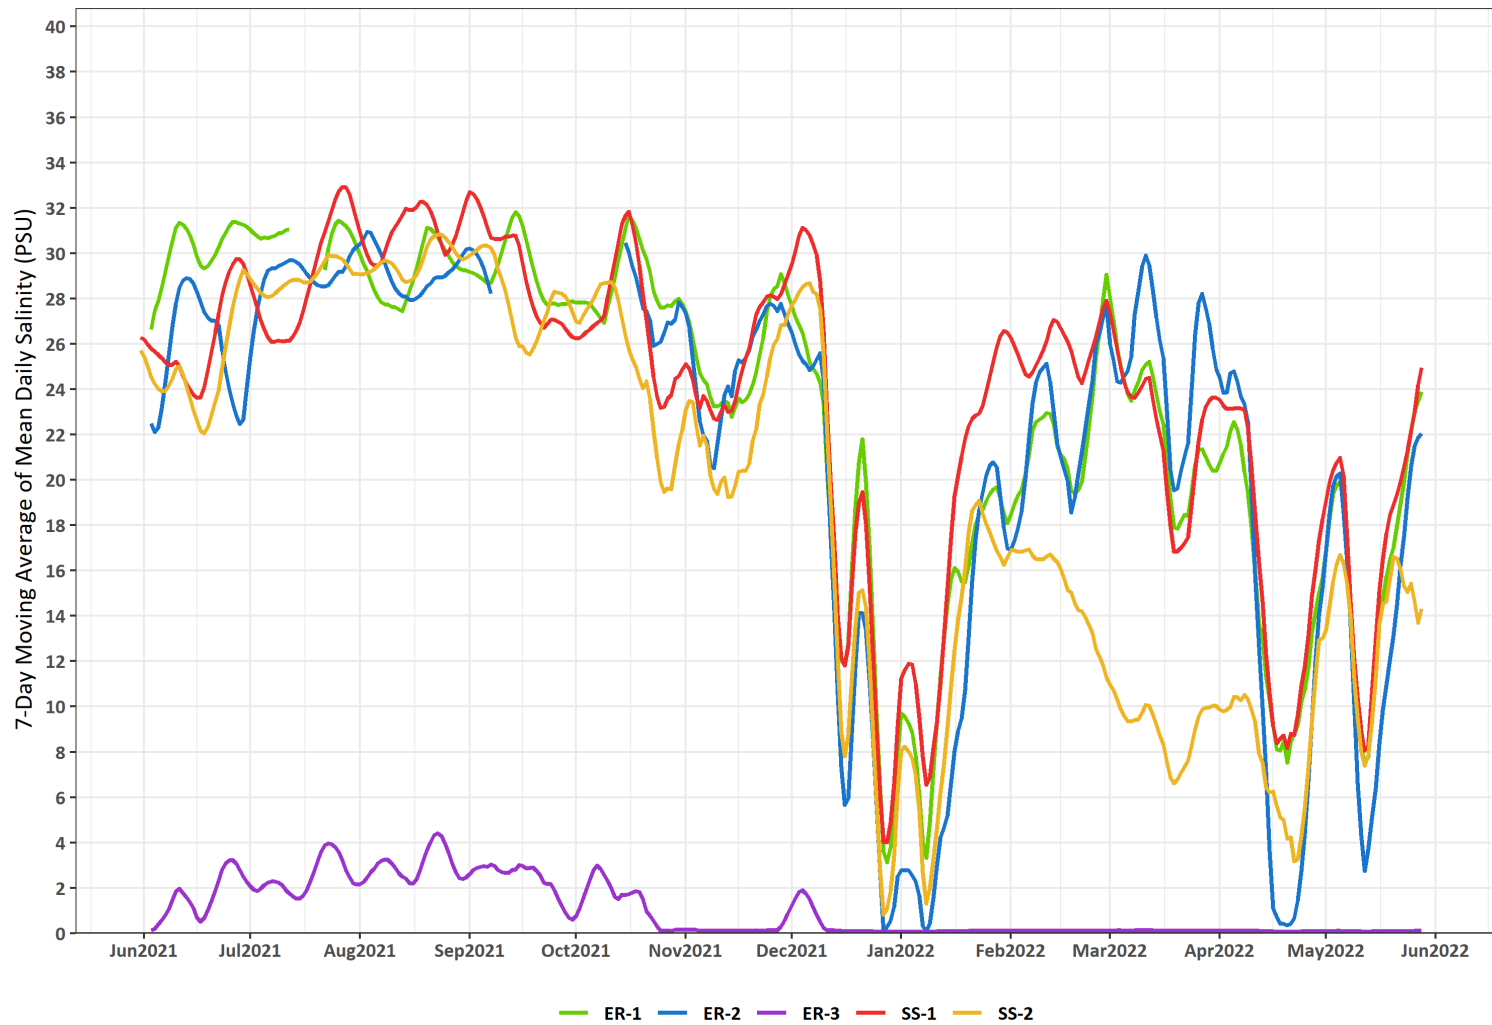
Figure 2-15. Seven-day moving average of the mean daily salinity at continuous monitoring sites on Elk River (ER-1, 2, and 3) and Swain Slough (SS-1 and 2).

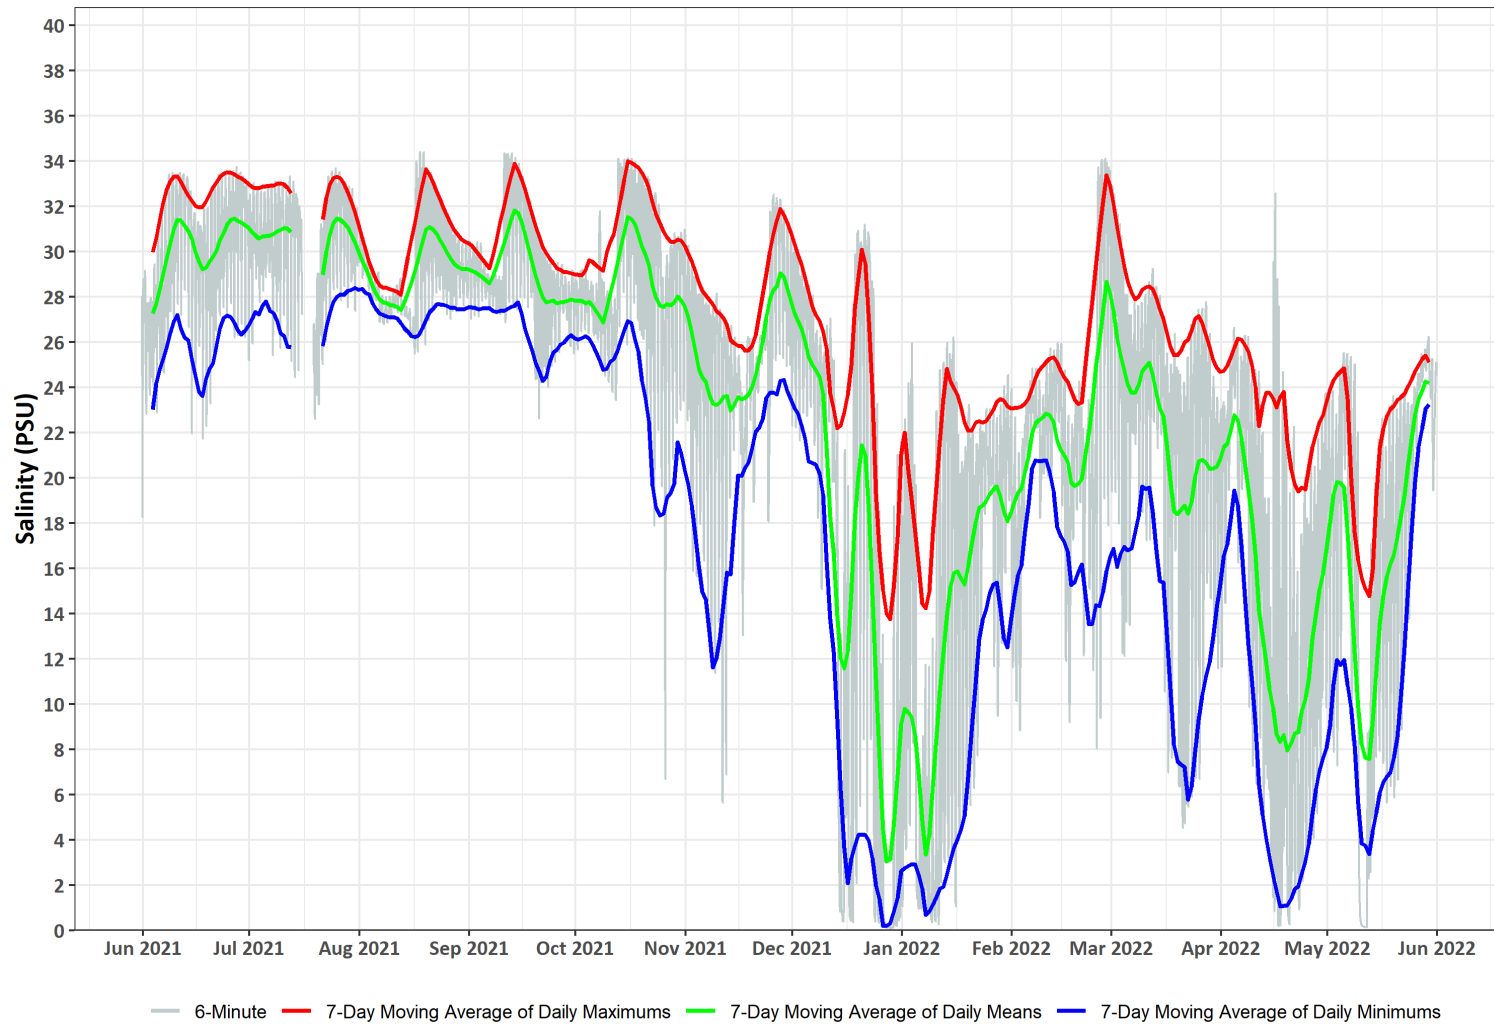
Figure 2-16. Seven-day average of daily maximum, mean and minimum salinity values at ER-1 during the monitoring period June 2021-June 2022.

Salinity stratification was detected at the lower Elk River monitoring sites (ER-1 and ER-2) during all seasons. During the summer months, ER-1 was stratified during 4 of 11 measurements. ER-2 was stratified whenever saline water was present (6 out of 8 measurements). The entire water column was fresh during the two samples dates that no stratification was detected. The more consistent stratification at ER-2 may be due to larger influence of stream flows and fewer opportunities for vertical mixing. During the summer and fall, the upper layer is brackish (7–18 ppt) and during the winter and spring the upper layer is fresh (<5 ppt). The fresher zone of water is confined to the upper foot of the water column and the remainder of the water column is >20 ppt.

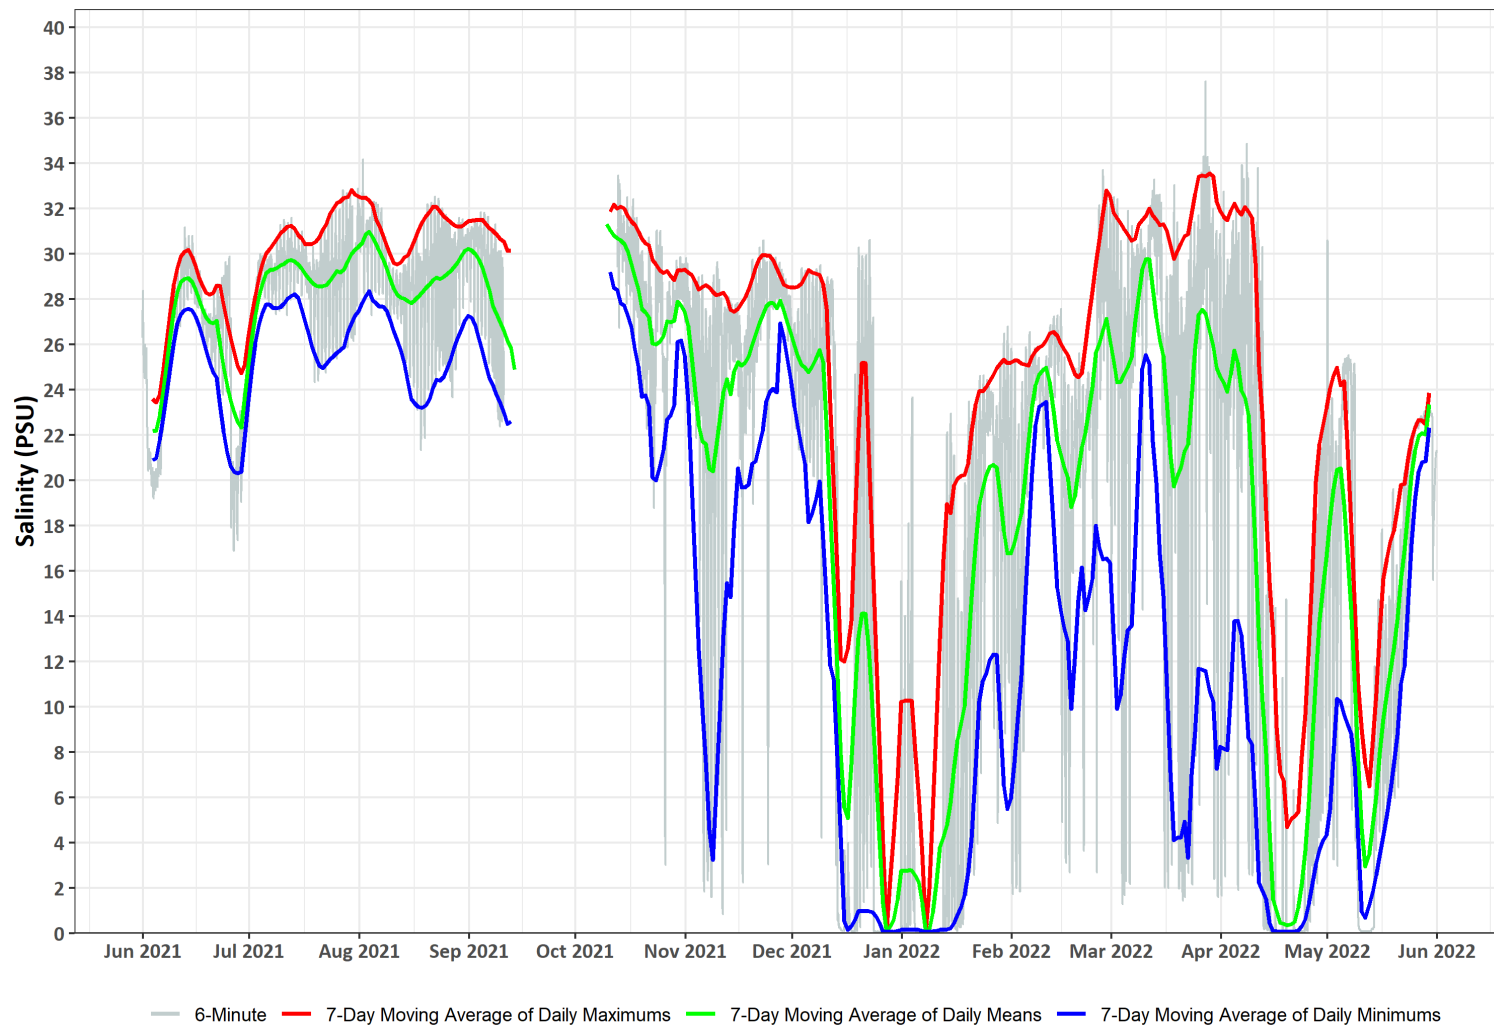
Figure 2-17. Seven-day average of daily maximum, mean and minimum salinity values at ER-2 during the monitoring period June 2021-June 2022.

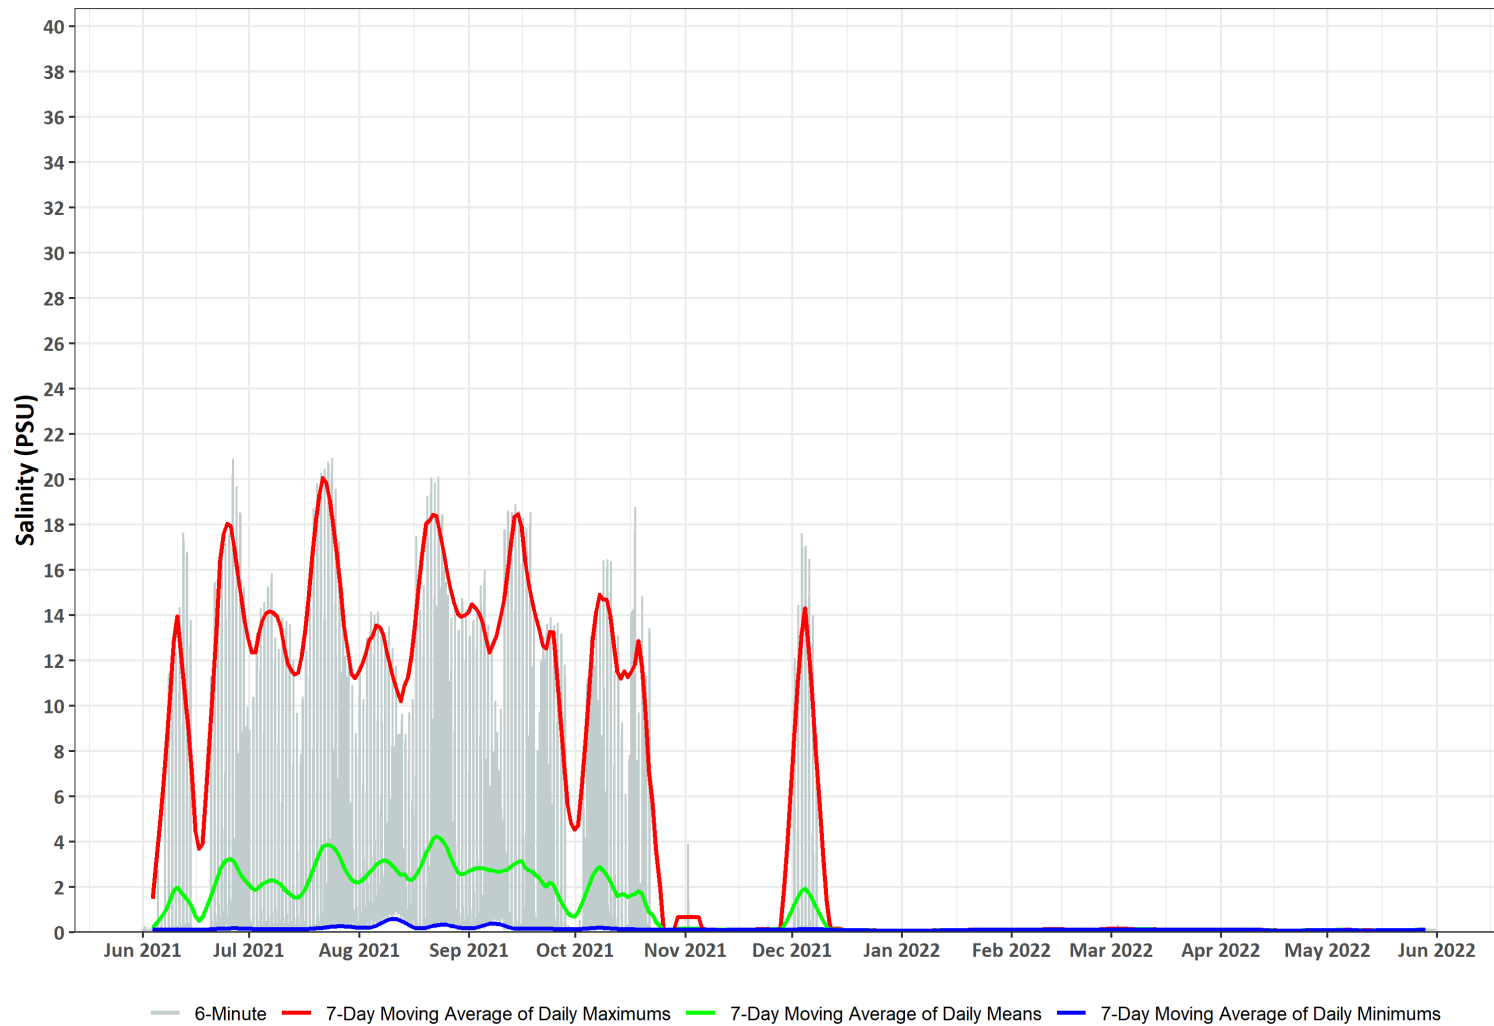
Figure 2-18. Seven-day average of daily maximum, mean and minimum salinity values at ER-3 during the monitoring period June 2021-June 2022.

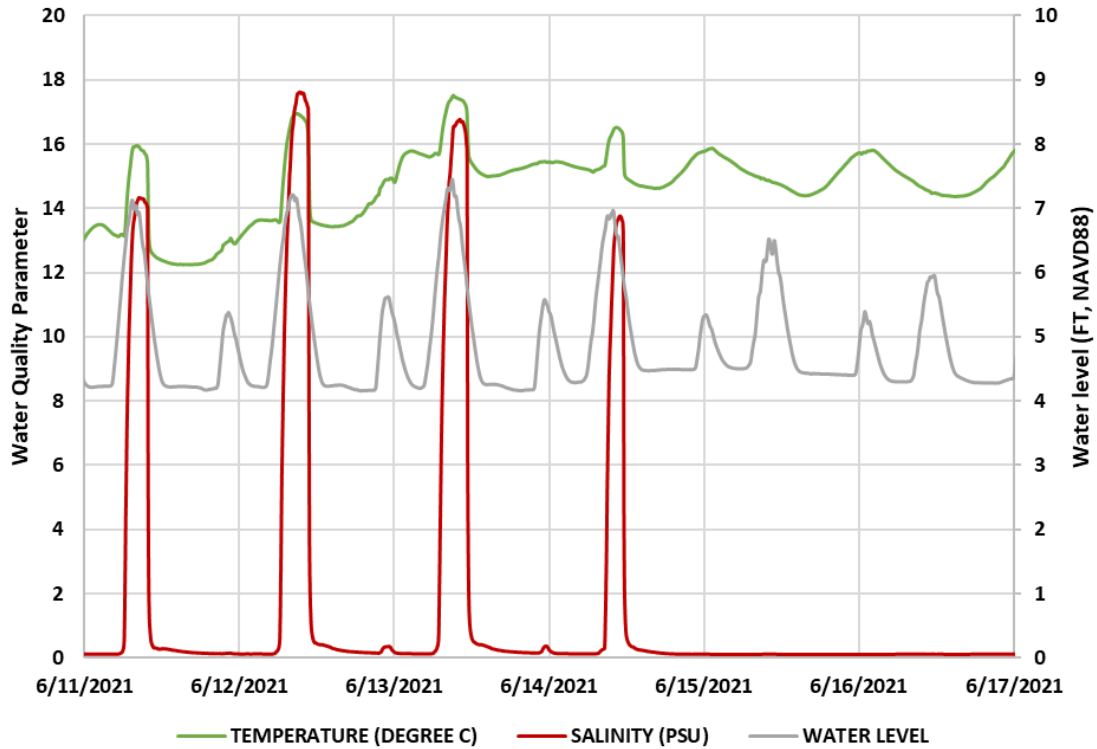
Figure 2-19. ER-3 salinity and temperatures fluctuations with and without the influence of saltwater at high tides (>6.5 ft) during summer low flow conditions.

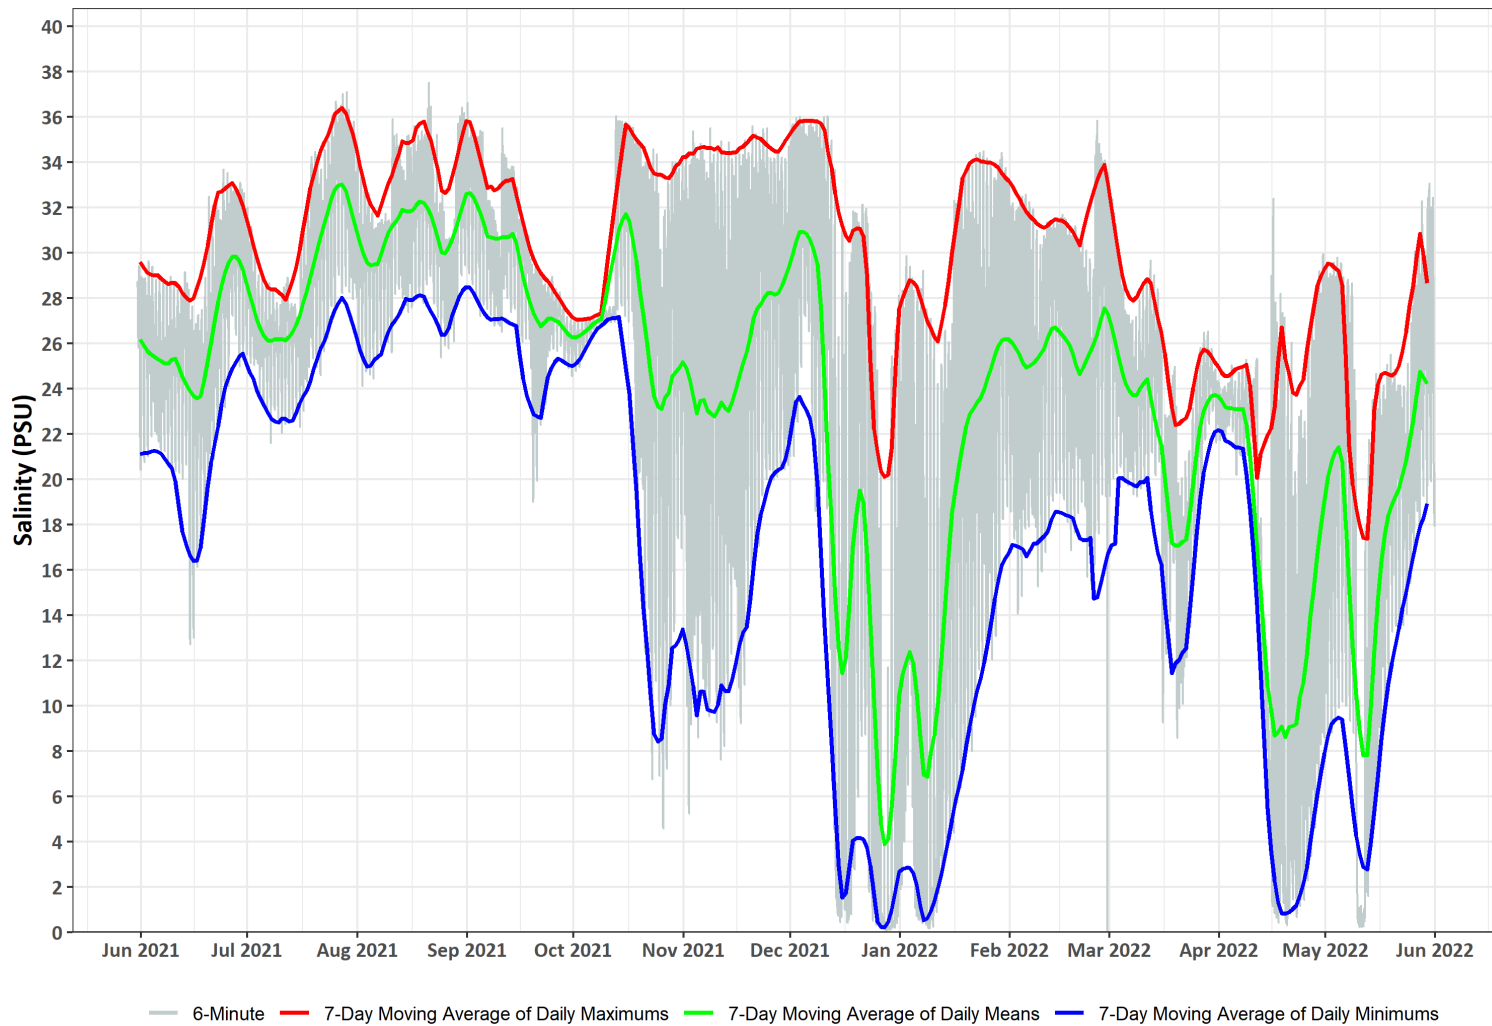
Figure 2-20. Seven-day average of daily maximum, mean and minimum salinity values at SS-1 during the monitoring period June 2021-June 2022.

Swain Slough follows the same general salinity pattern as ER-1 in the summer, fall and winter (Figure 2-15 and Figure 2-20). In the spring, the upstream site (SS-2) has substantially lower salinity levels than the downstream site (SS-1) and ER-1 and ER-2 (Figure 2-15, Figure 2-21, Table 2-5). Potential upstream freshwater sources that influence these lower salinity levels include numerous springs on the right valley wall, and small, presumable intermittent, tributaries that drain to Swain Slough (Figure 2-4).

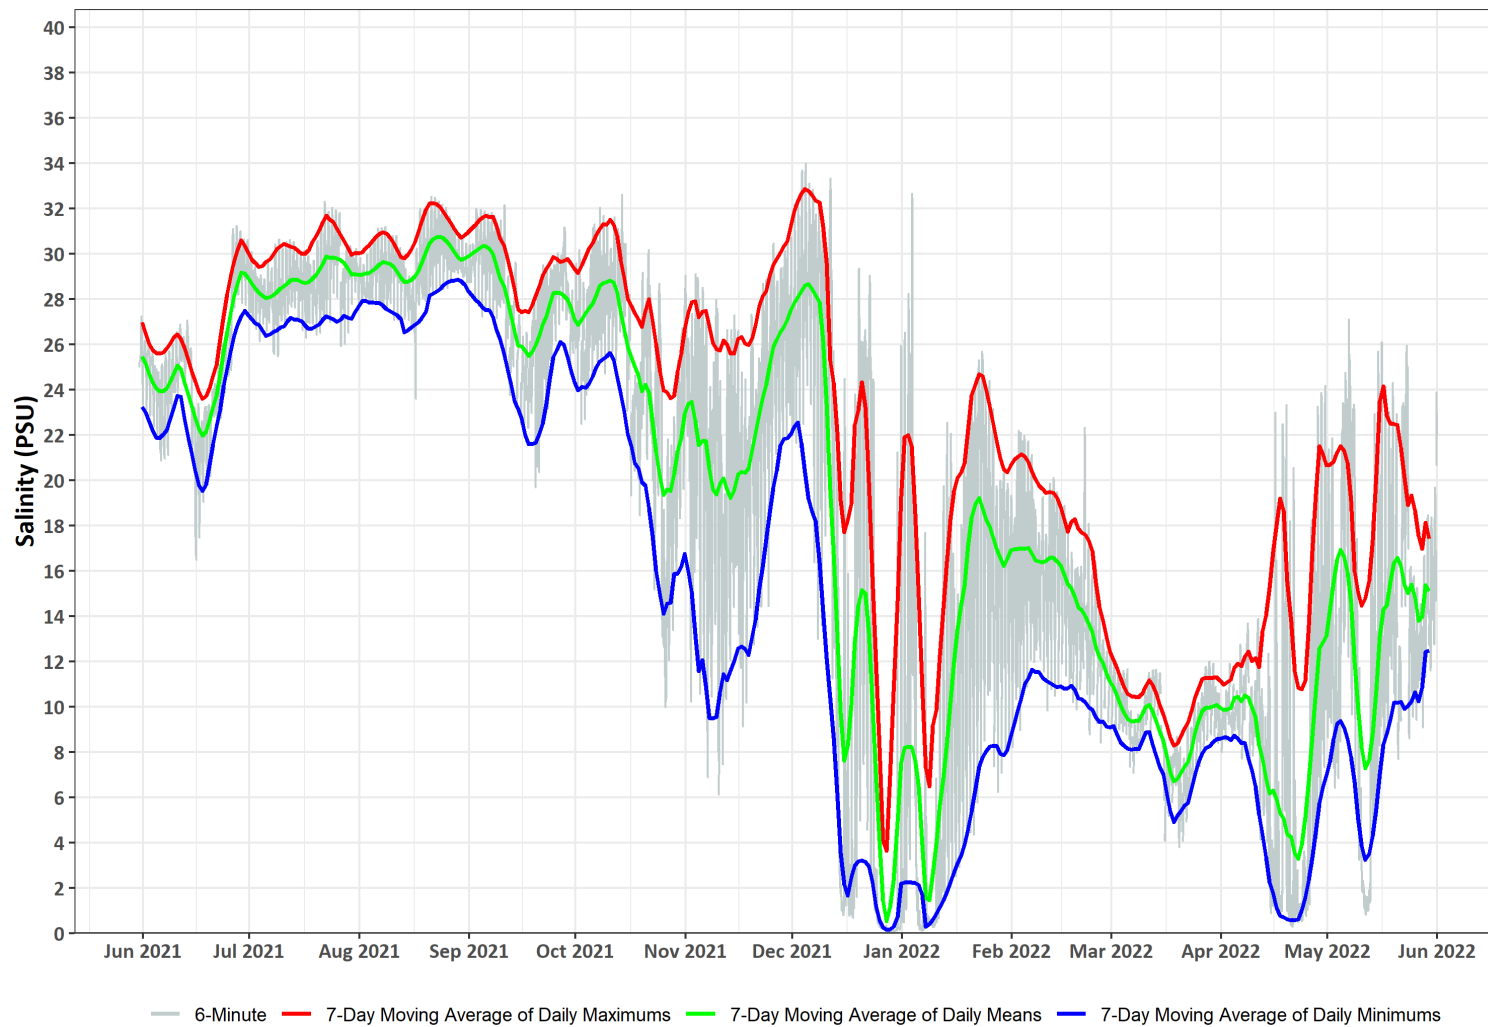
Figure 2-21. Seven-day average of daily maximum, mean and minimum salinity values at SS-2 during the monitoring period June 2021-June 2022.

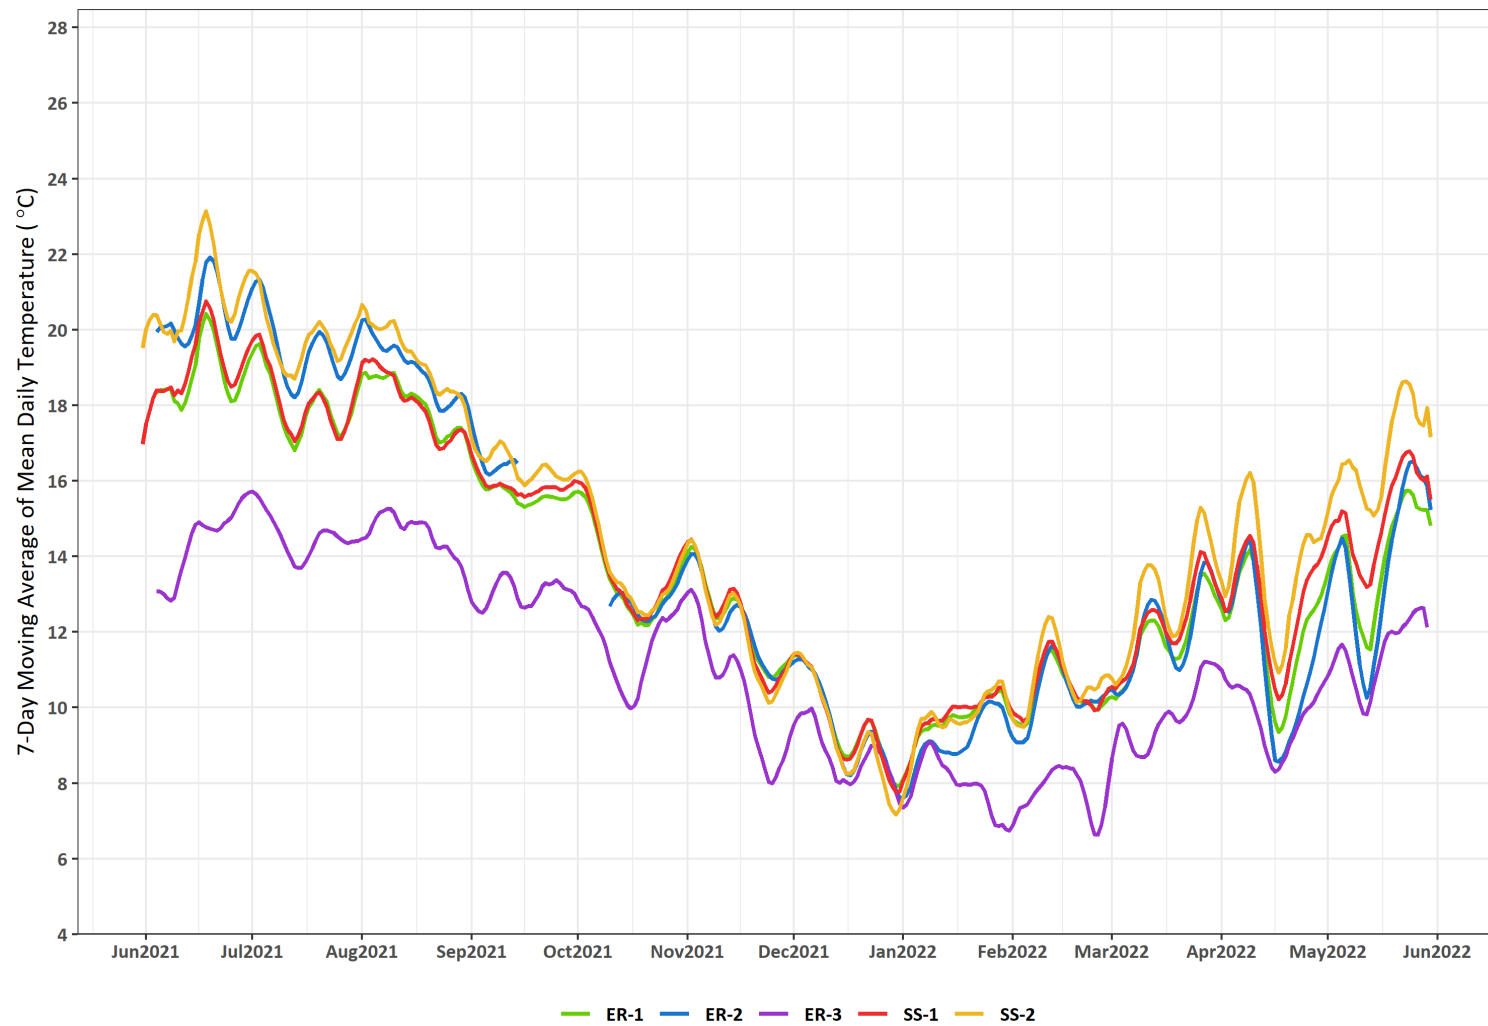
Figure 2-22. Seven-day mean temperature at continuous monitoring sites.

Temperature monitoring at Elk River sites (ER-1, 2, 3) show a similar seasonal pattern (Table 2-16 and Figure 2-22). The warmest temperatures occur in the summer and the coolest temperatures occur in the winter. The difference between winter and summer mean temperatures is 8.5°C at ER-1, 10°C ER-2, and 6.6°C at ER-3 (Table 2-16). A longitudinal pattern of warm temperatures downstream, and cooler temperatures upstream persists throughout the seasons (Table 2-16).

In contrast to the longitudinal pattern of warming in the downstream direction observed in the Elk River, Swain Slough warms in the upstream direction. The downstream Swain Slough site (SS-1) mean temperatures track closely with ER-1 with slightly warm temperatures (Table 2-16), particularly in late spring of 2022 (Figure 2-22). SS-2 was consistently warmer than SS-1 and ER-1 during the summer, fall and spring periods.

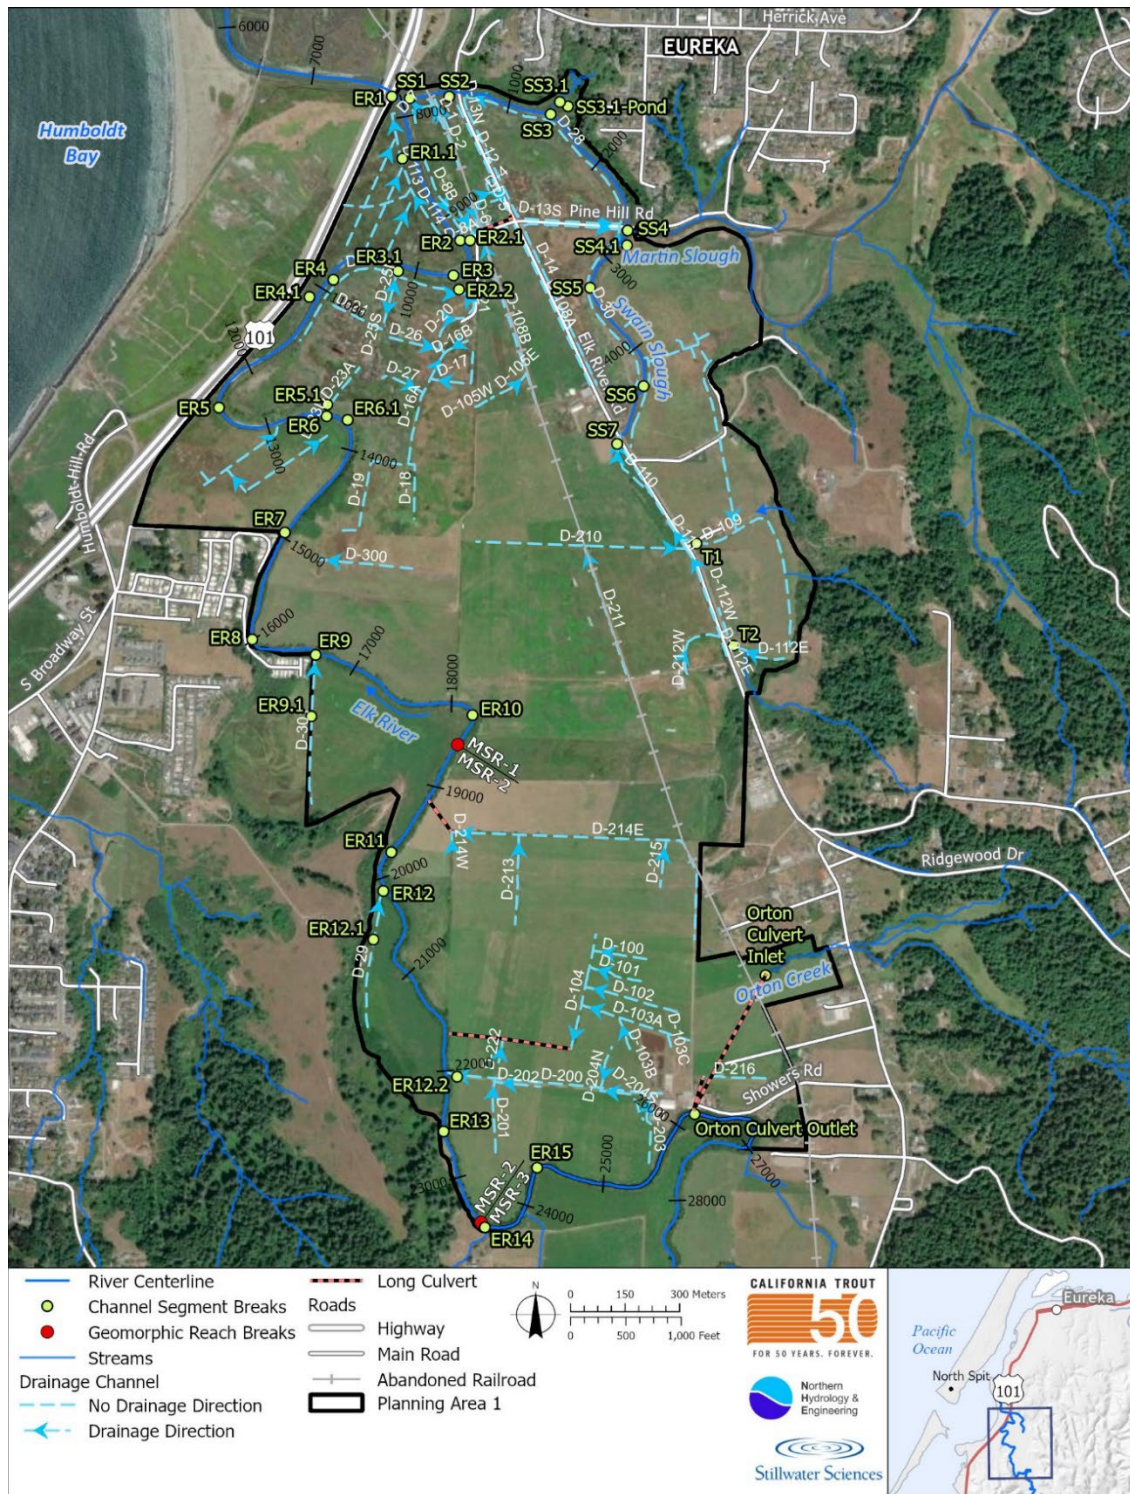
Figure 2-23. Channel segment used to characterize fish habitat in Planning Area 1.

In most of Planning Area 1, clear geomorphic habitat units could not be identified due to the channelized, tidally influenced, and relatively homogeneous nature of the channel (uniform width, depth, and substrate). For this reason, traditional mesohabitat typing (e.g., pool, riffle, flatwater) was not feasible. Thus, for the purposes of characterizing and describing fish habitat conditions, the main channels of lower Elk River (MSR1 and MSR2) and Swain Slough (SS) were delineated into channel segments based on tributary and off-channel habitat junctures, unique geomorphic or riparian characteristics, or other notable changes in channel conditions (Figure 2-23). These segments ranged in length from approximately 400 ft to 2,500 ft. Primary off-channel features connected to the main channels of Elk River and Swain Slough were also identified and characterized and are shown in Figure 2-23.

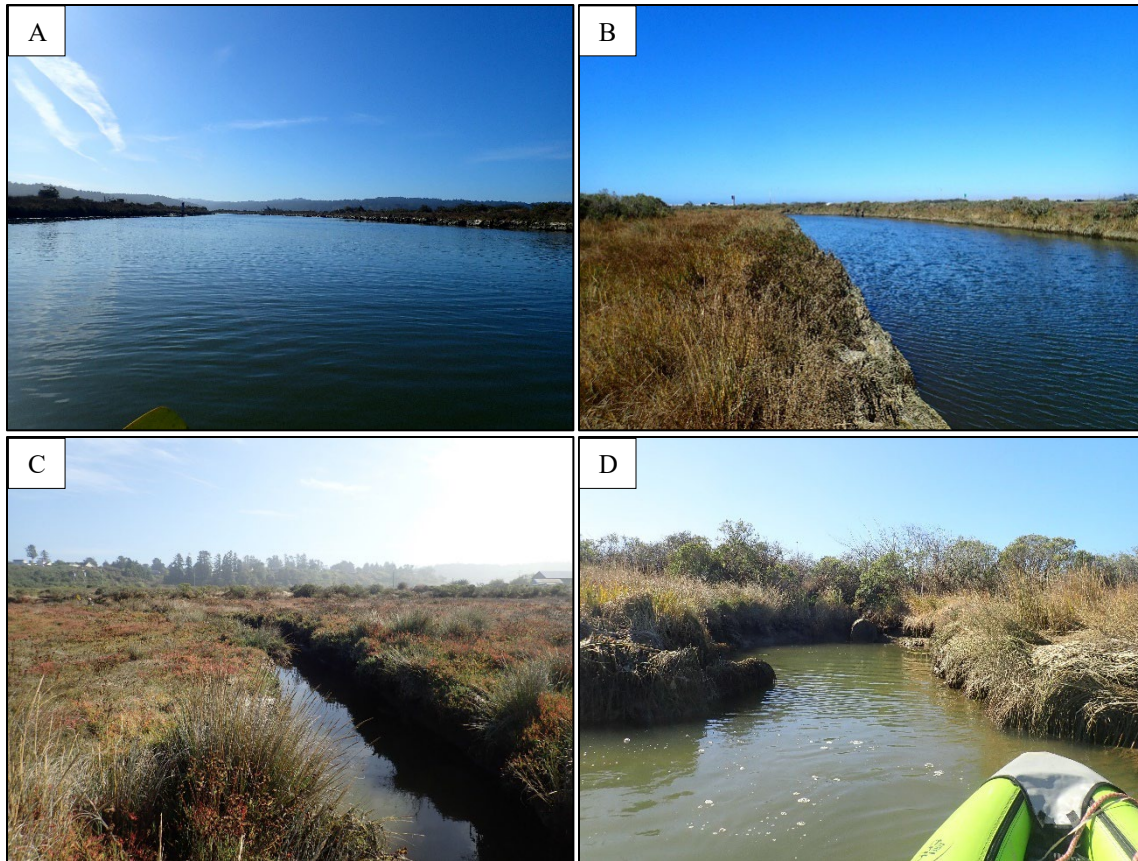
Figure 2-24. Photos from September 2021 showing representative main-channel summer fish habitat conditions in ER1 (A) and ER4 (B) and examples of accessible off-channel habitat features in ER1.1 (C) and ER3.1(D). Note: tidal stage was relatively high when these photos were taken.

In channel segments ER1–ER4 (the lower 4,720 ft of the assessed portion of MSR1), quality of physical summer rearing habitat for salmonids, Tidewater Goby, and other fish is, in general, relatively poor due to the homogenous and straight channel, steep banks, limited hydraulic and depth complexity, and lack of in-channel and riparian cover (Figure 2-24). In ER1–ER4, other than some shallow, grassy margins and small bank indentations along the main channel that are wetted during higher tides, the primary habitats with escape cover and lower velocities are associated with the ER.1 ditch network, alcove-like features present where drainage ditches enter the channel (e.g., ER2.1, ER2.2, ER3.1, ER4.1), and a single, small island at the upstream end of ER3. A network of partially wetted drainage ditches, relic slough channels, and depressions occurs throughout the ERWA adjacent to MSR1. These channels connect to the Elk River via tide gates at ER2.1, ER2.2, and ER3.1, but tidal exchange and fish access to these features are limited by dilapidated tide gates and low habitat complexity along with high salinities would limit juvenile salmonid rearing in these ditches during the summer (Section 2.2.2; Table 2-12 and Table 2-13). It was not possible to view the entire channel at the surveyed tide due to depth and turbidity, but except for a few pieces of submerged large wood observed in ER4, very little in-channel cover was observed in channel segments ER1–ER4. Additionally, no canopy cover or significant escape cover from riparian trees was observed. Because of the simplified channel and minimal off-channel habitat connectivity, high water velocities during higher ebb and flood tides may limit overall capacity of the channel to support juvenile Coho Salmon and other fish during the summer.

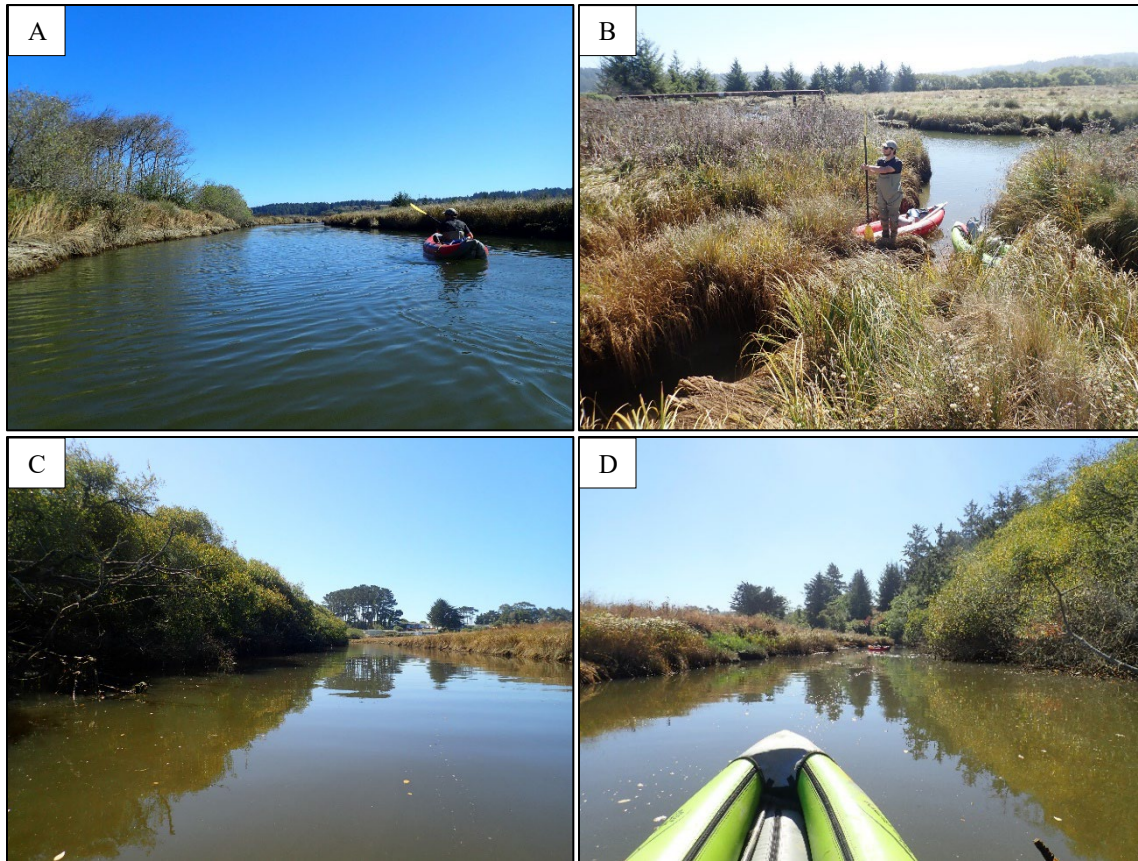
Figure 2-25. Photos from September 2021 showing representative main-channel summer fish habitat conditions in ER5 (A), an alcove habitat associated with a tide gate at ER5.1 (B), and examples of overhanging riparian cover in ER6 (C) and ER7 (D). Note: tidal stage was relatively high when these photos were taken.

In channel segments ER5–ER7, overall fish habitat quantity and quality continues to be limited by the simplified, straight channel bordered by relatively steep banks and limited off-channel habitat. Main-channel salmonid summer rearing habitat quality improves somewhat relative to ER1–ER4 due to long patches of continuous riparian trees with overhanging branches on the right bank of ER5 and ER6 and on the left bank of ER7. These branches provide both overhead and in-channel escape cover for juvenile fish (Figure 2-25). Based on observations during the winter survey, which was conducted at a lower tidal stage than the summer survey, the area of suitable salmonid rearing habitat provided by these overhanging branches is expected to be greatest at higher tidal stages, when they and the few gradually sloping banks become more inundated. It was difficult to fully assess in-channel cover at the surveyed tide due to depth and turbidity, but other than several pieces of submerged large wood in ER7, most cover was associated with channel margins (branches from live trees and grasses).

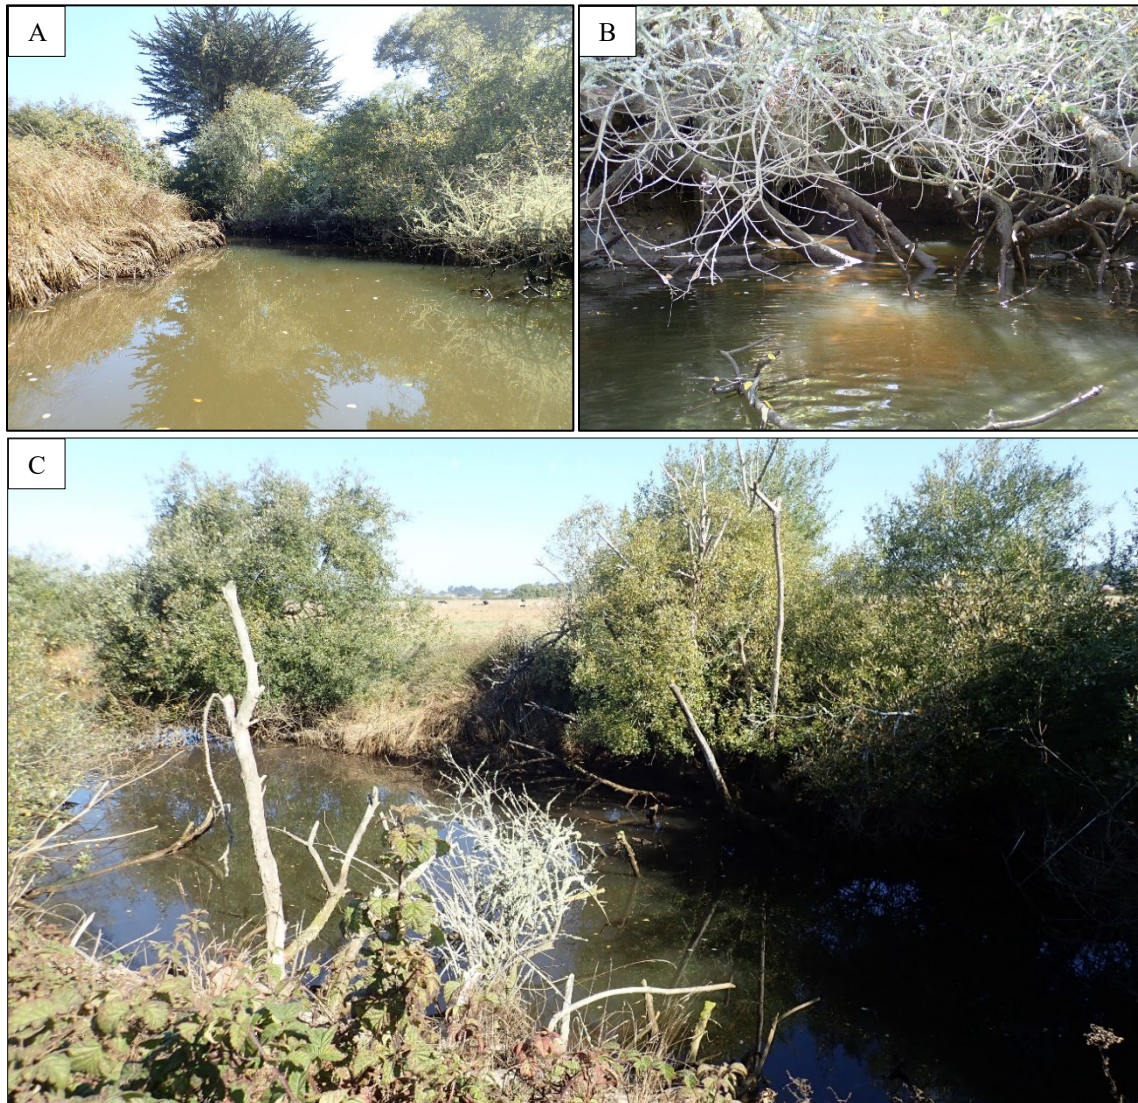
Figure 2-26. Photos from September 2021 showing a steep, grassy bank on the right bank of ER8 and overhanging riparian branches on the left bank (A) complex overhanging and in-channel tree branches on a near-vertical bank in ER8 (B), and section of ER9 with patchy riparian on both banks (C).

In channel segments ER8–ER9 (the upper 2,260 ft of MSR1), overall quality of summer rearing habitat for salmonids increases substantially due the presence of thick riparian trees with complex overhanging and in-channel branches on one or both banks (Figure 2-26). Additionally, several pieces of in-channel large wood that provide high quality habitat were observed in both ER8 and ER9. The channel in these segments is still relatively homogeneous, with steep banks on both sides and is narrower and deeper relative to downstream segments. In many places, overhanging branches provide shade and escape cover for fish across much of the narrow channel. However, in several sections of the right bank of in both ER8 and ER9, the riparian zone is interrupted by several long areas of grassy bank with few trees and little fish cover. No connected alcoves, tidal sloughs, or other features that provide flow refugia or off-channel rearing opportunities were documented in ER8 or ER9. A seasonally wetted drainage ditch, ER9.1, enters Elk River at the ER8/ER9 boundary via a tide gate, but is not currently accessible to fish. This location, which historically had a connected tidal slough channel (Figure 2-3), is fed by springs/seeps draining the hillslope. As described below, if restored, it has potential to provide high quality off-channel rearing habitat.

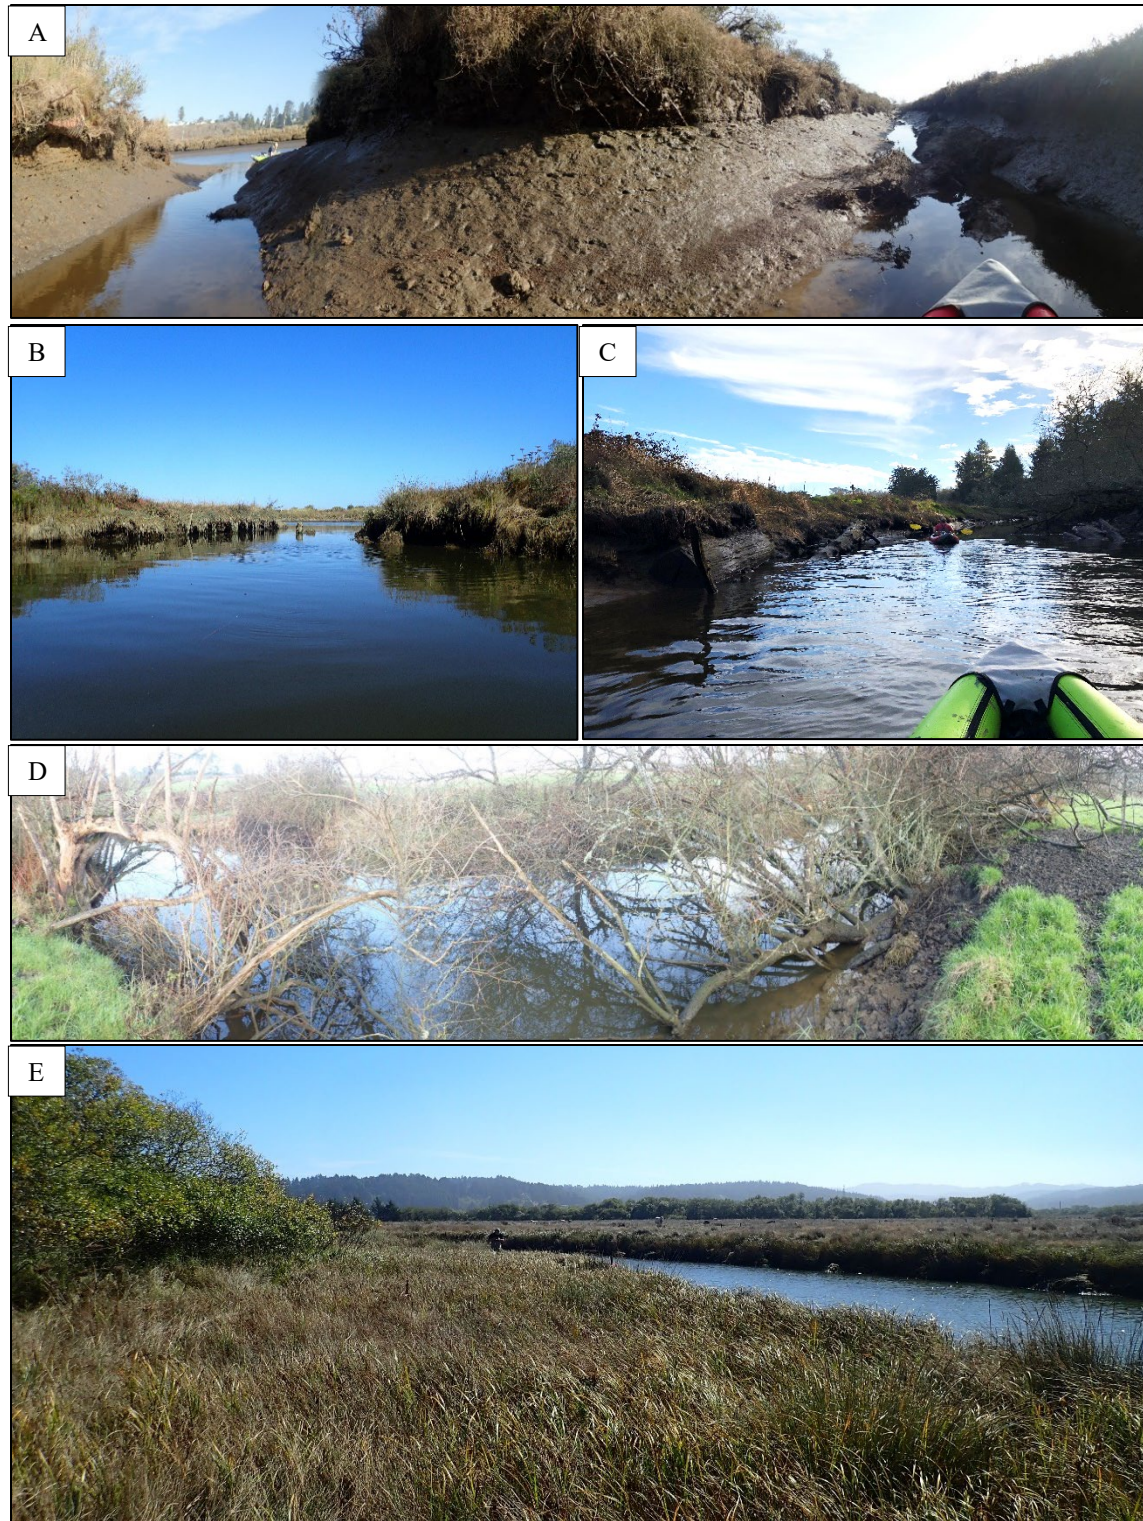
Figure 2-27. Examples of locations in MSR1 that have potential to provide high flow refugia for fish in MSR1, including connected borrow ditch at ER1.1 (A), large alcove associated with ER2.2 (B), large wood along both channel margins in ER7 (C), relatively gradually sloped bank with in-channel willow branches in ER9 (D), and inset bench on right bank in ER5 (E).

The primary areas with potential to provide velocity refugia during higher stream flows include (1) the ER.1 ditch network, the alcove-like features present where drainage ditches enter the channel (e.g., ER2.1, ER2.2, ER3.1, ER4.1, ER5.1, and ER6.1) (2) small areas in ER6, ER7, ER8, and ER9 that have both relatively gradual slopes and complex, overhanging, in-channel riparian branches or large wood along the bank, and (3) the few pieces of in-channel large wood big enough to potentially provide small areas of low velocity habitat (Figure 2-25). A series of 20–40 ft wide “inset benches” (bounded by levees) located along the right bank in ER3 and ER5 have gradual bank slopes (after an initial step up from the active channel). These sites may also provide velocity refugia when they are flooded during higher flows (Figure 2-27).
