FINAL REPORT • MAY 2023

Elk River Planning Area 1: 10% Design Report

Northern Hydrology and Engineering
P.O. Box 2515
McKinleyville, CA 95519

Stillwater Sciences
850 G Street, Suite K
Arcata, CA 95521

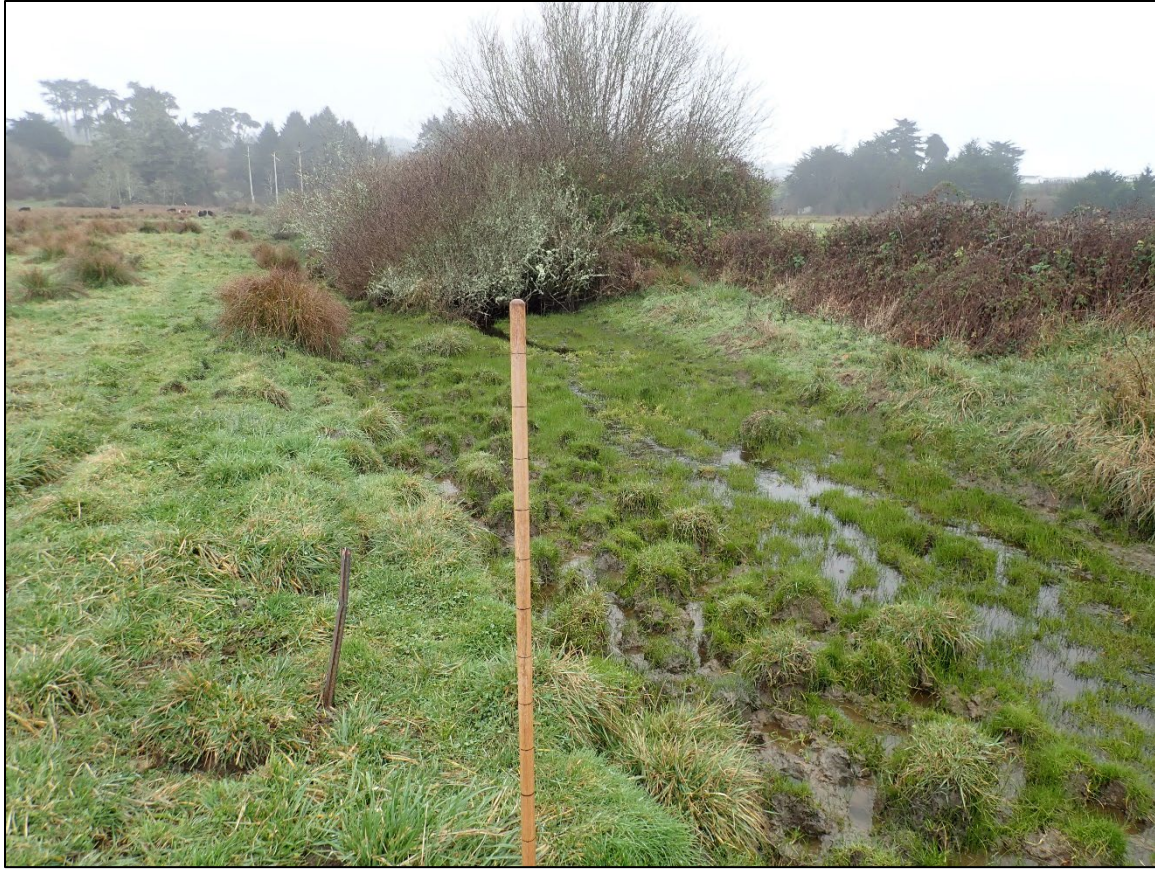
Figure 2-28. Photo from January 2022 showing the lower portion of the drainage ditch at ER9.1.

The network of drainage ditches, relic slough channels, and depressions in the ERWA have potential to provide large areas of high-quality winter refugia and rearing habitat depending on flow and tidal stage, but the current habitat is generally in poor condition. Additionally, as described above, ER9.1 is not currently accessible to fish, but if restored, has potential to provide a large area of high-quality, off-channel salmonid winter rearing habitat. During the relatively dry winter period, a significant amount of fresh water was observed entering the ditch via the adjacent hillslope, which would help maintain water quality at the site if it were made accessible to fish (Figure 2-28).

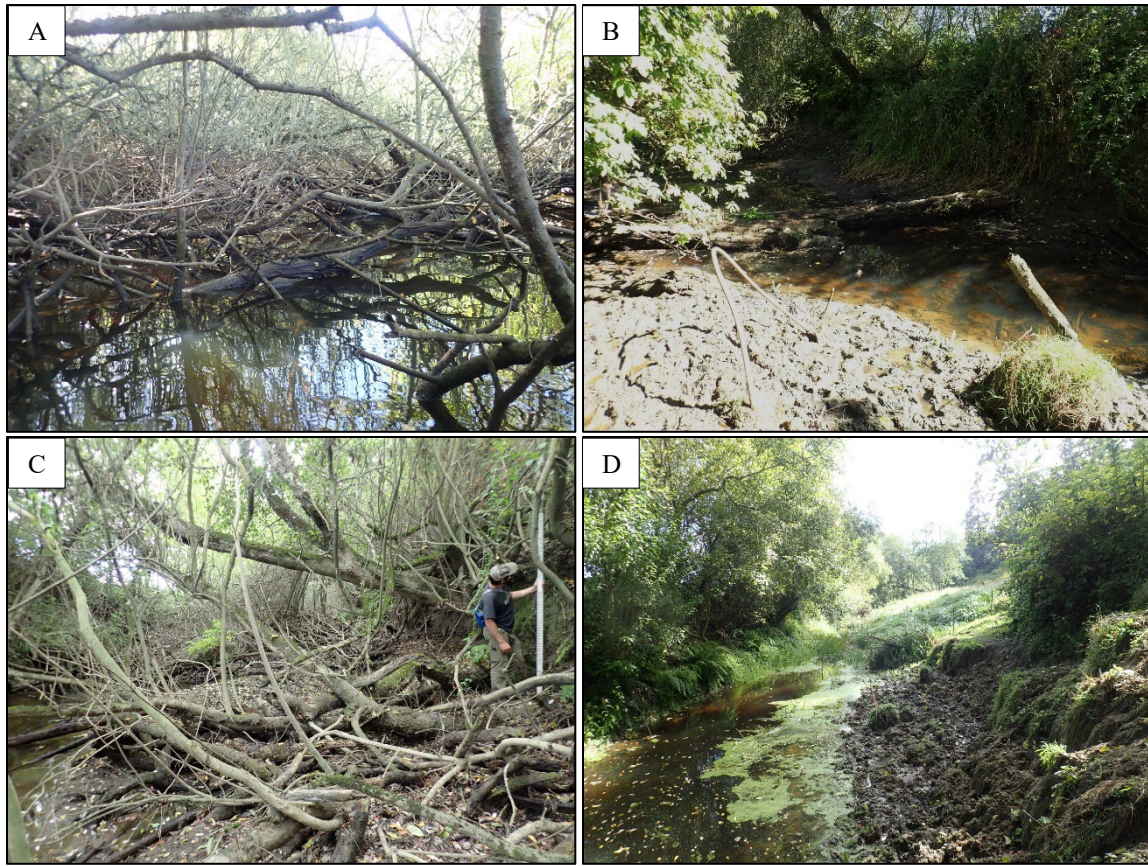
Figure 2-29. Representative summer rearing habitat in MSR2. Dense willow branches and small woody debris covering much of the channel in ER10 (A), a more open section in ER11 with some functional large wood and cattle impacts in the channel (B), dense in-channel branches and entrenched channel in ER12 (C), and shallow, stagnant section of ER13 with in cattle impacts (D).

Despite the generally abundant and high-quality summer rearing habitat observed for salmonids, restoration actions that increase the depth and complexity of pools and mitigate for in-channel cattle impacts would be valuable in portions of MSR2. Implementing restoration actions that improve winter rearing habitat—such as through the addition of large wood—will also improve summer habitat.

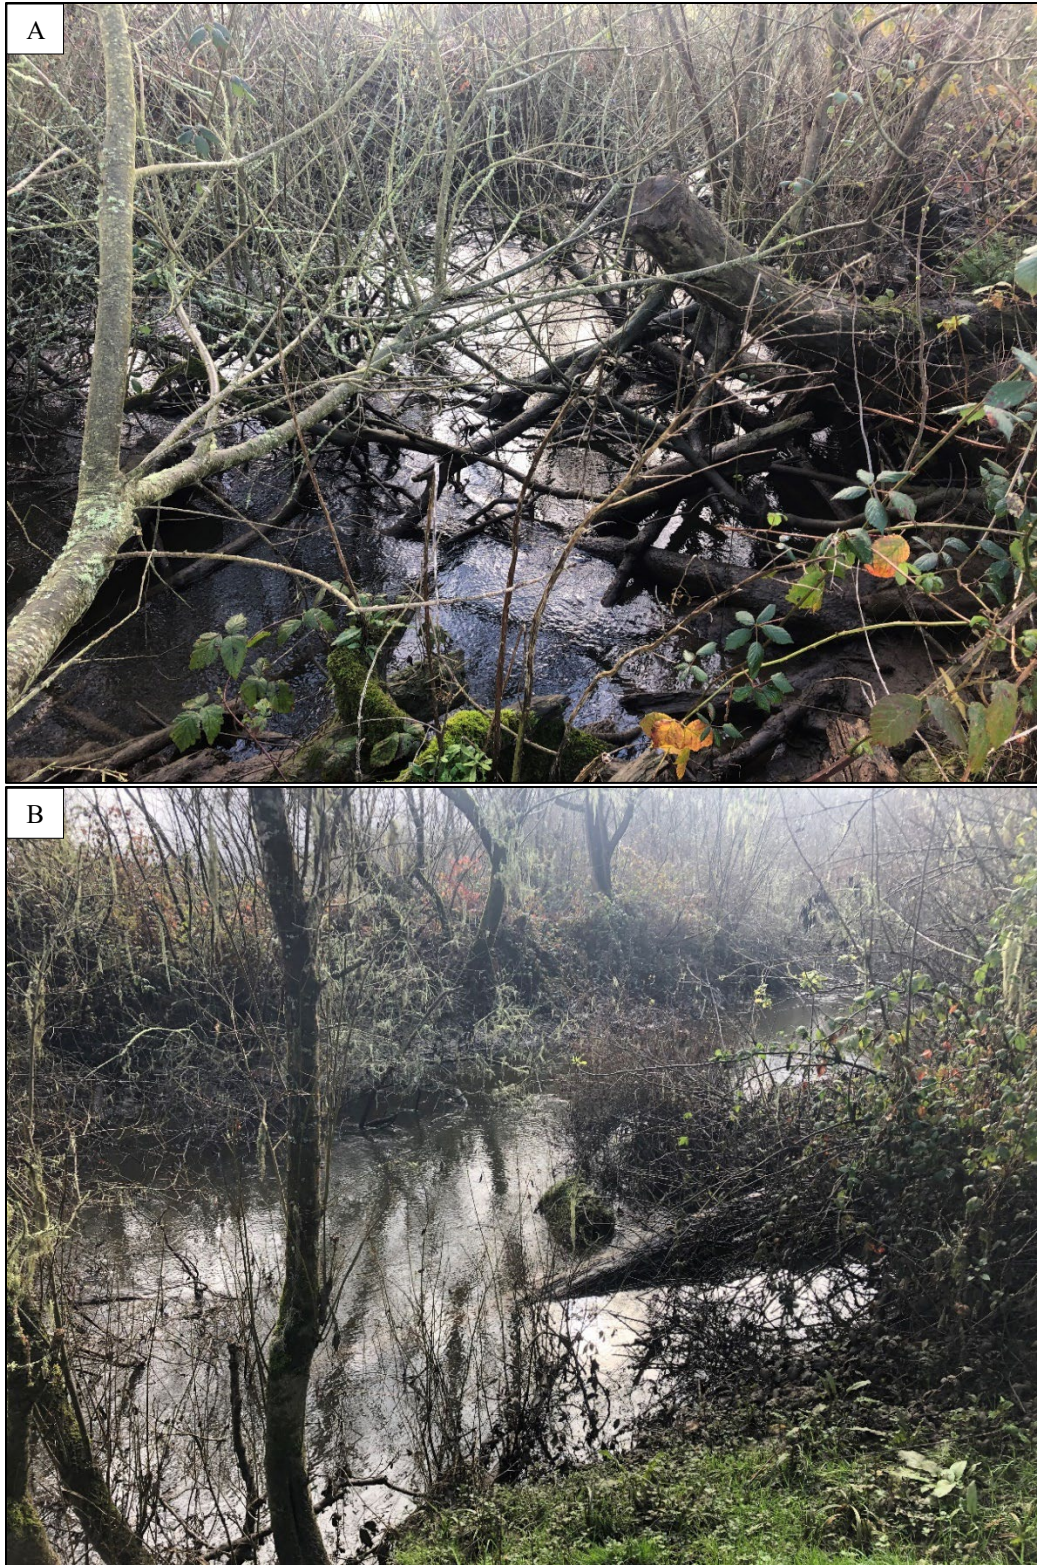
Figure 2-30. Examples of low-velocity in-channel habitat in MSR2 observed during the January 2022 survey conducted at a moderate winter base flow. Dense in-channel branches and small wood pieces in ER10 (A) and a piece of large wood creating alcove-like habitat at the observed flow in ER11 (B).

Overall, quality of winter habitat in MSR2 is relatively poor, with minimal in-channel flow refugia due to low large wood densities, essentially no connected off-channel habitat features, and severely restricted connectivity with adjacent floodplains. During the winter habitat assessment conducted in January 2022 at a moderate winter baseflow, small areas of relatively low-velocity habitat (<1.0 ft per second) were observed along the channel margins in a few locations where banks were more gradually sloped and dense willow branches or large wood were present (Figure 2-30). However, because of the entrenched channel and limited functional large wood, even moderate high-flow events are expected to produce water velocities that exceed values preferred by Coho Salmon for rearing (approximately 0.6 ft per second ft/s; Beecher et al. 2002) throughout much of the reach. In some locations, it is possible that the extremely dense in-channel willow trunks and instream branches create low-velocity refugia along the channel margins or slow upstream water velocities through backwatering. Several groups of large wood pieces that were observed also likely create some in-channel flow refugia at higher flows.

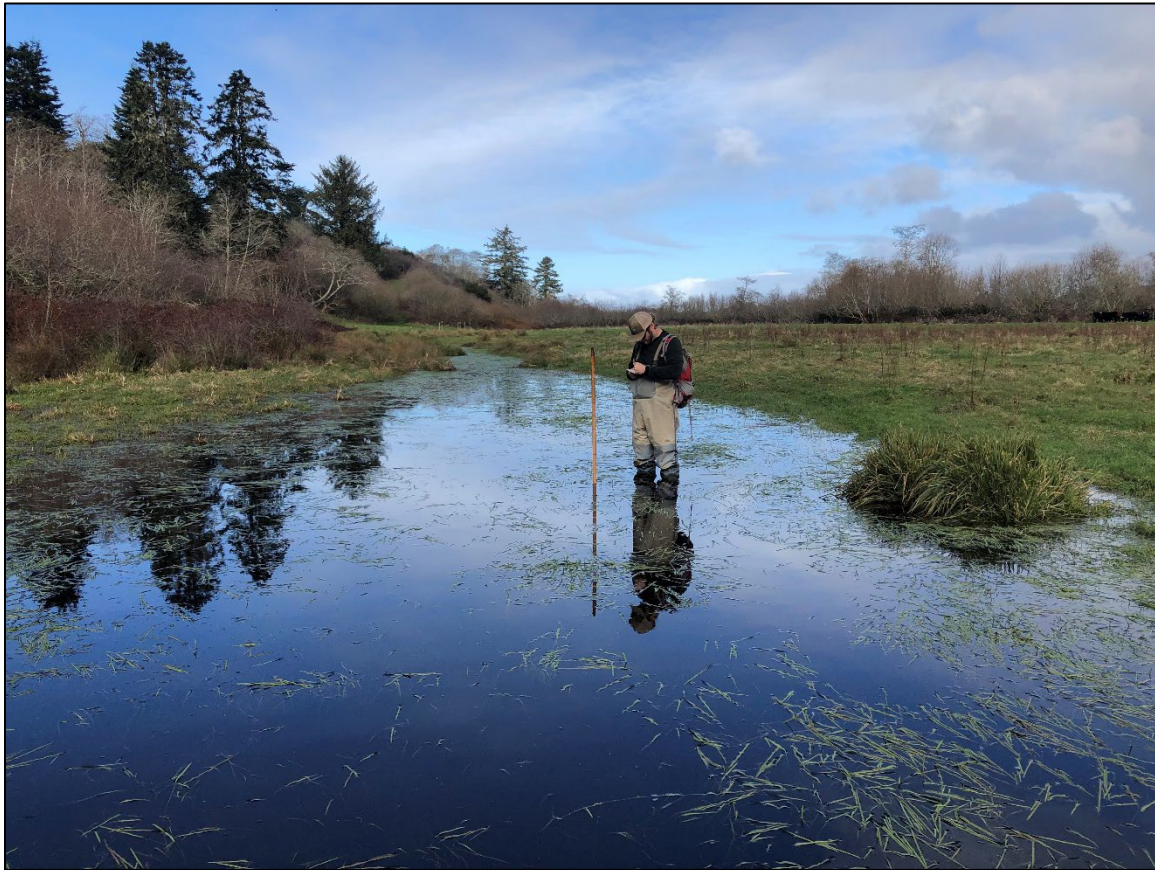
Figure 2-31. Large area of existing off-channel habitat at ER12.1 that is inaccessible to fish due to a tide gate.

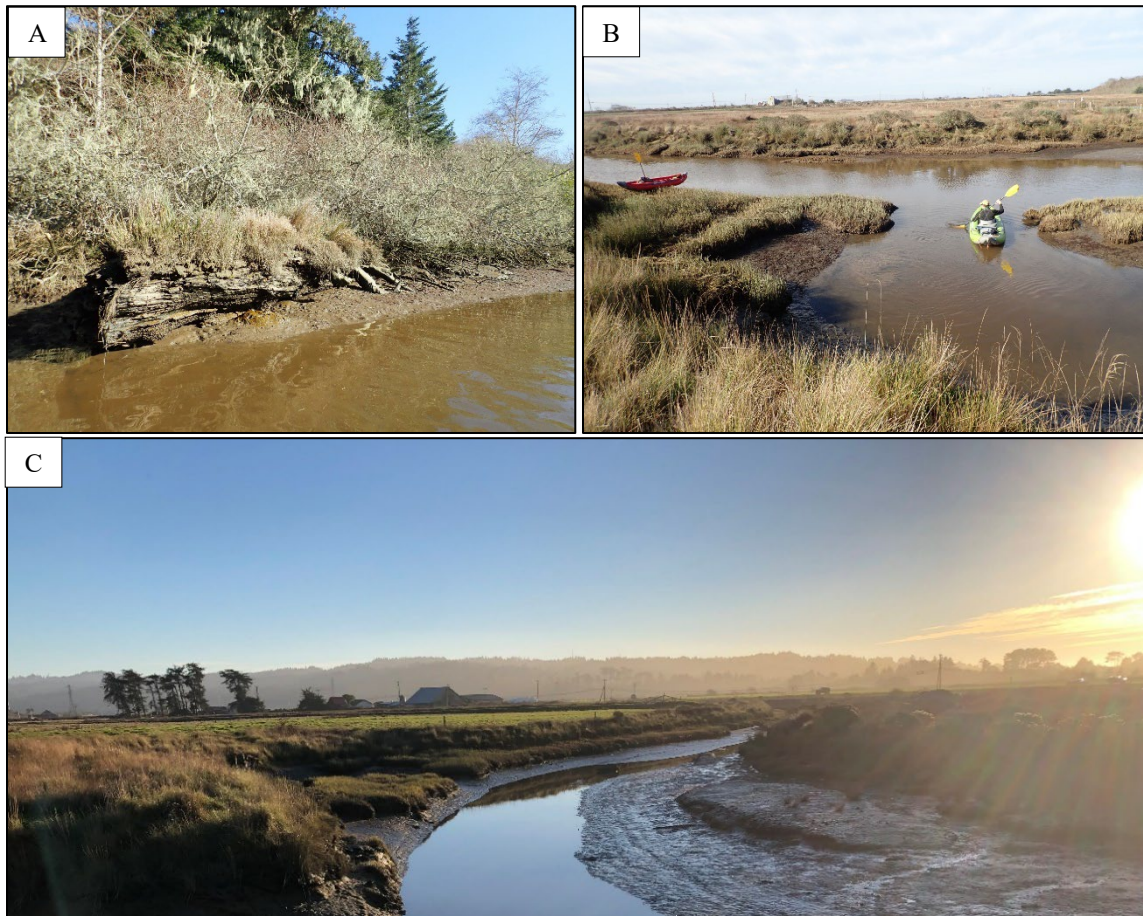
Figure 2-33. Photos of from the January 2022 fish habitat assessment of Swain Slough. Examples of potential high flow refugia habitat, including large wood located on the relatively gradually sloping right bank of SS3 (A) and an alcove at SS4.1 (B) and representative area with shallow water and low in-channel habitat complexity that occurs during lower tidal stages in SS4 (C).

During wetter periods of winter and spring with more freshwater influence, like MSR1, Swain Slough has potential to support rearing age-0 juvenile salmonids and other freshwater-dependent or brackish species (Table 2-18). Winter habitat complexity and fish escape cover in the Swain Slough channel during moderate winter flows is similar to that described for summer habitat: relatively large areas of high-quality habitat are accessible along the channel margins during higher tidal stages and minimal in-channel habitat is available during lower tides (Figure 2-32 and Figure 2-33). During high winter flows, when significant freshwater enters Swain Slough via Martin Slough and upstream drainages, water velocities in much of the channel may become too high to support juvenile salmonid rearing. As described above, access to off-channel and floodplain habitats that provide velocity refugia is limited by the levees that run along much of Swain Slough. During high flow conditions, some high-flow refugia habitat appears to be present along the more natural bank margins that occur along the right bank of SS2 and SS3, which has sections with relatively gradual slopes (up to the base of the adjacent hillslope) with thick overhanging tree branches and some bankside large wood (Figure 2-33). Fish may also find velocity refugia where the levees have failed, and they can access the network of borrow ditches

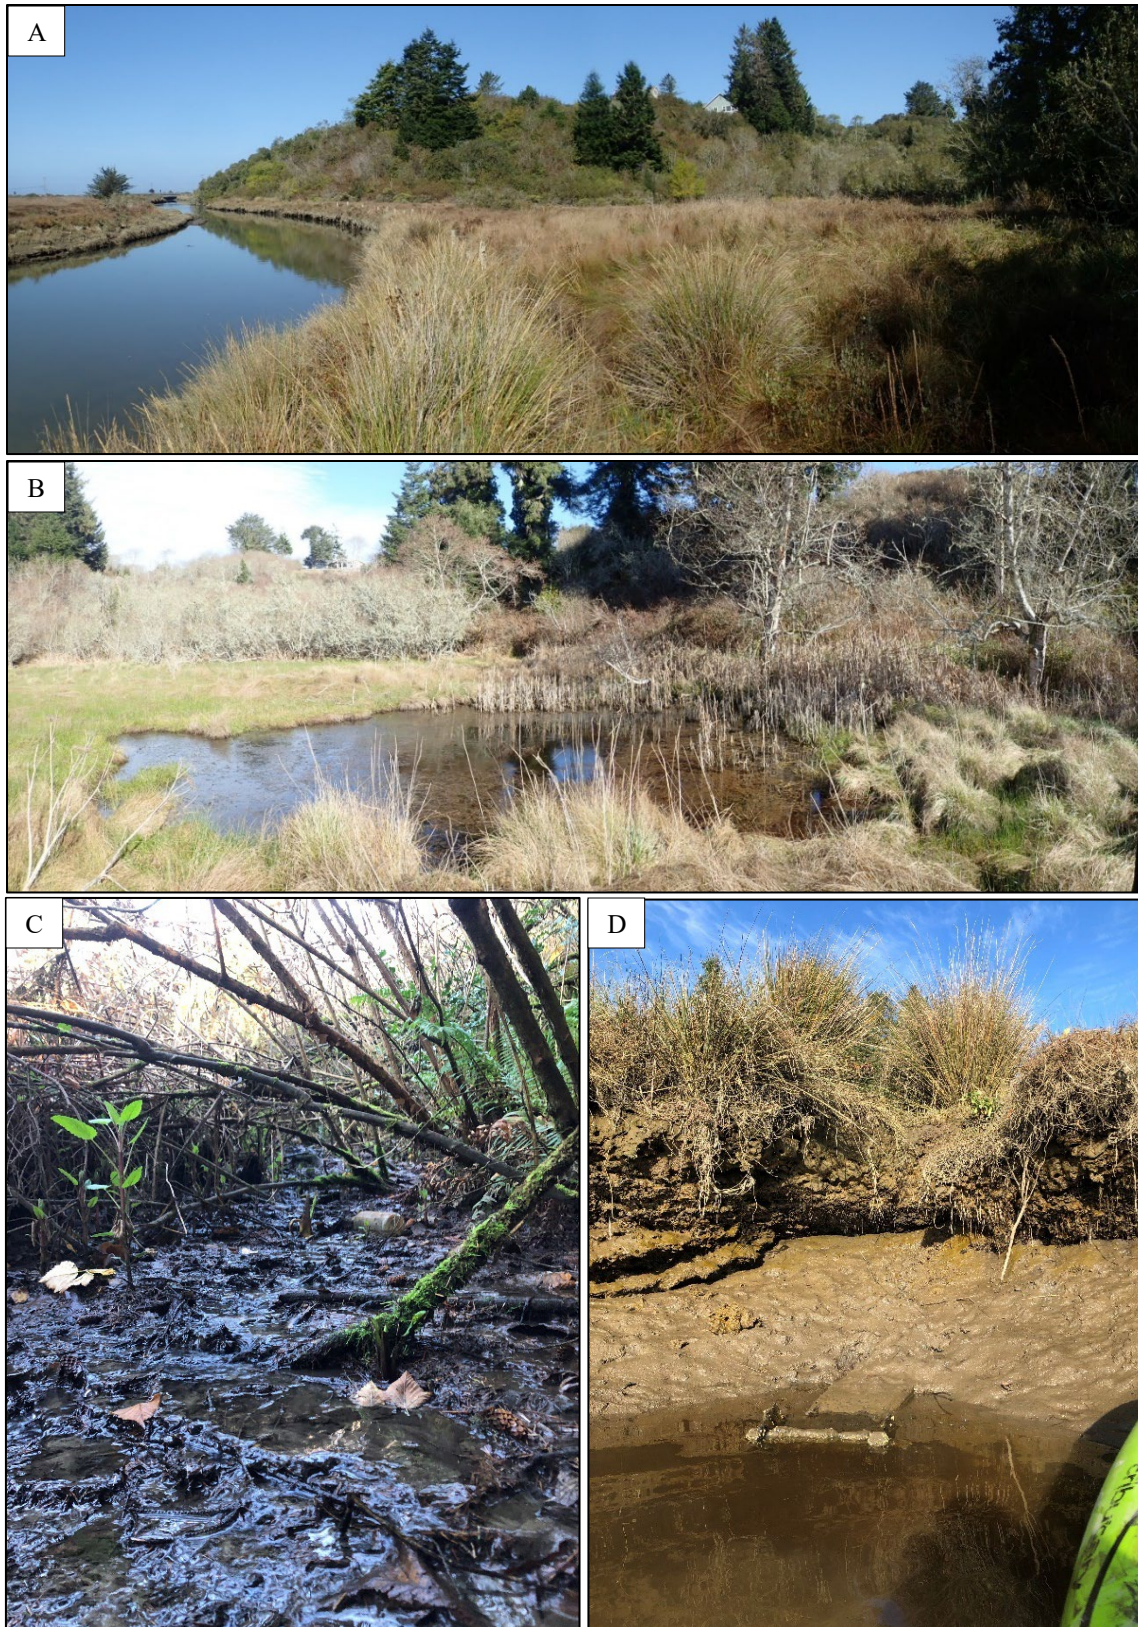
Figure 2-34. Photos of disconnected off-channel salt marsh (A), associated pond (B), small tributary flowing into marsh (C), and old tide gate that enters Swain Slough (D).

The salt marsh that occurs east of the SS2/SS3 boundary (SS3.1), is currently largely disconnected; however, it has high potential to provide a large area of high-quality fish habitat adjacent to lower Swain Slough (Figure 2-34). The approximately 1-ac marsh is fed by a small drainage originating in the adjacent wooded hillslopes that provide significant freshwater inputs to the site during the wet season. Most of this water appears to drain into a narrow (2 ft) and very entrenched (3–5 ft deep) drainage ditch that runs across the meadow before terminating in Swain Slough through a small tide gate at the base of a channel-side levee. An existing, small (40x40 ft) brackish pond is present on the eastern edge of the marsh. It does not have an obvious inlet or outlet channels but appears to be tidally connected at some tidal stages (was brackish during September site visit) and likely receives some freshwater from the adjacent hillslopes. The site appears to become inundated at the highest tidal stages that flood the berm that runs along this channel/marsh margin (Figure 2-1). However, field observations suggest the marsh is inaccessible to fish at most tidal stages. It is unclear how frequently the site floods during winter flow events

but appears to be disconnected by the relatively high elevation berm at most flows. This site has significant potential for restoration of high quality and valuable fish habitat since it is an undeveloped low-elevation salt marsh habitat with an off-channel pond in the lower estuary that could be fed by significant freshwater. If restored, this site could provide high flow refugia habitat during flood events and persistent off-channel rearing habitat for salmonids and other fish during the winter and spring.

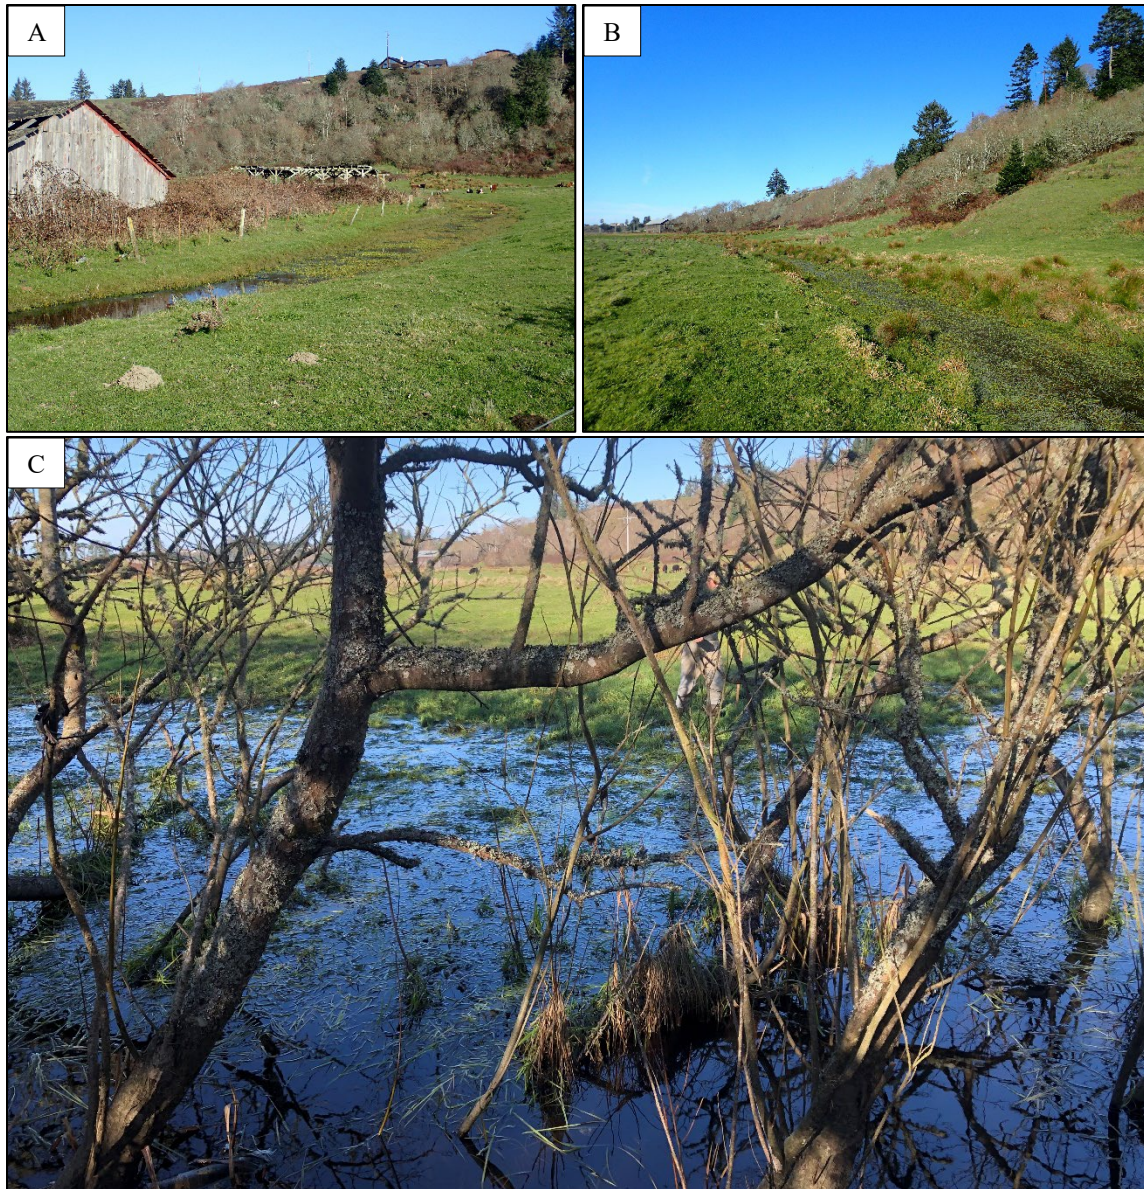
Figure 2-35. Relic Swain Slough channel complex east of Elk River Road. T1 channel near Elk River Road(A) and along hillslope (B) and deep depression along riparian forest associated with T2.

A disconnected relic slough feature that is fed by two small tributaries (T1 and T2) and borders cattle pasture on the east side of Elk River Road, was also assessed due to its potential for fish habitat restoration (Figure 2-23; Figure 2-35). This site consists of two channel-like depressions that are mostly dry in the summer but appear to remain wetted for much of the winter and spring. The northern channel, T1, is fed by a seasonal drainage from the north, a small tributary, and at least one spring entering from hillslope to the east of the channel. The T1 channel is approximately 1,900 ft long and flows north and west before passing through a culvert under Elk River Road and entering a drainage ditch (SS7) that flows into Swain Slough (Figure 2-23, Section 2.6, Appendix A). The southern channel, T2, is fed primarily by a tributary flowing from the southeast hillslope that enters a depression along the southern edge of the cattle pasture before passing through a culvert under Elk River Road and eventually flowing into Swain Slough via a drainage ditch that follows the west side of Elk River Road (Figure 2-23, Section 2.6, Appendix A). This feature includes about 400 ft of ponded habitat on the edge of the cattle field, including a relatively deep (1 ft) section partially within the adjacent riparian forest (Figure 2-35). Neither of these relic channels are currently accessible to fish but contribute valuable freshwater to Swain Slough and have potential to provide high quality winter rearing habitat for salmonids if reconnected.

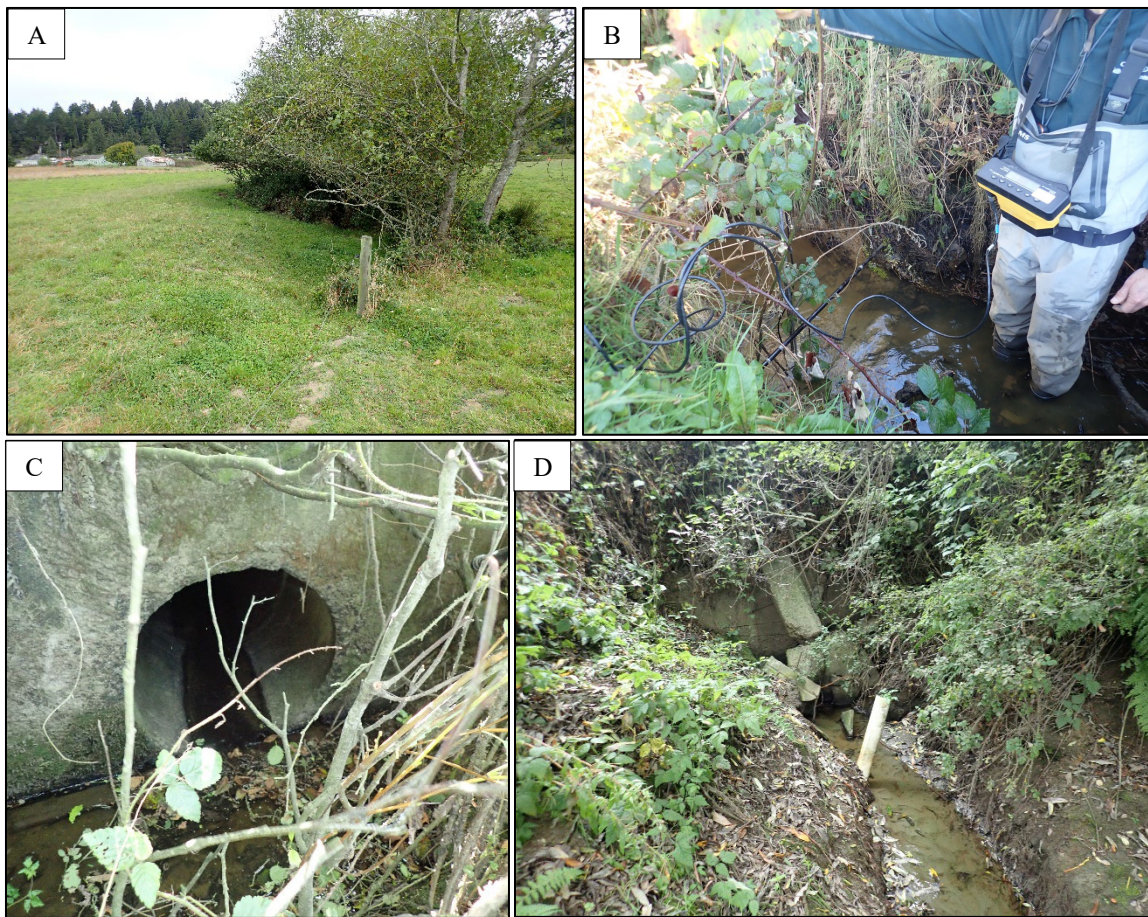
Figure 2-36. Photos of Orton Creek and the culvert connecting it with Elk River. Riparian zone near culvert inlet (A), wetted channel during January 2022 flow measurement near culvert inlet (B) culvert inlet during August 2021 site visit (C) and culvert outlet and flow into Elk River during September 2021 habitat assessment.

Orton Creek is a small perennial tributary draining an area of approximately 1.5 square kilometers (km^2) (0.6 square miles [mi^2]) (Figure 2-23) east of Elk River Road. After crossing Elk River Road through a culvert that is a barrier to fish movement just east of Planning Area 1, the stream flows west for approximately 900 ft before entering a culvert that routes it southwest for approximately 1,400 ft to Elk River near the end of Showers Road. Historical aerial photographs and terrain analyses indicate that the stream likely flowed into Swain Slough before being re-routed (Figure 2-3). Although the contributing drainage area and stream channel are relatively small (approximately 3–4 ft wetted width in January), Orton Creek delivers a significant amount of fresh water to the planning area. Notably, the stream was wetted and had detectable flow

during a site visit in August 2021, following a historically dry winter. During the winter habitat assessment on January 14, 2022 following a relatively dry period (7 days without rain), stream flow measured near the culvert inlet was near 0.4 cfs. The portion of the channel in the planning area that is above ground currently has a relatively small area of suitable salmonid rearing habitat due to its small size. The channel is narrow and has limited connectivity with the flood plain since it is generally entrenched by 3–6 ft relative to the adjacent pasture. The channel consists of alternating short riffles and pools with depths generally <1 ft during January. Bed substrate includes a mix of silt, sand, and small gravels. Water temperature in Orton Creek was 12.5°C on at 12:40pm on October 1, 2021 and 8°C at 12:14 pm on January 14, 2022. Despite limited existing physical habitat for fish, reconnecting freshwater flows from Orton Creek to a relic Swain Slough channel would have high value by lowering salinities and helping to maintain water quality in restored channels. Additionally, if the channel were restored, Orton Creek could provide some high-flow refugia for salmonids and provide quality spawning habitat for Coastal Cutthroat trout and potentially other salmonids.

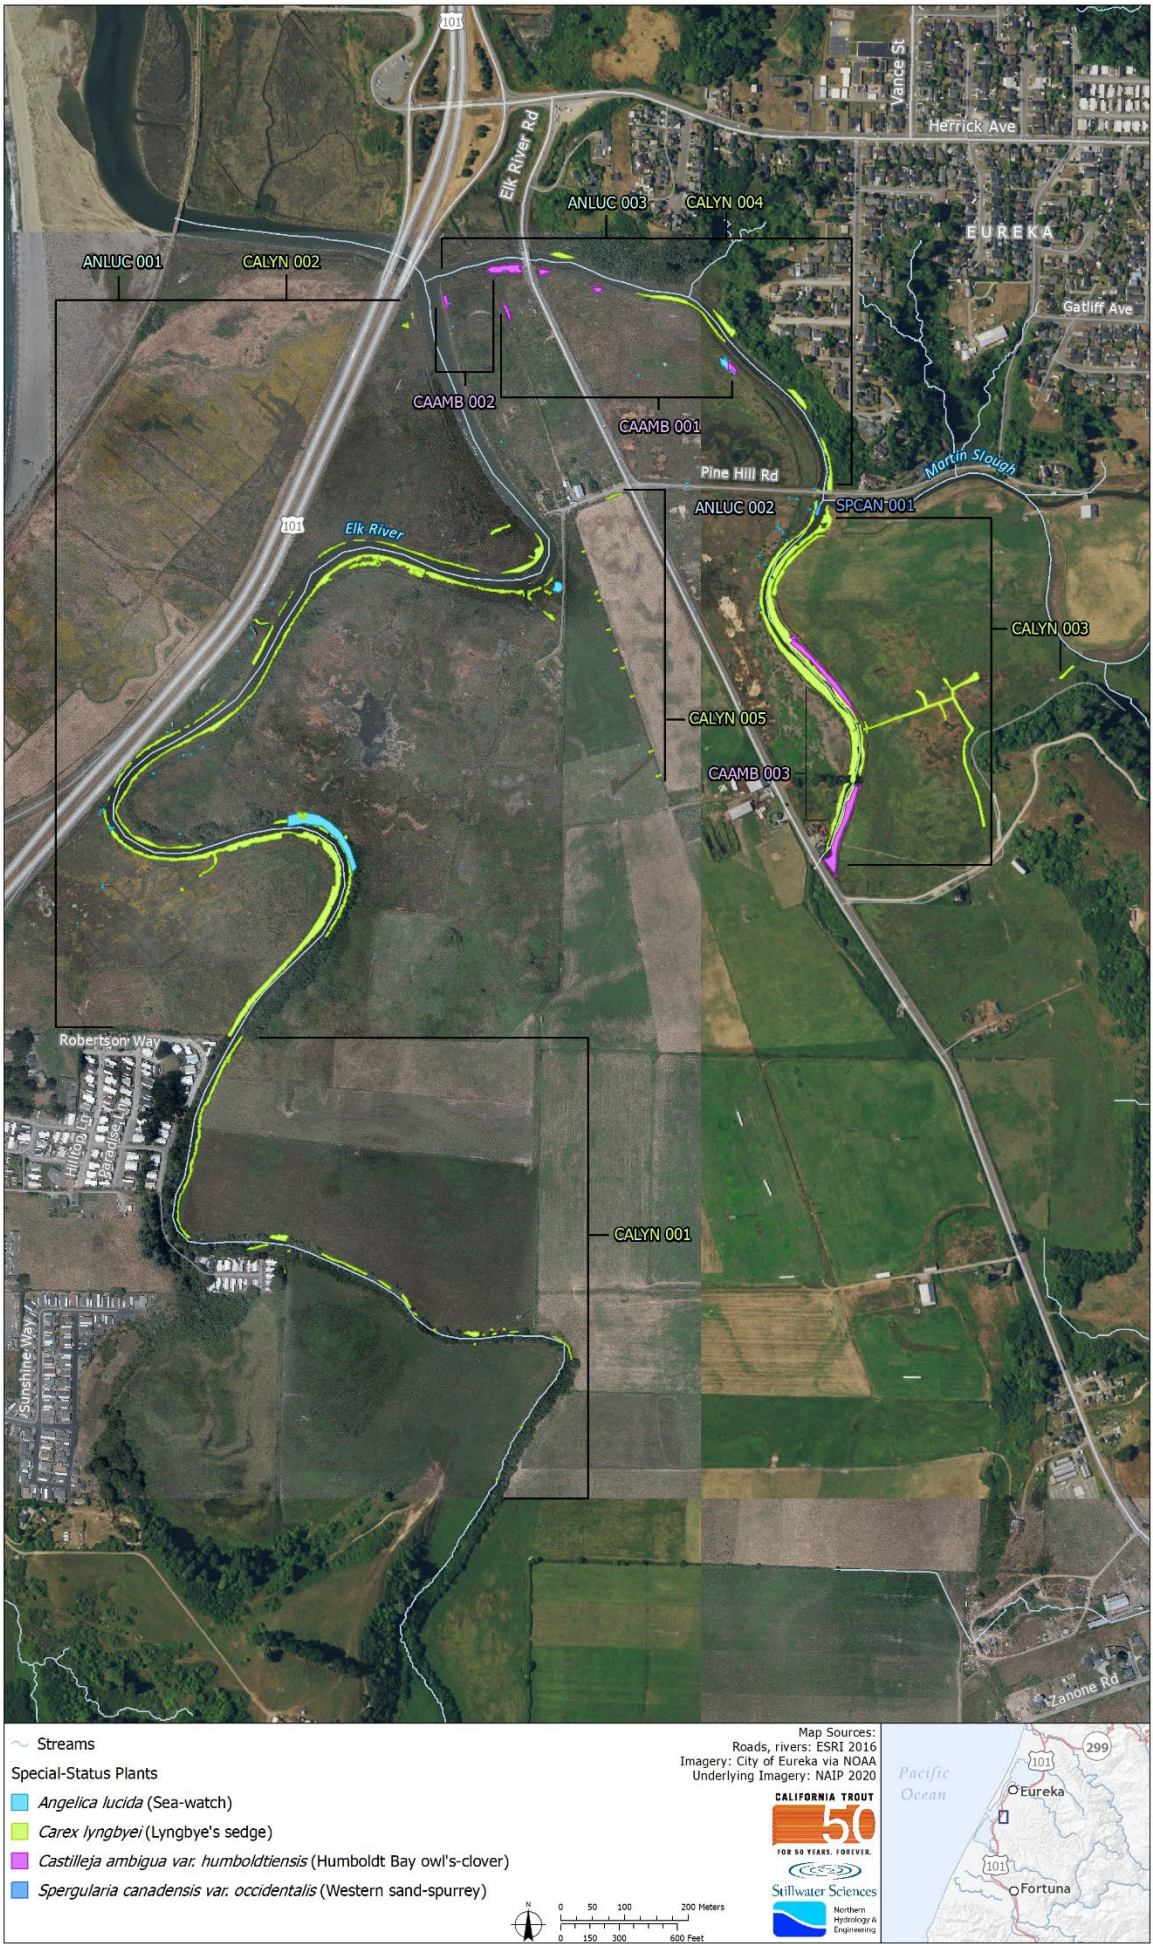
Figure 2-37. Special-status plant occurrences in Elk River Planning Area 1.

Four special-status plant species were documented in the planning area: *Carex lyngbyei* (Lyngbye's sedge), *Angelica lucida* (sea-watch), *Spergularia canadensis* var. *occidentalis* (western sand-spurrey), and *Castellija ambigua* subsp. *humboldtiensis* (Humboldt Bay owl's-clover) (Figure 2-37). Occurrence data for all documented occurrences are provided in Table 2-21 and summarized in the following sections. Completed CNDDDB forms for all 2021 documented occurrences are provided in Appendix B.

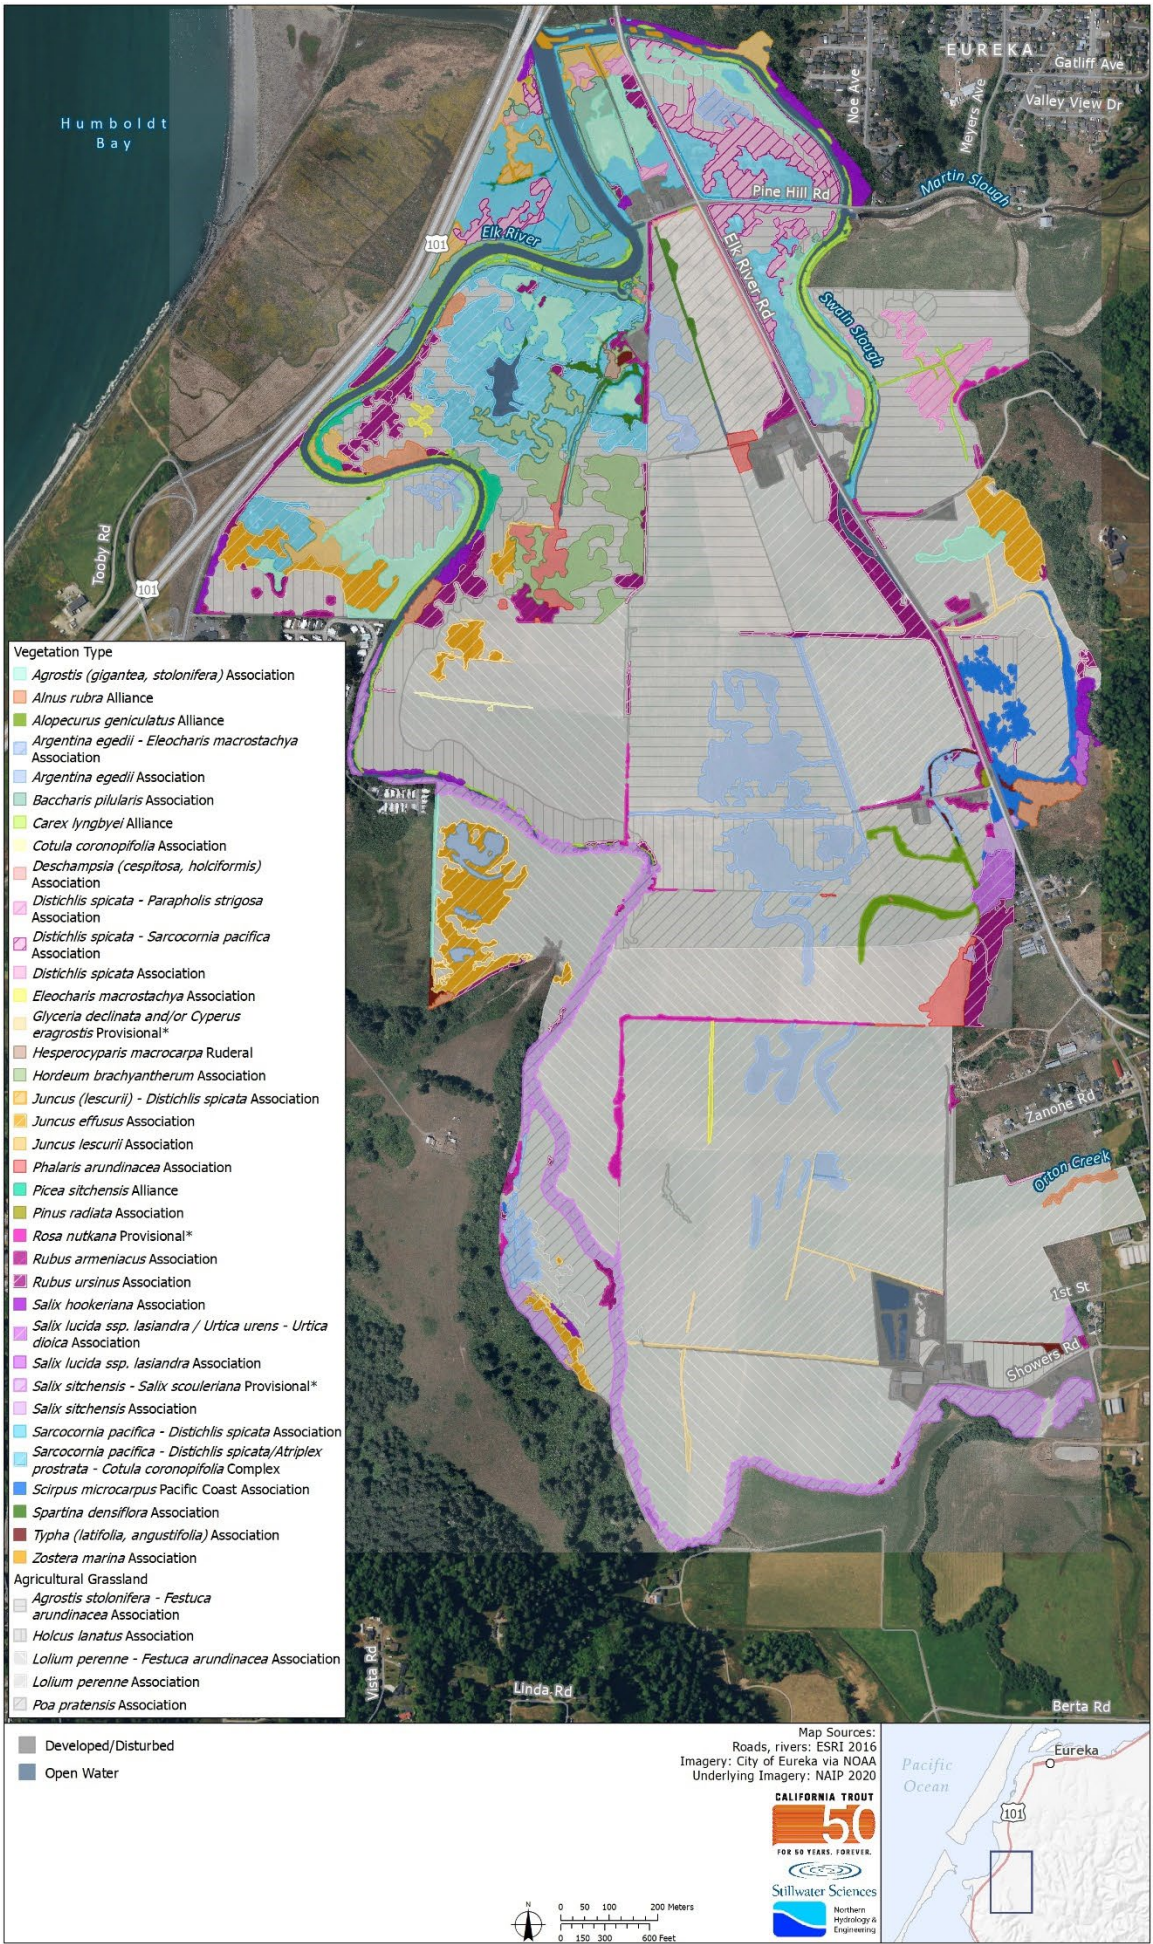
Figure 2-38. Vegetation cover types within the Elk River Planning Area 1.

The vegetation map includes four native and two nonnative forest associations, six native and one nonnative shrubland associations, and 18 native and 10 nonnative herbaceous alliances/associations (Figure 2-38, Table 2-23). An overview of these mapped vegetation communities is provided in Figure 2-38 with a set of larger scale maps provided in Appendix B. Other cover types included developed/disturbed and open waters (Figure 2-38, Table 2-23). Since vegetation was mapped based on areal extent of vegetative canopy, open waters in the vegetation map are associated with waterways that lacked an overstory canopy. Extent of waters within the planning area are provided in Section 2.5. Development and disturbed areas were associated with agricultural land use (e.g., barns, access roads), paved roadways, private residential, and utilities (i.e., substation).

Covering a total of 553 ac (~62%) of the planning area, most of the Elk River valley bottom was occupied by nonnative grassland associations related to active agricultural land use, primarily grazing pasture for dairy cows and hay production (Figure 2-38, Table 2-23). Leaky tide gates and degraded earthen berms along Elk River and Swain Slough have returned tidal influence back onto historical tidelands in and adjacent to ERWA and some parcels along Swain Slough. These tidally influenced locations are no longer managed for agriculture land use and thereby contain most of the native and naturalized herbaceous vegetation types documented in the planning area. Tidal regimes in reclaimed tidelands of Elk River and Swain Slough formed intertidal coastal salt marsh and brackish marsh communities that totaled approximately 99 ac of the planning area (Figure 2-39). The Elk River riparian corridor was narrowed by land use throughout the planning area. It was composed mostly of willow species, although a small stand of intact evergreen conifers was observed near the ERWA. Overall riparian vegetation in the planning area totaled approximately 39 ac (Table 2-23). Lowland swales and drainages throughout the valley bottom were composed of hydrophytic herbaceous species. Vegetation composed of hydrophytic wetlands within the planning area totaled ~70 ac (Table 2-12). Levee crests and upland earthen berms were composed of species assemblages associated with coastal scrub habitat (~30 ac) (Figure 2-39). Sensitive natural communities observed in the planning area and semi-natural alliances characterized by nonnative invasives in the region are described in the following sections.

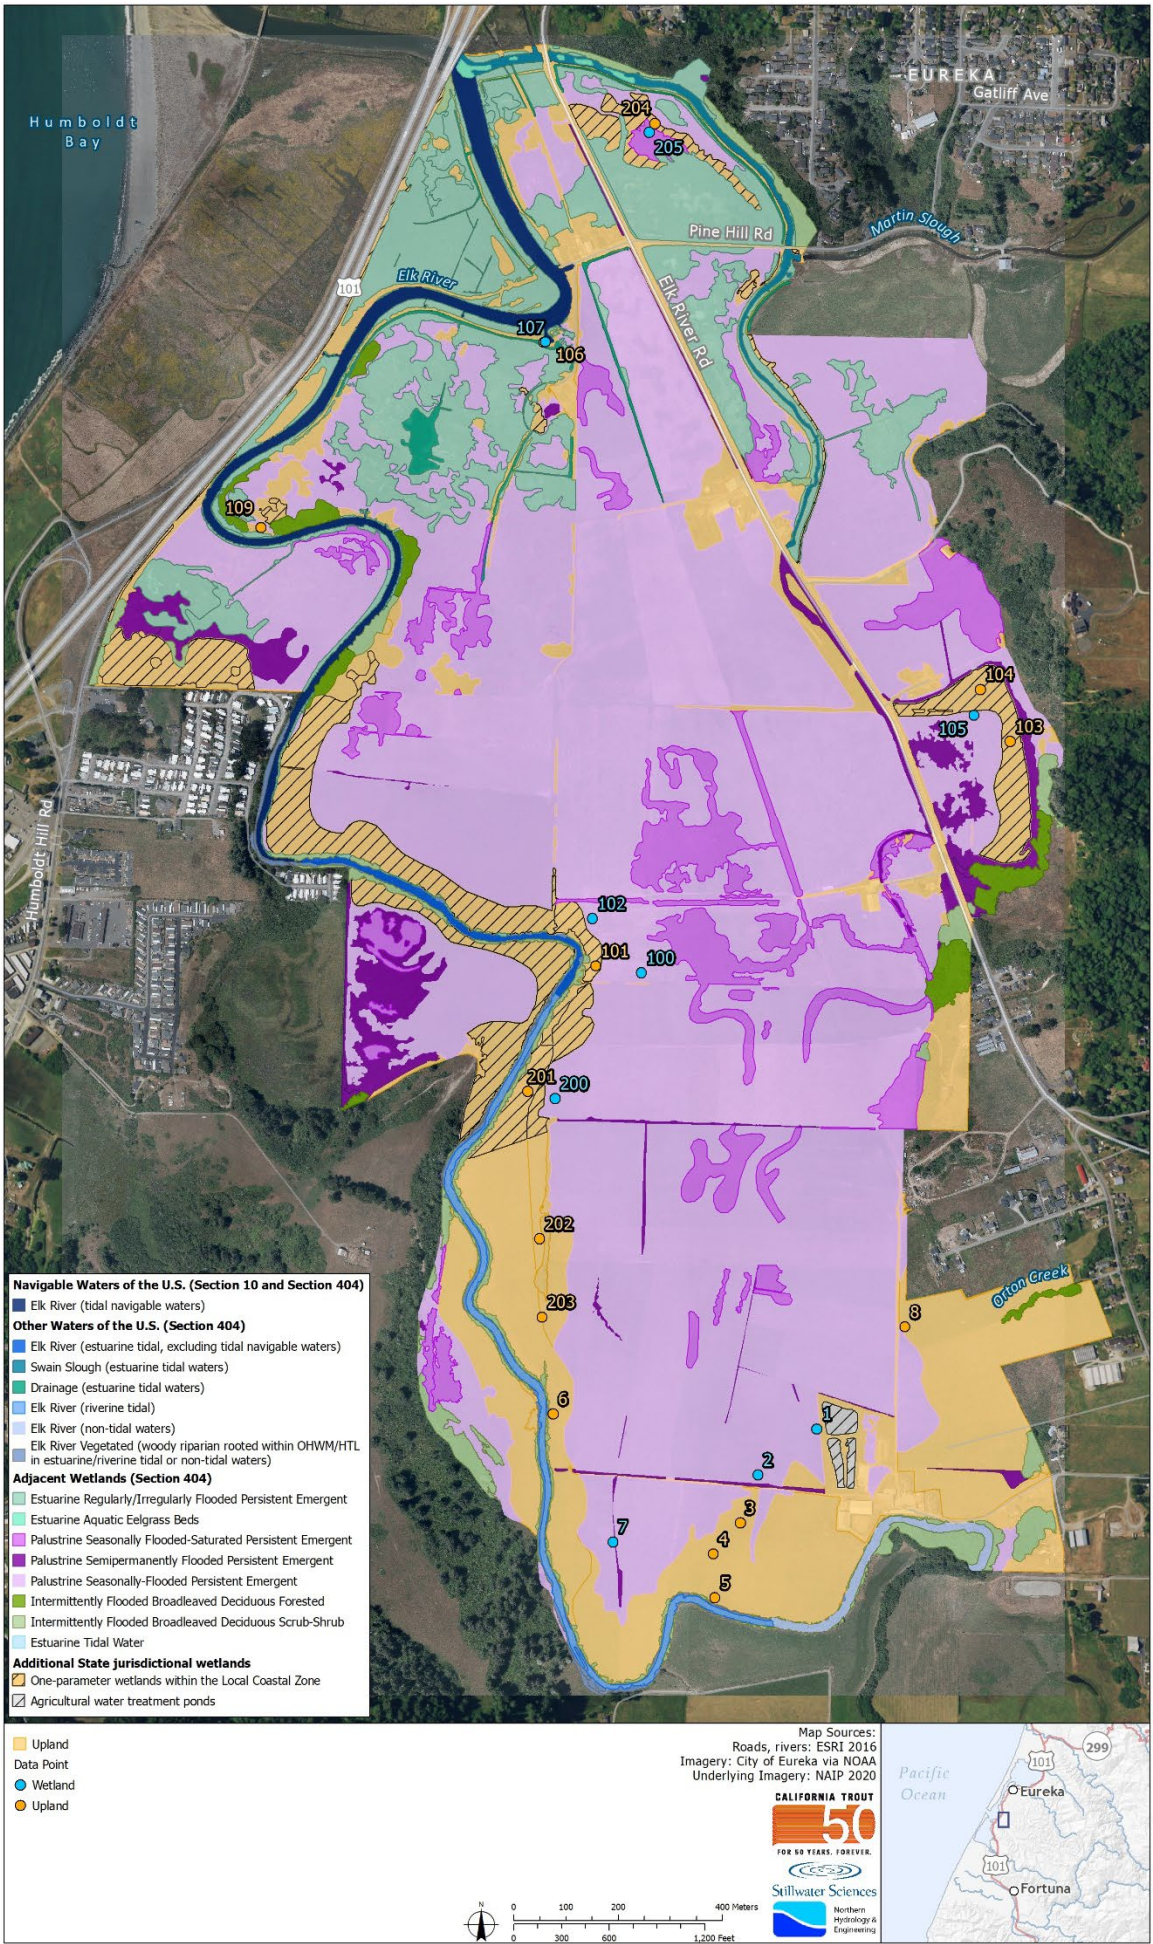
Figure 2-39. Preliminary jurisdictional waters and wetlands in Elk River Planning Area 1.

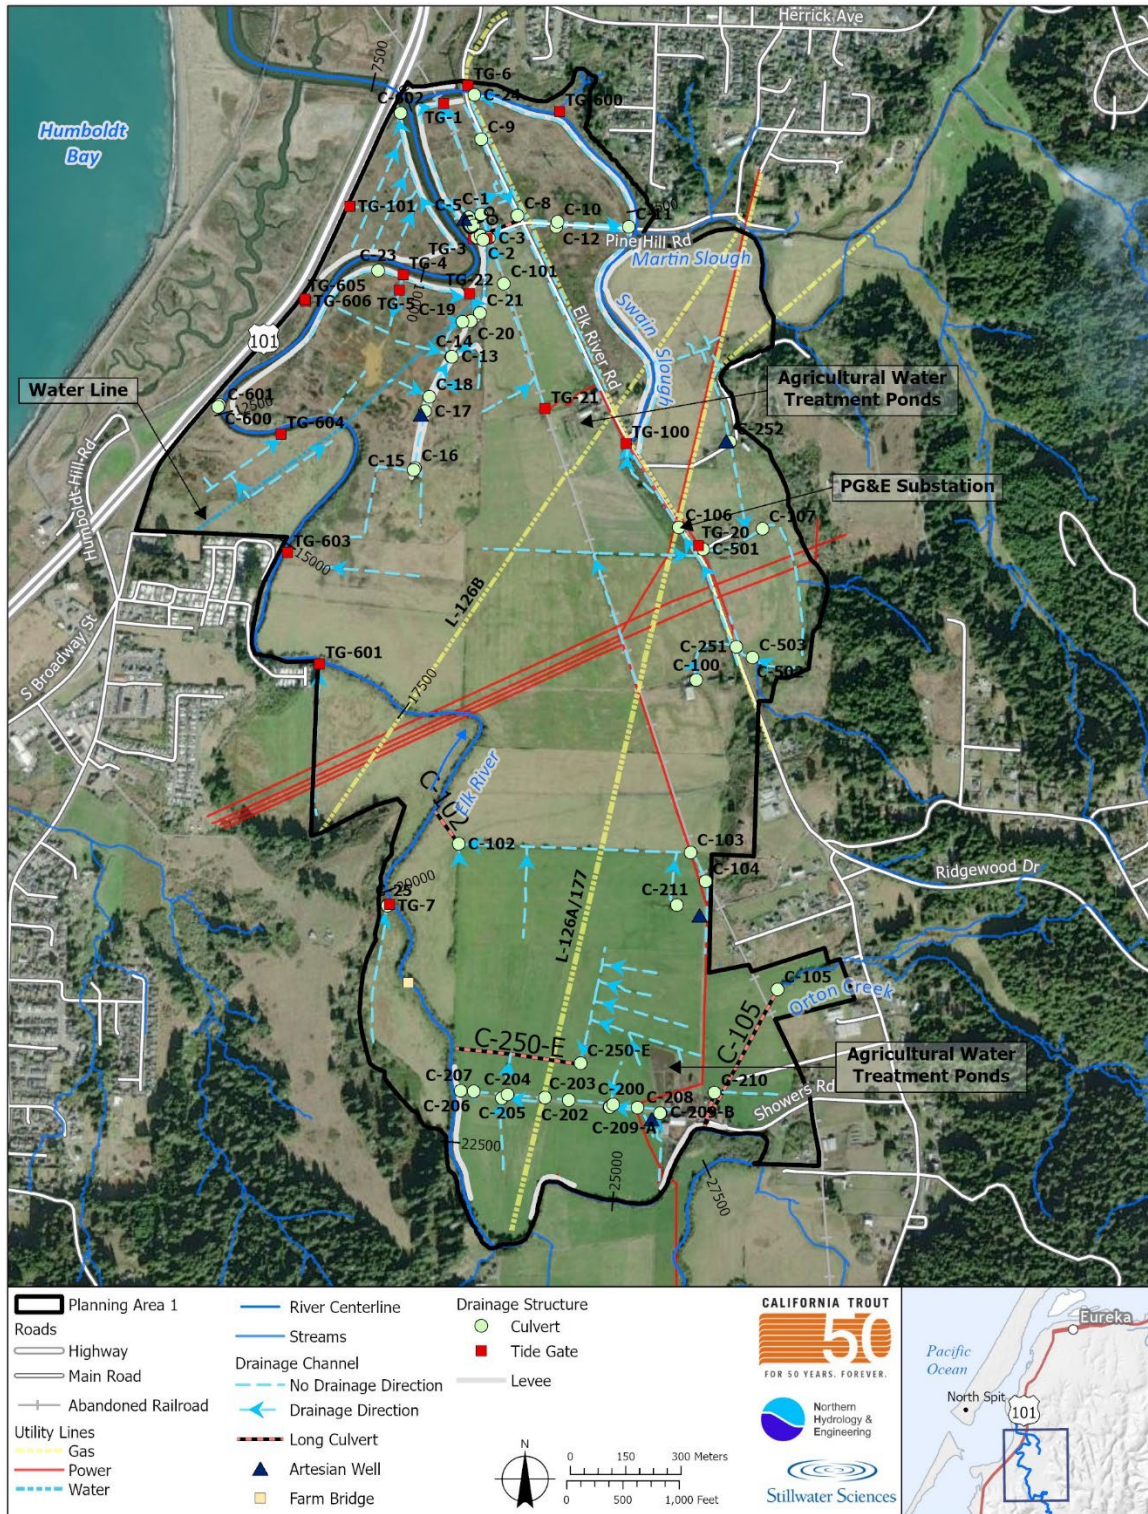
Figure 2-40. Existing infrastructure map of Planning Area 1.

Shallow water lines (Figure 2-40) runs through the central portion of the project site. These water lines will be replaced, in coordination with Humboldt Community Services District (HCSD). This action removes a significant constraint to restoration of the project site, improves the reliability of the water supply and reduces the vulnerability of the line to future sea level rise.
