FINAL REPORT • MAY 2023

Elk River Planning Area 1: 10% Design Report

Northern Hydrology and Engineering
P.O. Box 2515
McKinleyville, CA 95519

Stillwater Sciences
850 G Street, Suite K
Arcata, CA 95521

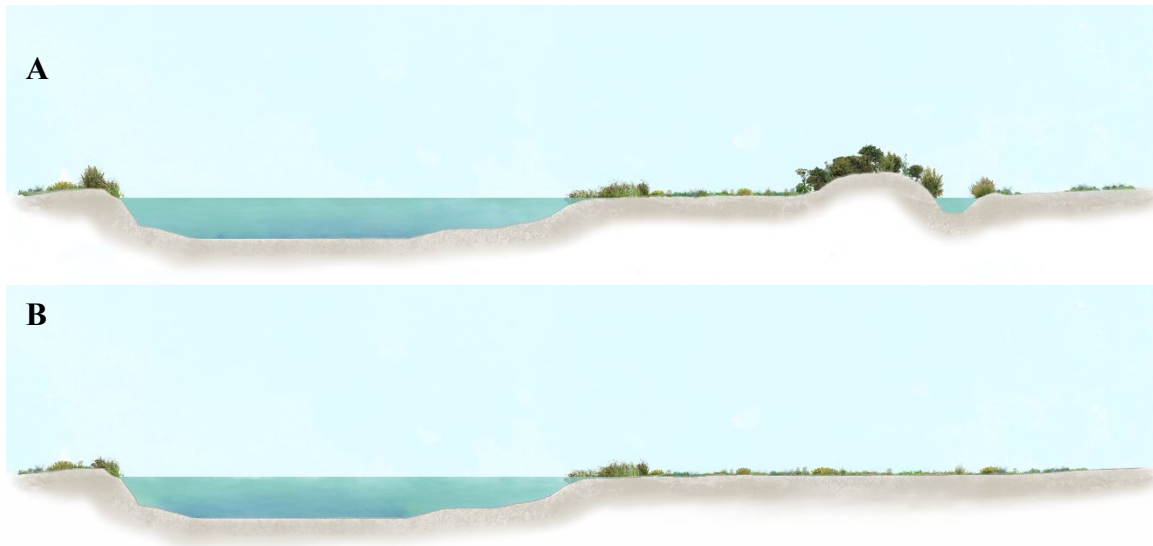
Figure 3-1. Elk River salt and brackish marshes. Existing conditions - with a narrow strip of marsh plain disconnected from larger tidal wetlands by existing levees (A). Proposed conditions resulting from removing and modifying levees to reconnect Elk River to extensive salt and brackish marsh plains during high tides, and from enhancing slough channel networks (B). Example is from ERWA- South in PA1.

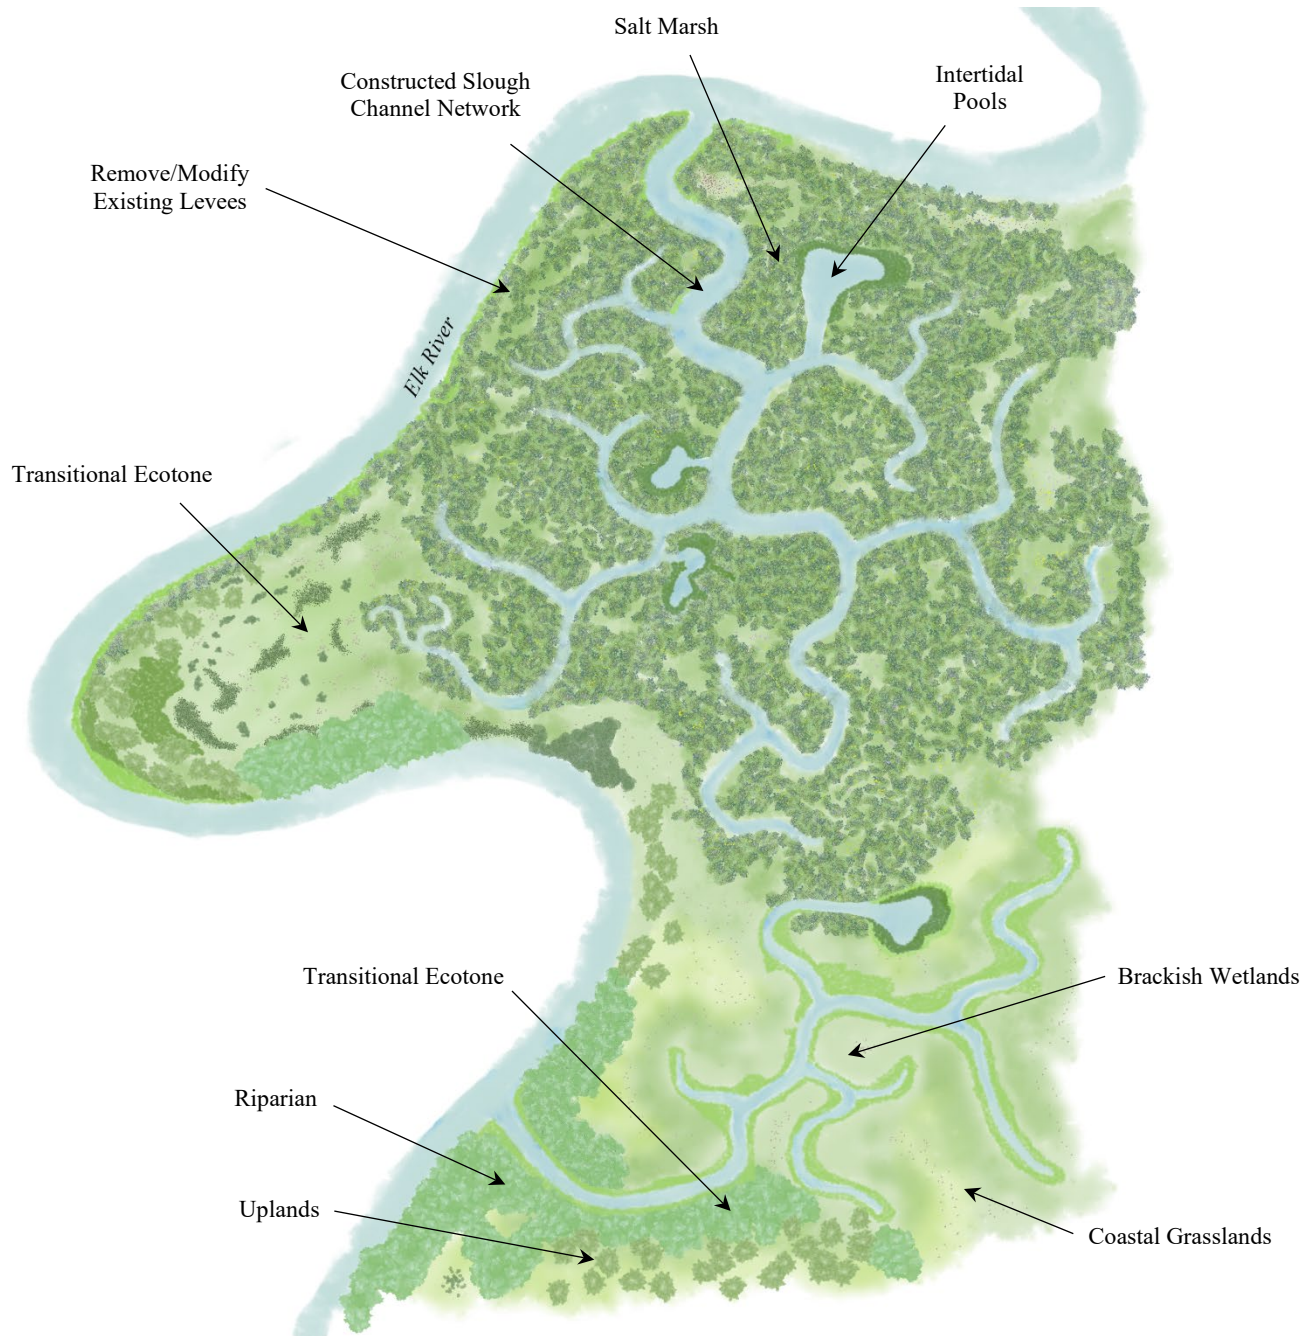
Figure 3-2. Tidal marsh enhancement including enhancement of slough channels, intertidal ponds, salt marsh, brackish wetlands, wetland-to-riparian and wetland-to-upland ecotones, riparian, coastal grasslands, and uplands. Example is from ERWA-South in PA1.

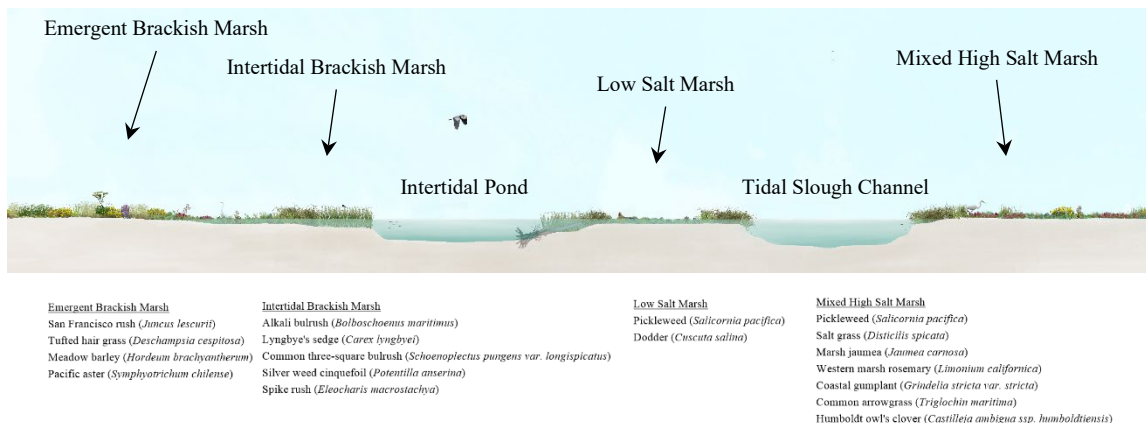
Figure 3-3. Salt marsh enhancement including an enlarged slough channel network, intertidal pools, brackish vegetation along channel edges and mixed high marsh. Water elevation shown is approximately mean higher high water (MHHW). Example is from ERWA-Sough in PA1.

brackish marsh (based on Elk River's extant Lyngbye's sedge population), mixed high salt marsh, and high brackish marsh as shown in Figure 3-2 to Figure 3-4. Further along the elevation gradient tidal influence will decrease, and the formation of native riparian scrub, shrub, and forested communities will be enhanced and created (Figure 3-5). These design features will also serve as an area for potential marsh migration.

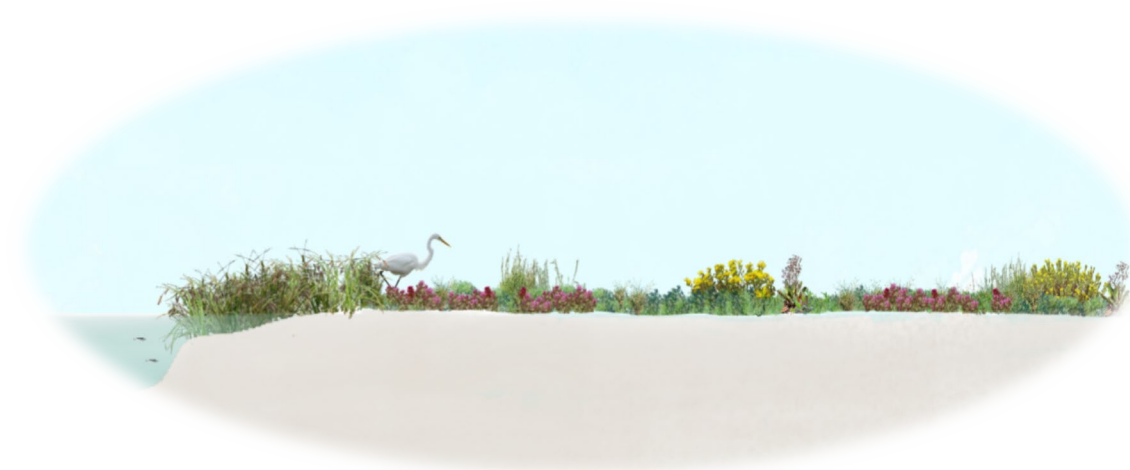
Figure 3-4. Mixed high salt marsh is located at an elevation near MHHW.

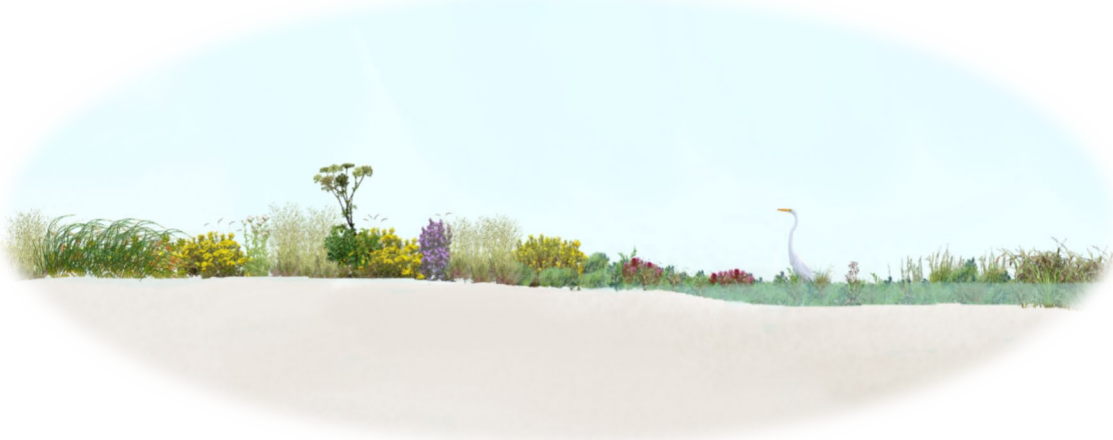
Figure 3-5. Emergent brackish marsh is located at an elevation above MHHW.

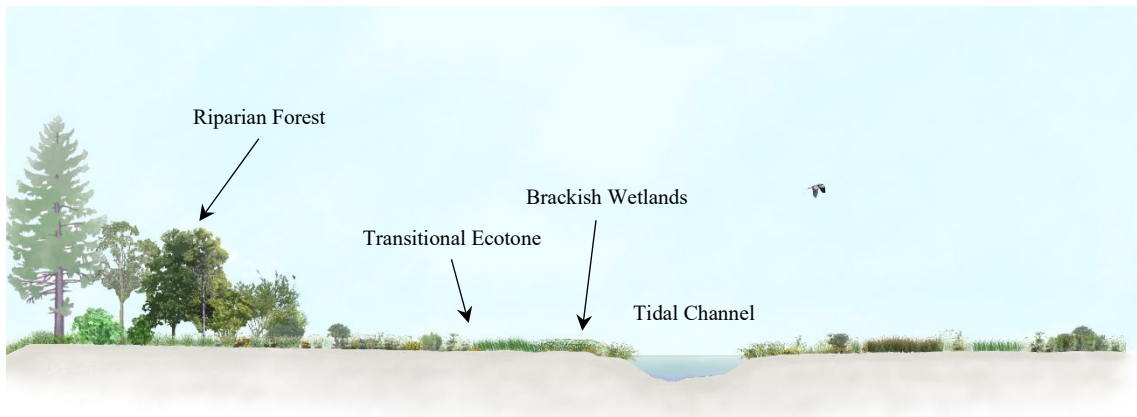
Figure 3-6. Brackish wetlands enhancement including off-channel habitat with tidal channels fringed with brackish marsh vegetation. Brackish wetlands transition through a wetland-to-riparian ecotone, grading to riparian forest and uplands.

- i) re-grading of an existing ~1,400-ft drainage ditch to increase sinuosity and enhance channel bed and bank complexity (e.g., inset benches, pools, bank scallops),
- ii) creation or deepening of a ~0.63-ac seasonal or perennial brackish pond fed by freshwater springs at the base of nearby hillslopes (Figure 3-6), and
- iii) excavation of an alcove where the design channel meets the mainstem Elk River (Sta 16,000).

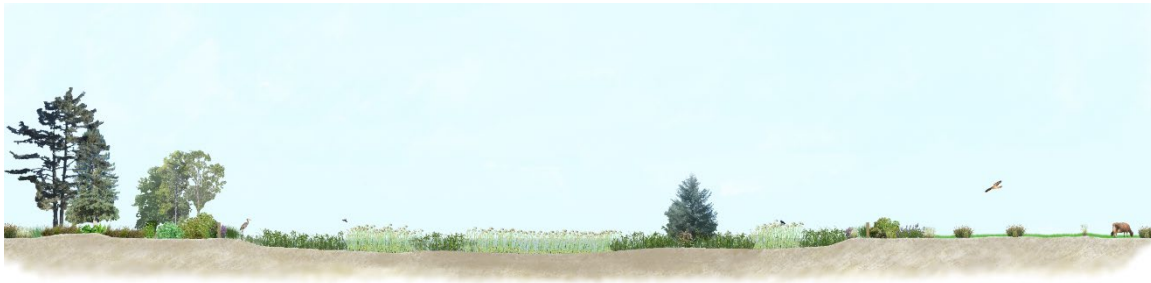
Figure 3-7. Seasonal wetland off-channel from the Elk River.

Two new ponds, with areas of roughly 0.25 and 1.2 ac, will be connected to upstream sources of fresh water during higher flow events via a ~1,300 ft floodplain channel (Figure 3-7 to Figure 3-9). The diameter and invert elevation of the upstream culvert through Pine Hill Rd will need to be properly designed to ensure adequate supply of freshwater to the site while minimizing excessive flooding of the property. The design channel will incorporate pool features, as well as complex banks, inset benches, and wood structures to create varied flow fields and provide a diversity of habitats. Final design specifications regarding channel and pond geometry will depend on the results of future hydraulic modeling as well as on-site groundwater data collection. It is anticipated that proposed levee modifications, together with the installation of the Pine Hill Rd culvert (C-DG1) will precipitate a conversion from a salt/brackish marsh to freshwater habitat/communities. Consideration will be given to the maintenance of adequate water quality (e.g., dissolved oxygen, nutrients, and salinity) in the proposed features given the lack of a perennial freshwater source and the fact that much of the upstream water supply derives from overland runoff from adjacent agricultural pastures.

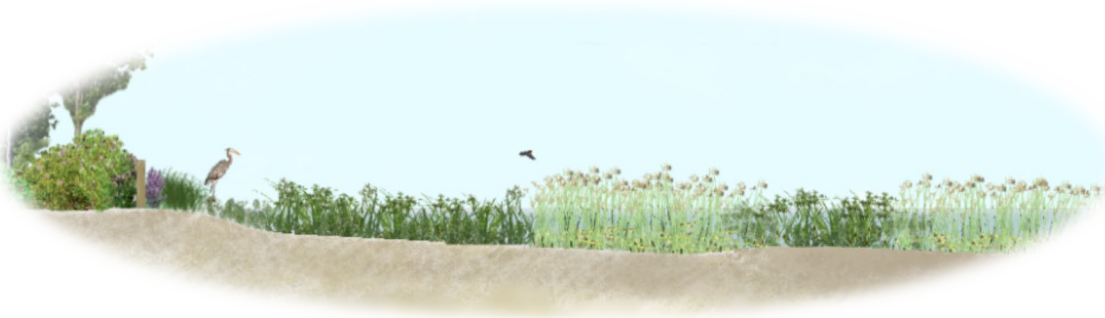
Figure 3-8. Seasonal wetlands are dominated by emergent vegetation that flood during high flows.

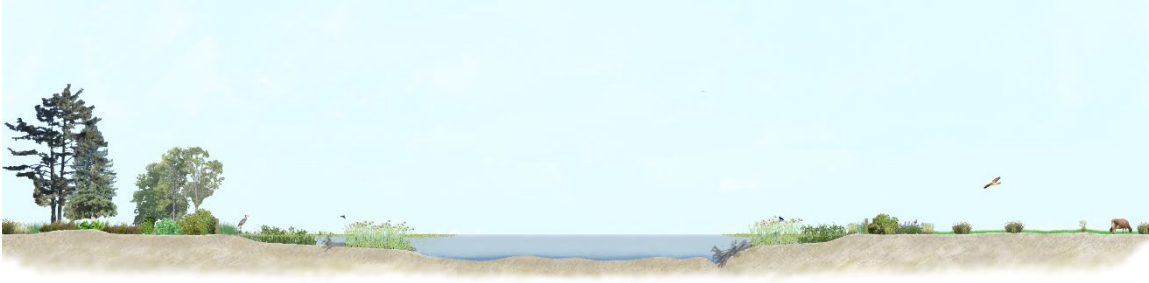
Figure 3-9. Perennial wetland off-channel from the Elk River.

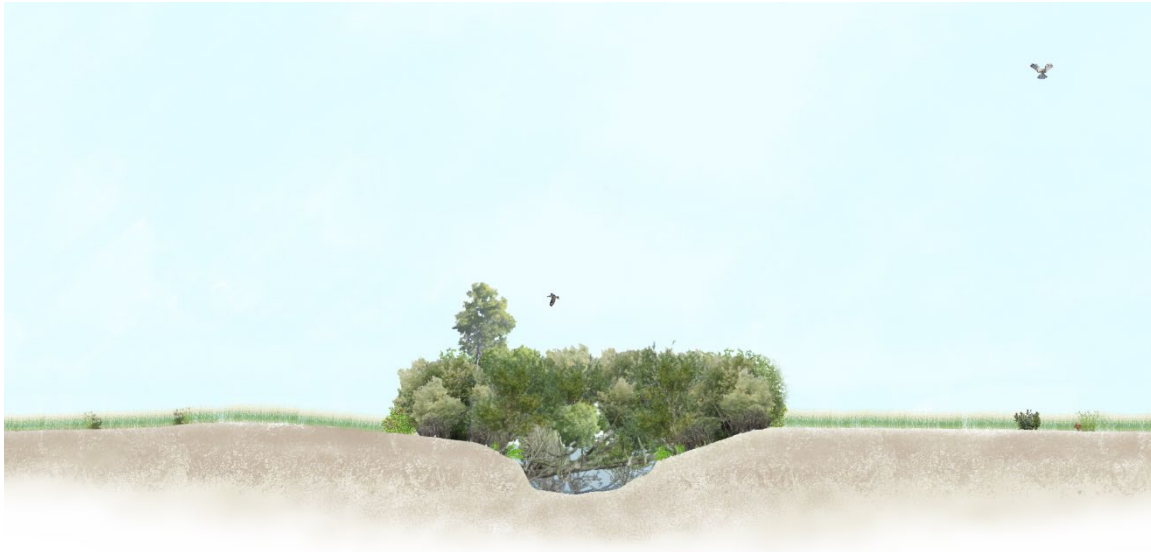
Figure 3-10. Existing of existing riparian vegetation along sections of Elk River (ER-10 and ER-12) that are dominated by fine stem clonal willow growth that cover the banks.

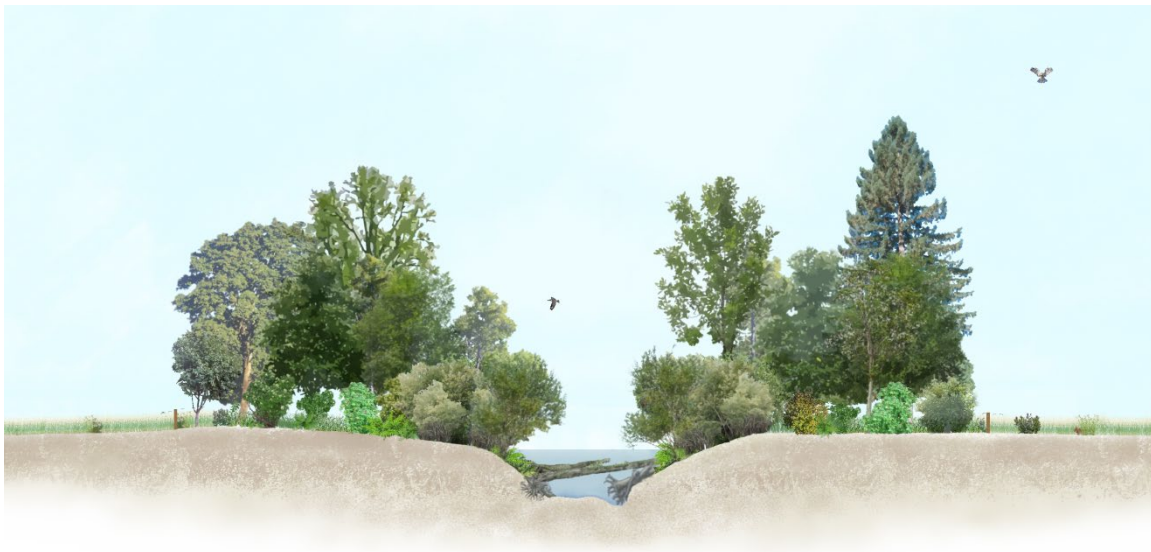
Figure 3-11. Example of riparian enhancement in mainstem Elk River.

Collectively, riparian enhancement, nonnative vegetation removal, and large wood augmentation will be similar to illustrations (Figure 3-11).

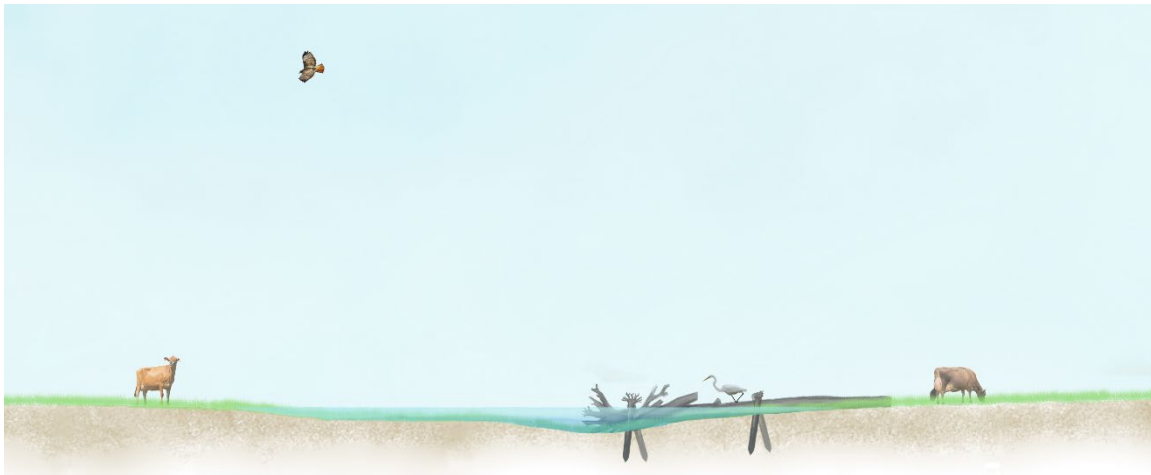
Figure 3-12. Floodplain channel through agricultural grasslands during flood flows in the Elk River. The low flow channel, set within a broad shallow floodplain channel, provides deeper flow paths with cover for fish to pass through agricultural grasslands to reach higher quality habitats as high water recedes. During dry periods, the floodplain channel is grazed.

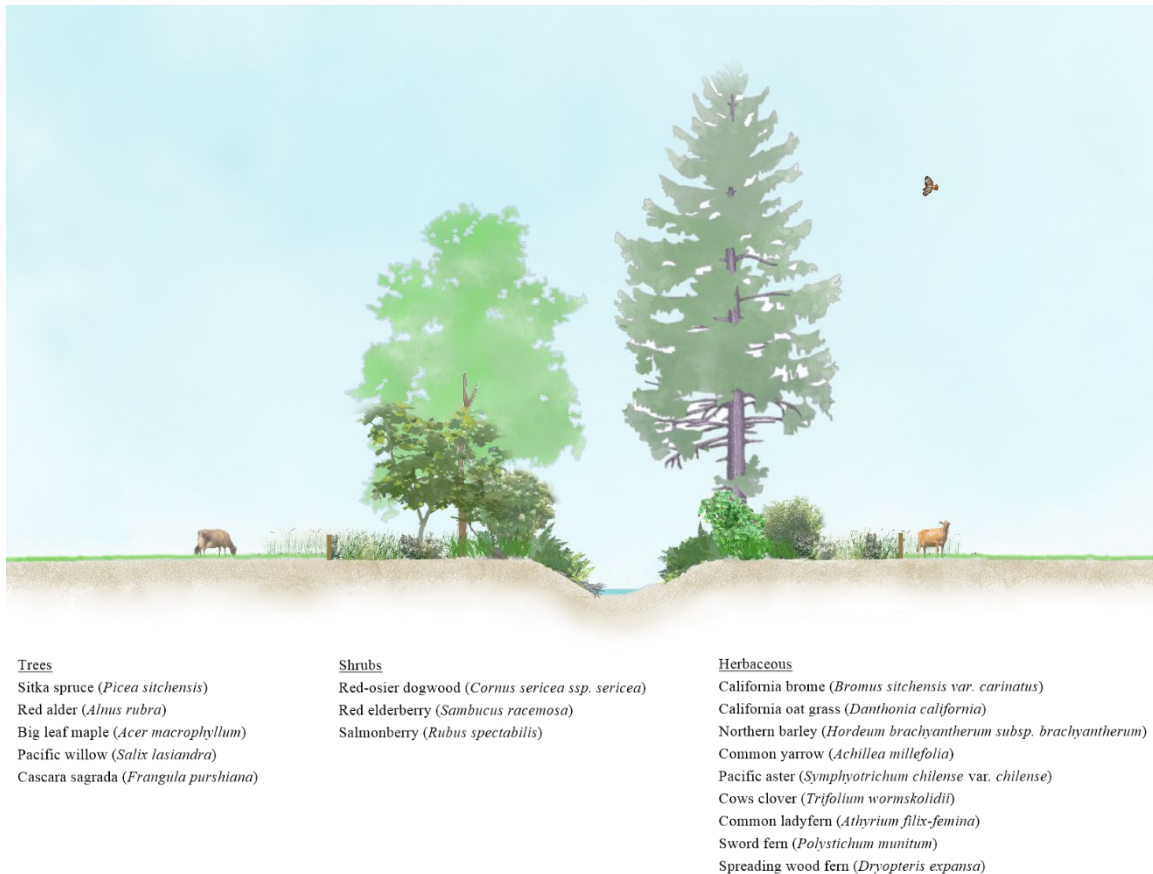
Figure 3-13. Tributary restoration may include daylighting tributaries that flow through long culverts, riparian enhancement, improving channel complexity wood, alcoves, inset benches, and exclusion fencing. Some riparian areas may be suitable for flash grazing as shown. Example is from Orton Creek in PA1.

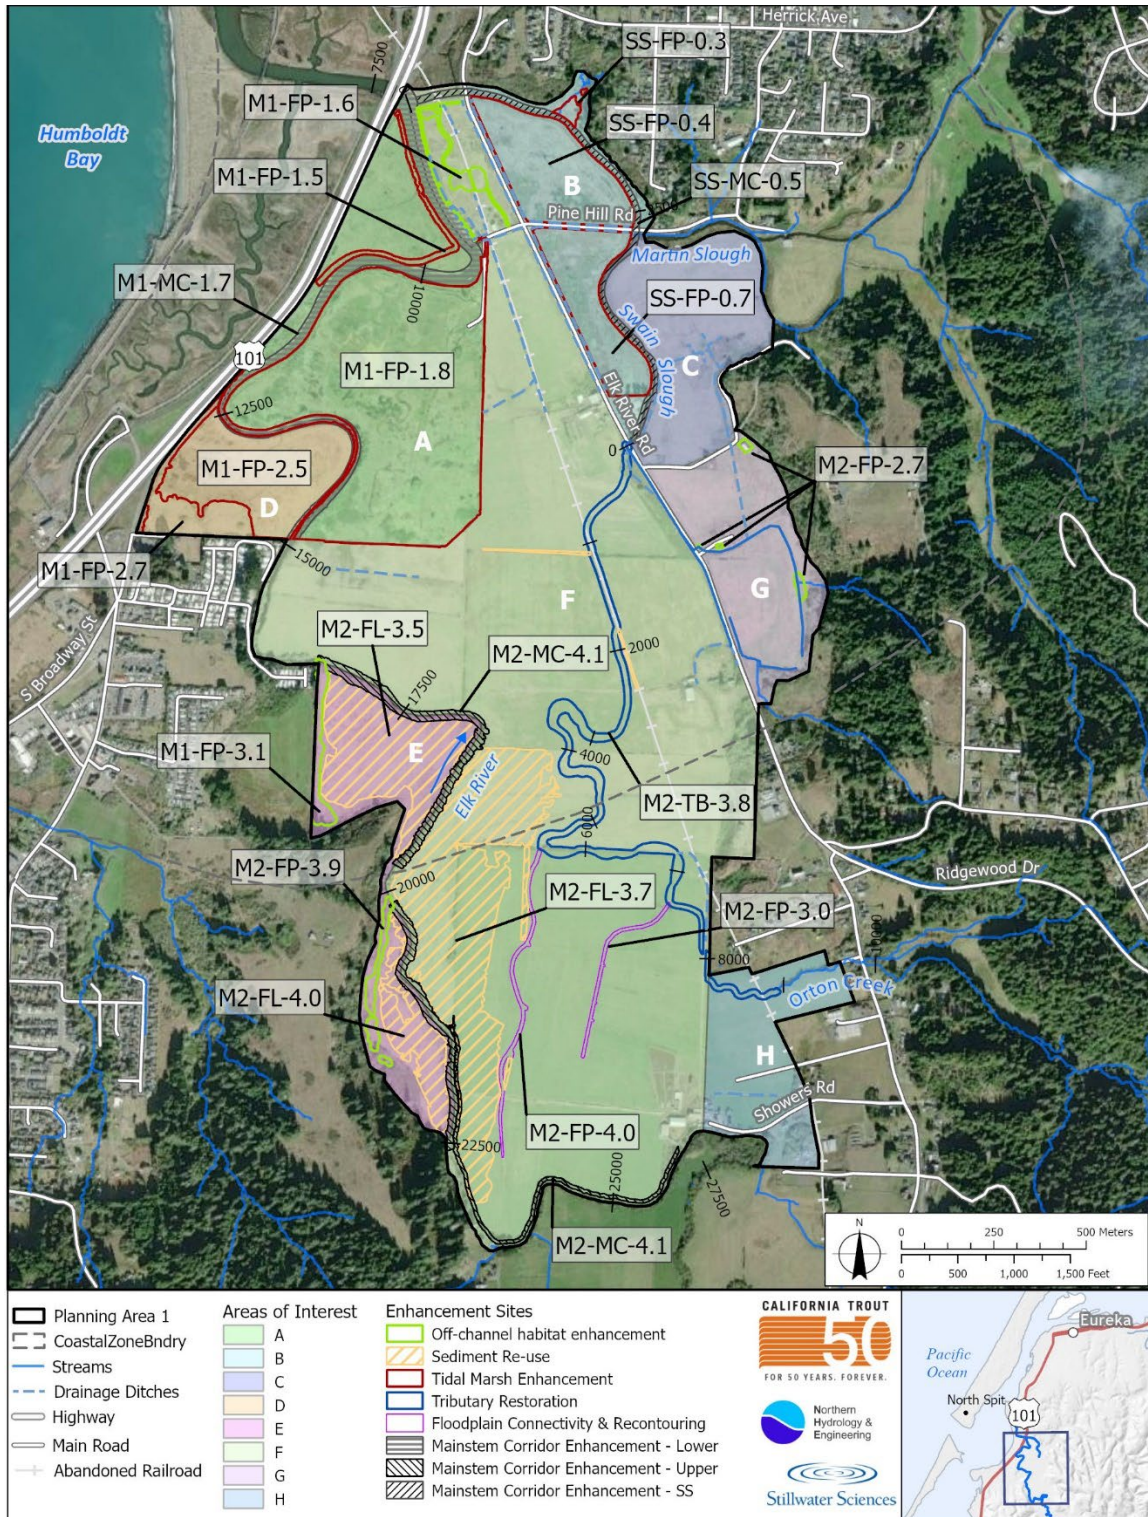
Figure 3-14. Enhancement Sites and Areas of Interest in Planning Area 1.

PA 1 is divided into Areas of Interest (AOI) labeled A–H (Figure 3-14). The areas of interest cover the entire planning area and are used within the report to summarize benefits or impacts that extend beyond the enhancement sites.

These enhancement sites are in AOI D and are bound by Hwy 101 to the west, residential properties to the south and Elk River to the north and east (Figure 3-14). These sites occupy a single parcel that is part of a possible land acquisition, and the conceptual design was developed under the assumption that the acquisition will be successful. Subsequent design phases will incorporate any additional opportunities/constraints identified in coordination with the new landowner.

This 1.8 ac enhancement site is located within the southern parcel of AOI E along the western edge of PA-1 near river station 20,000 (Figure 3-14). Proposed enhancement measures within site M2-FP-3.9 include three main actions:

This 2.1 ac enhancement site is located within the northern parcel of AOI E along the western edge of PA-1 near river station 16,750 (Figure 3-14). Proposed enhancement measures within site M1-FP-3.1 are focused on three main actions:

This ~2.8 ac enhancement site occupies the very northern portion of the Central Floodplain Corridor (AOI F) near the Hwy 101 bridge and confluence of Elk River and Swain Slough (Figure 3-14). The principle focus of the conceptual design in the Northern Pond Complex is to expand off-channel freshwater habitat through the excavation of channels and ponds, improve drainage to mitigate upstream flooding by installing or modifying culverts and tide gates, and protect agricultural land from tidal inundation through the modification of an existing levee.

This 0.4-ac site is located within AOI G on the eastern side of the PA-1 between Elk River Rd and the Elk River valley eastern valley floor (Figure 3-14). The central focus of design in this area is to:

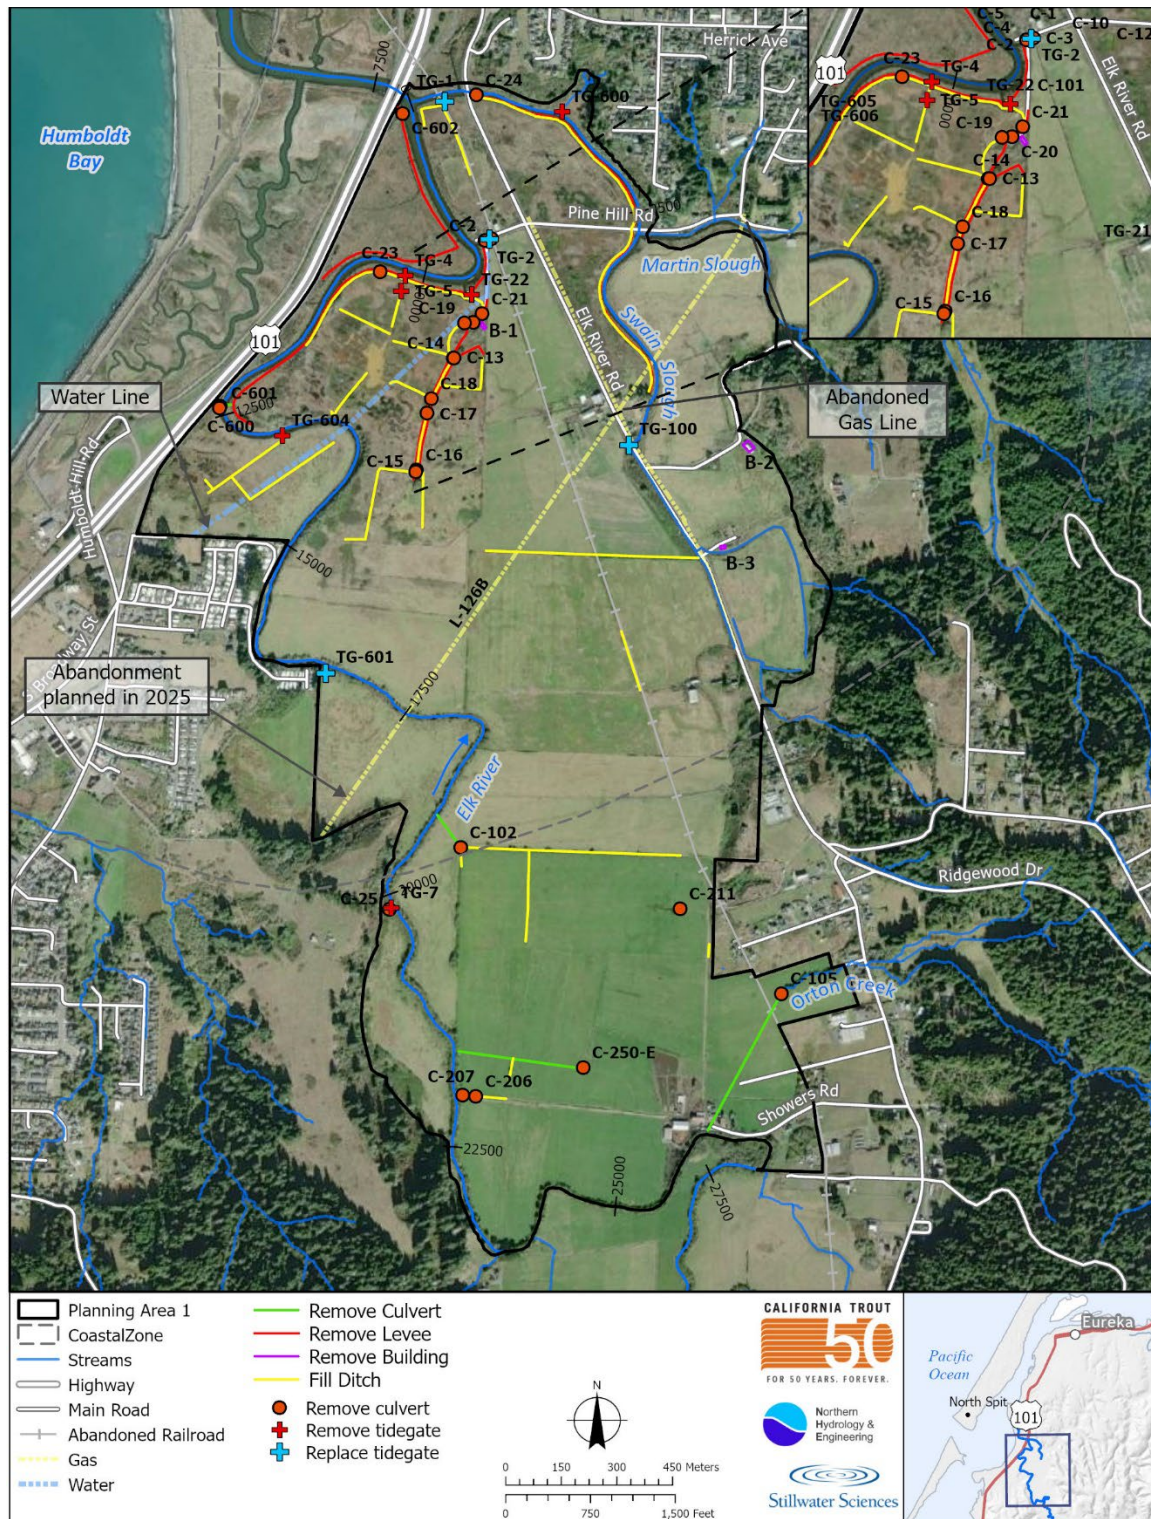
Figure 3-15. Infrastructure proposed for removal. These actions focus on routing overbank flow down valley, removing cross-valley drainage, retrofitting tide gates with fish friendly flap gates, and removing tide gates and levees at tidal march enhancement sites.

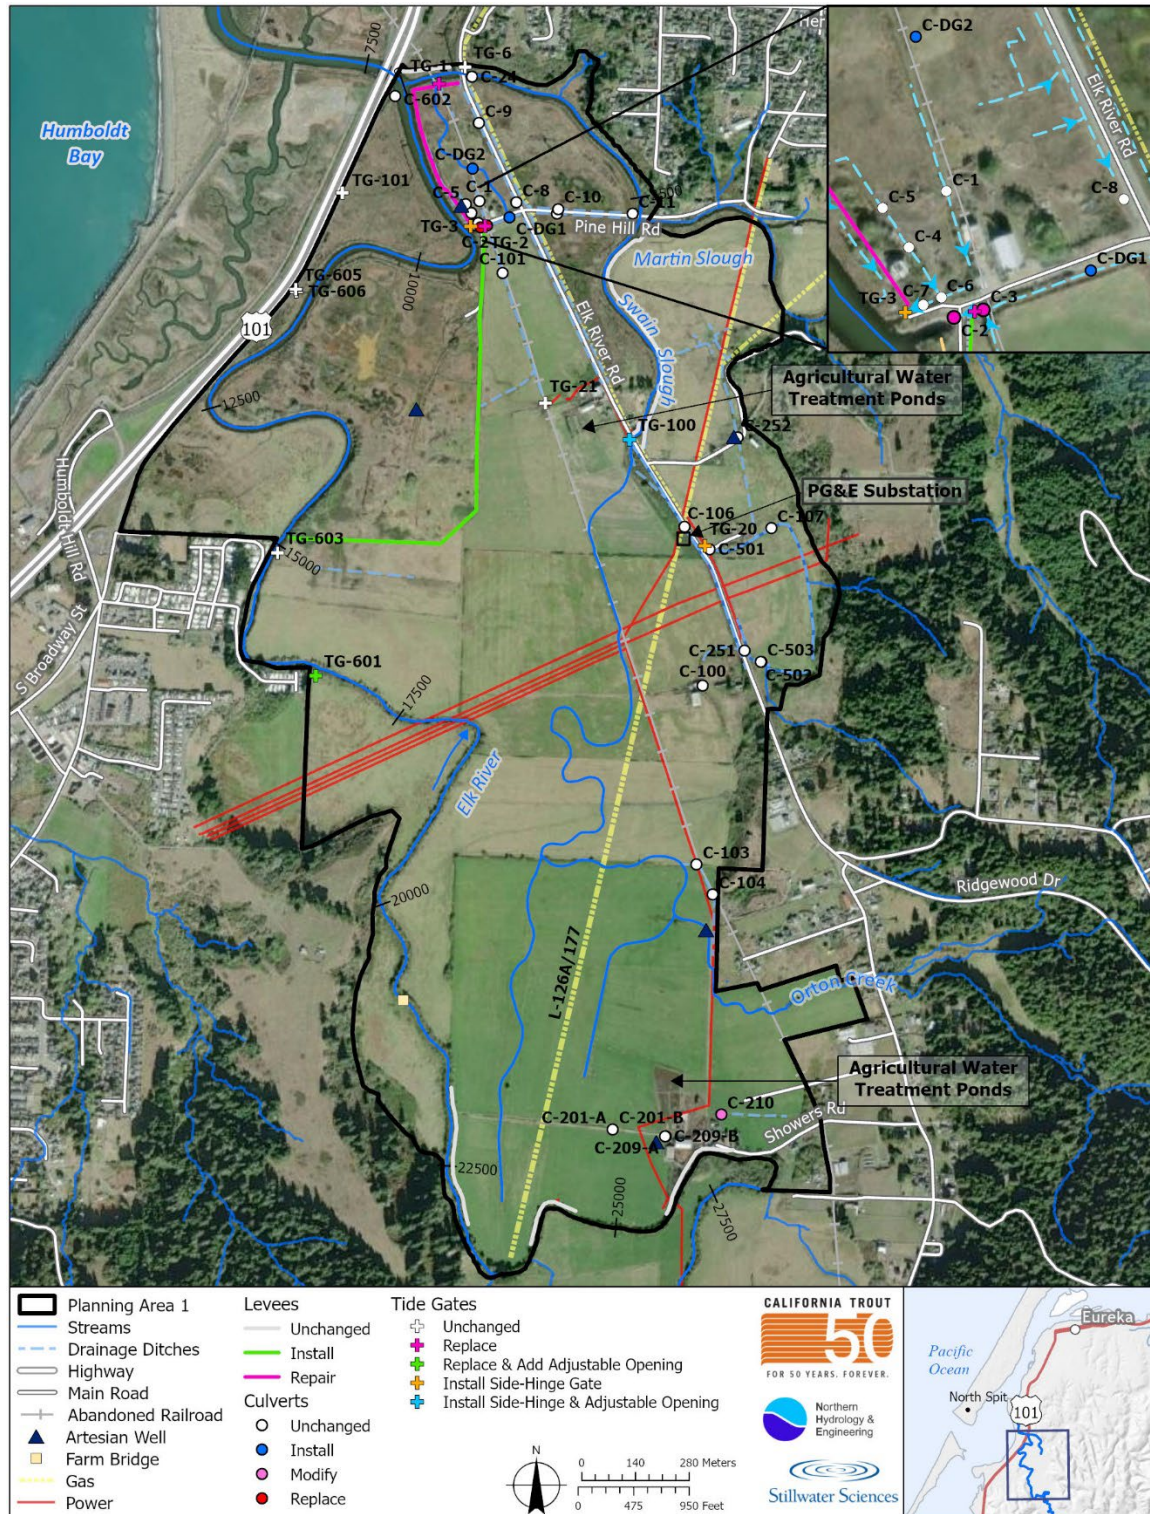
Figure 3-16. Proposed new infrastructure includes installing larger tide gates (side-hinge with optional ability to allow a muted tide at select sites), culvert through Pine Hill Road to improve drainage, increase existing levee height to protect freshwater off-channel enhancement site, eco-berm to protect agricultural lands while allowing full tidal restoration.

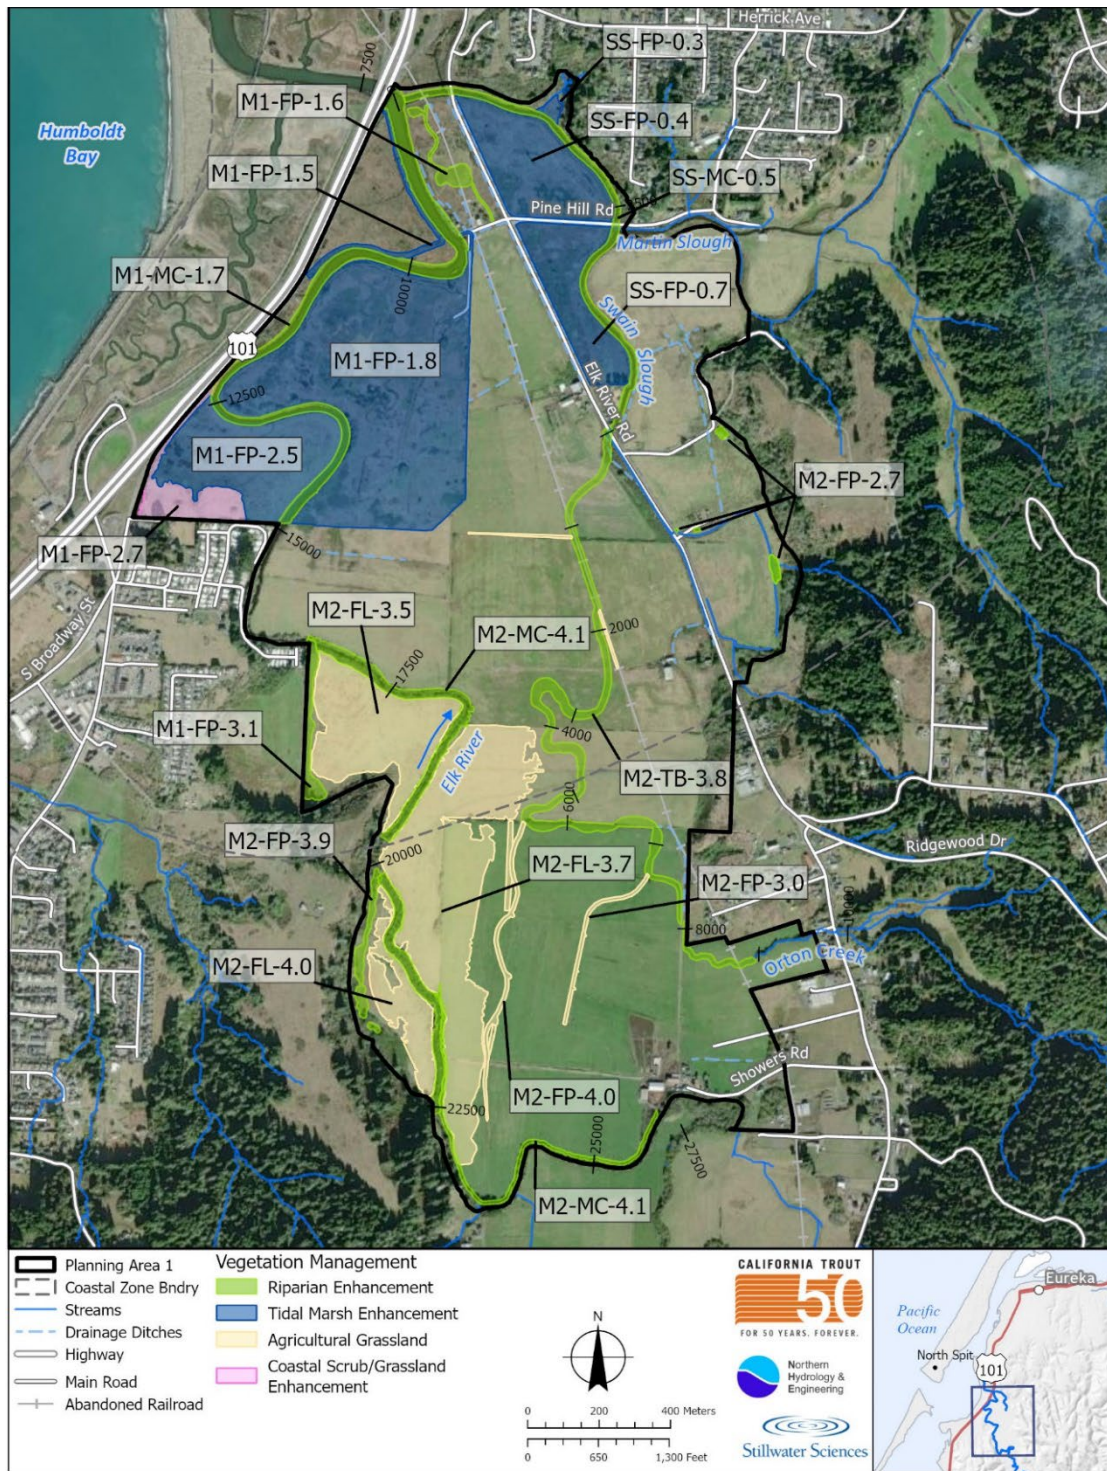
Figure 3-17. Vegetation actions in the enhancement sites include post-disturbance revegetation of sediment reuse areas to re-establish grasslands for grazing and excavated floodplain swales, conversion of agricultural grasslands to riparian forests along mainstem Elk River and the new alignment of Orton Creek, thinning and interplanting of vegetation along mainstem Elk River to improve diversity and wildlife habitat, and conversion of agricultural grasslands to tidal marsh at tidal marsh enhancement sites.

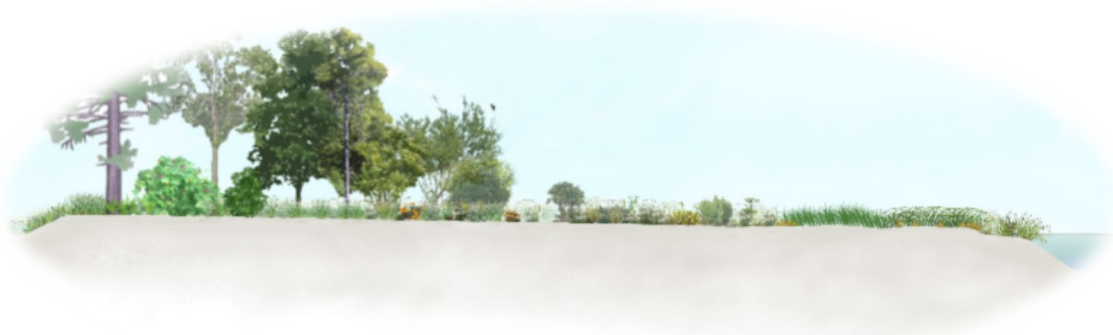
Figure 3-18. Constructed eco-levees provide a low-gradient transition between inundated channels and wetlands to riparian forests, coastal grasslands, and uplands.

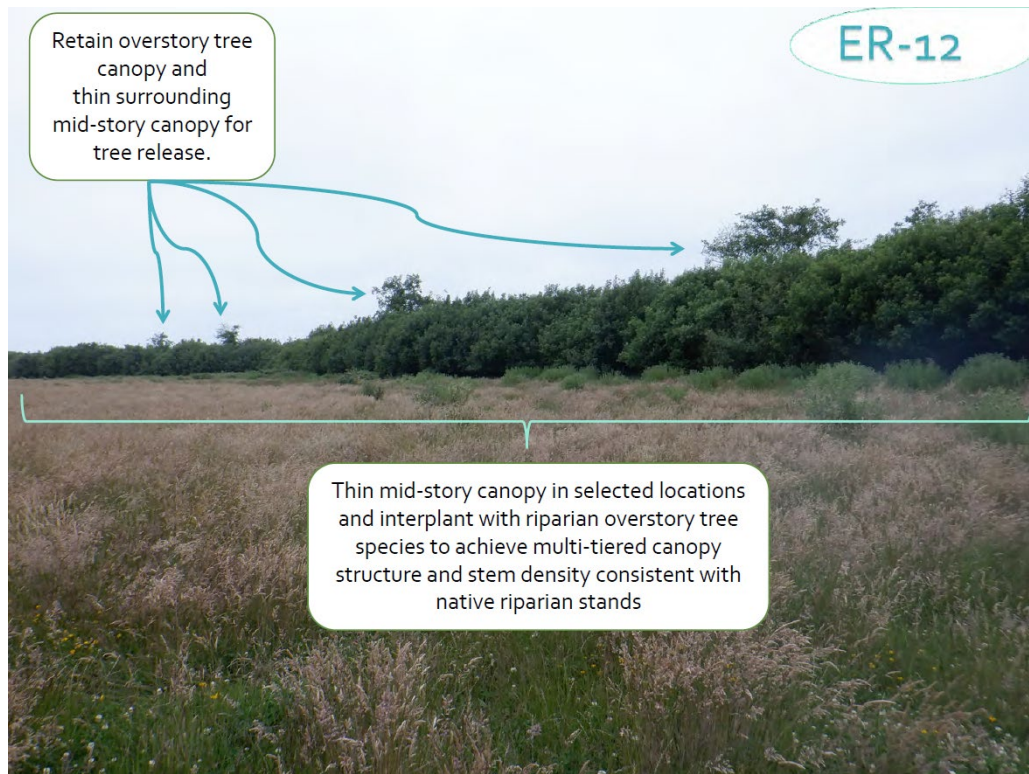
Figure 3-19. Vegetation at ER-12 where thinning and interplanting is proposed to increase structural diversity and promote stem density consistent with native riparian stands.

Thinning and/or the removal of live wood in the Elk River channel is recommended for reaches that have high in-channel encroachment of low to midstory shrubs and channel-spanning fallen live wood (i.e., ER-10, ER-12). Individual trees and/or large diameter stems contributing to overstory canopy will be preserved and high-value native riparian trees (e.g., red alder, Pacific willow) will be retained (Figure 3-19). The areas surrounding high value trees will be cleared to enhance their performance (i.e., by increasing basal growth and height and providing regeneration opportunities).

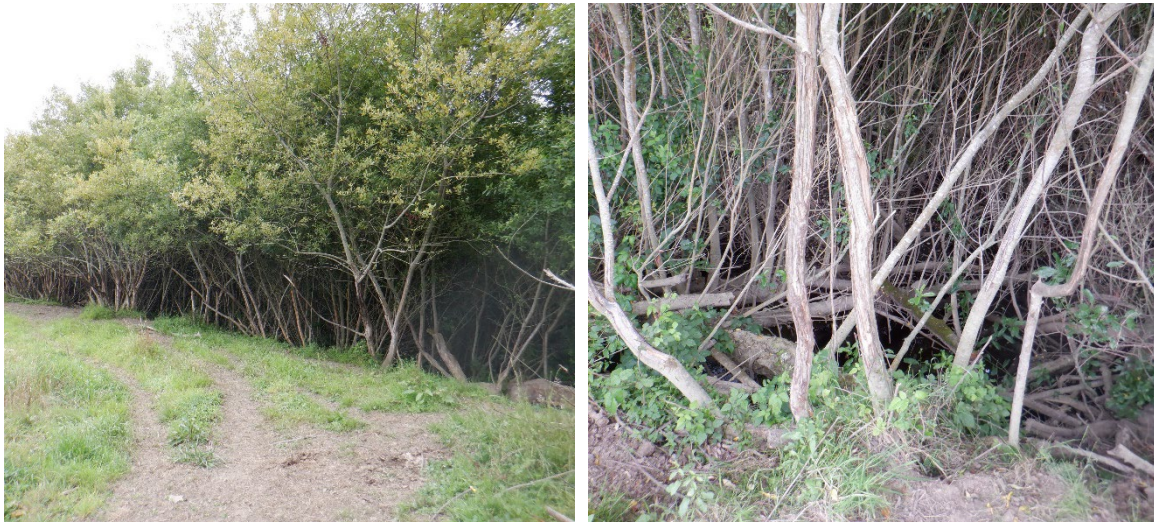
Figure 3-20. Example of high-density fine stem clonal willow growth in the channel (ER-12).

Resprouted live wood on the channel bed will need to be taken out or pruned to remove horizontal stems. Many trees are rooted along the channel bank, so the subsequent resprouting growth will be vertical from root crown or stem base. Vertically aligned resprouting growth won't contribute to channel roughness as much as the horizontal growth that is currently common in many parts of the channel. Monitoring will be conducted to assess growth patterns, but only minimal maintenance and removal is anticipated.

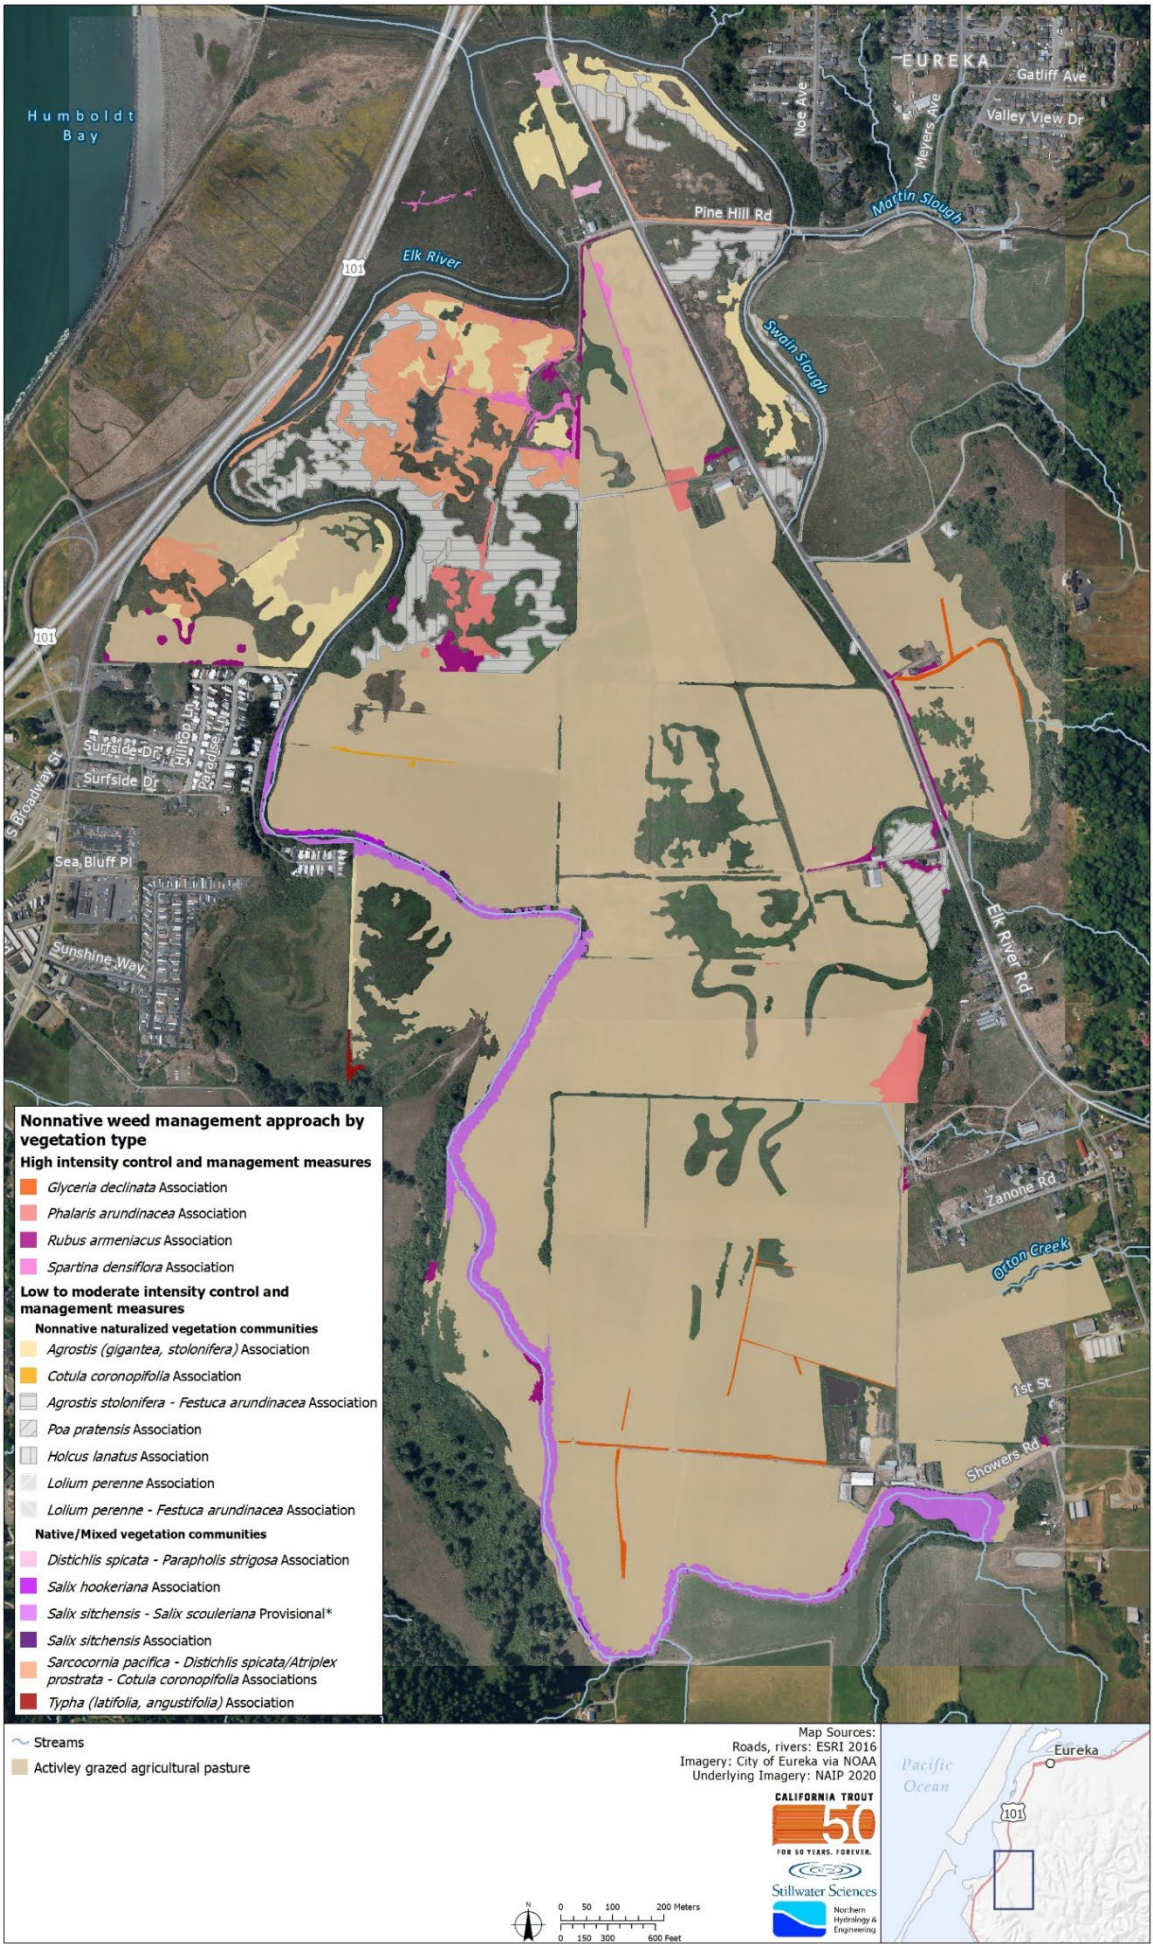
Figure 3-21. Vegetation communities associated with invasive and nonnative naturalized stands and nonnative weed occurrences in the planning area. The legend identifies the intensity scale for nonnative weed management within the Elk River planning area 1.

Vegetation communities that can benefit from nonnative weed control and management treatments are depicted in Figure 3-20. Nonnative weed management areas span the enhancement design footprints described in Sections 3.4.1 through 3.4.4 and the surrounding features in the AOI. Invasive weeds in the planning area live in a range of patterns, from large stands to discrete patches within native vegetation communities (Figure 3-21). In general, stands characterized by invasives are anticipated to require a high intensity approach for control and management while other naturalized nonnative stands and native communities containing invasive weeds do not

require as much management (Figure 3-21). This nonnative weed management map (Figure 3-21) is intended to provide an overview of vegetation communities that can be enhanced by nonnative weed removal. The map does not capture all invasive weed occurrences, nor does it identify native habitats that can benefit from other enhancement activities (e.g., interplanting, increasing cover by native plants). The invasive weed management plan that will be developed in later phases of the design will describe the approach for site-specific strategies to manage invasive weed occurrences, large and small. As noted in Section 3.3.6, the invasive weed management plan will: (1) outline invasive weed management objectives within the planning area, (2) detail the integrated pest management approach for targeted nonnative weed occurrences, and (3) summarize the best management practices to avoid the spread of invasives plants and reduce non-target effects during enhancement activities. The integrated pest management approach for invasive weeds in the planning area may include treatments detailed in the following sections.
