FINAL REPORT • MAY 2023

Elk River Planning Area 1: 10% Design Report

Northern Hydrology and Engineering
P.O. Box 2515
McKinleyville, CA 95519

Stillwater Sciences
850 G Street, Suite K
Arcata, CA 95521

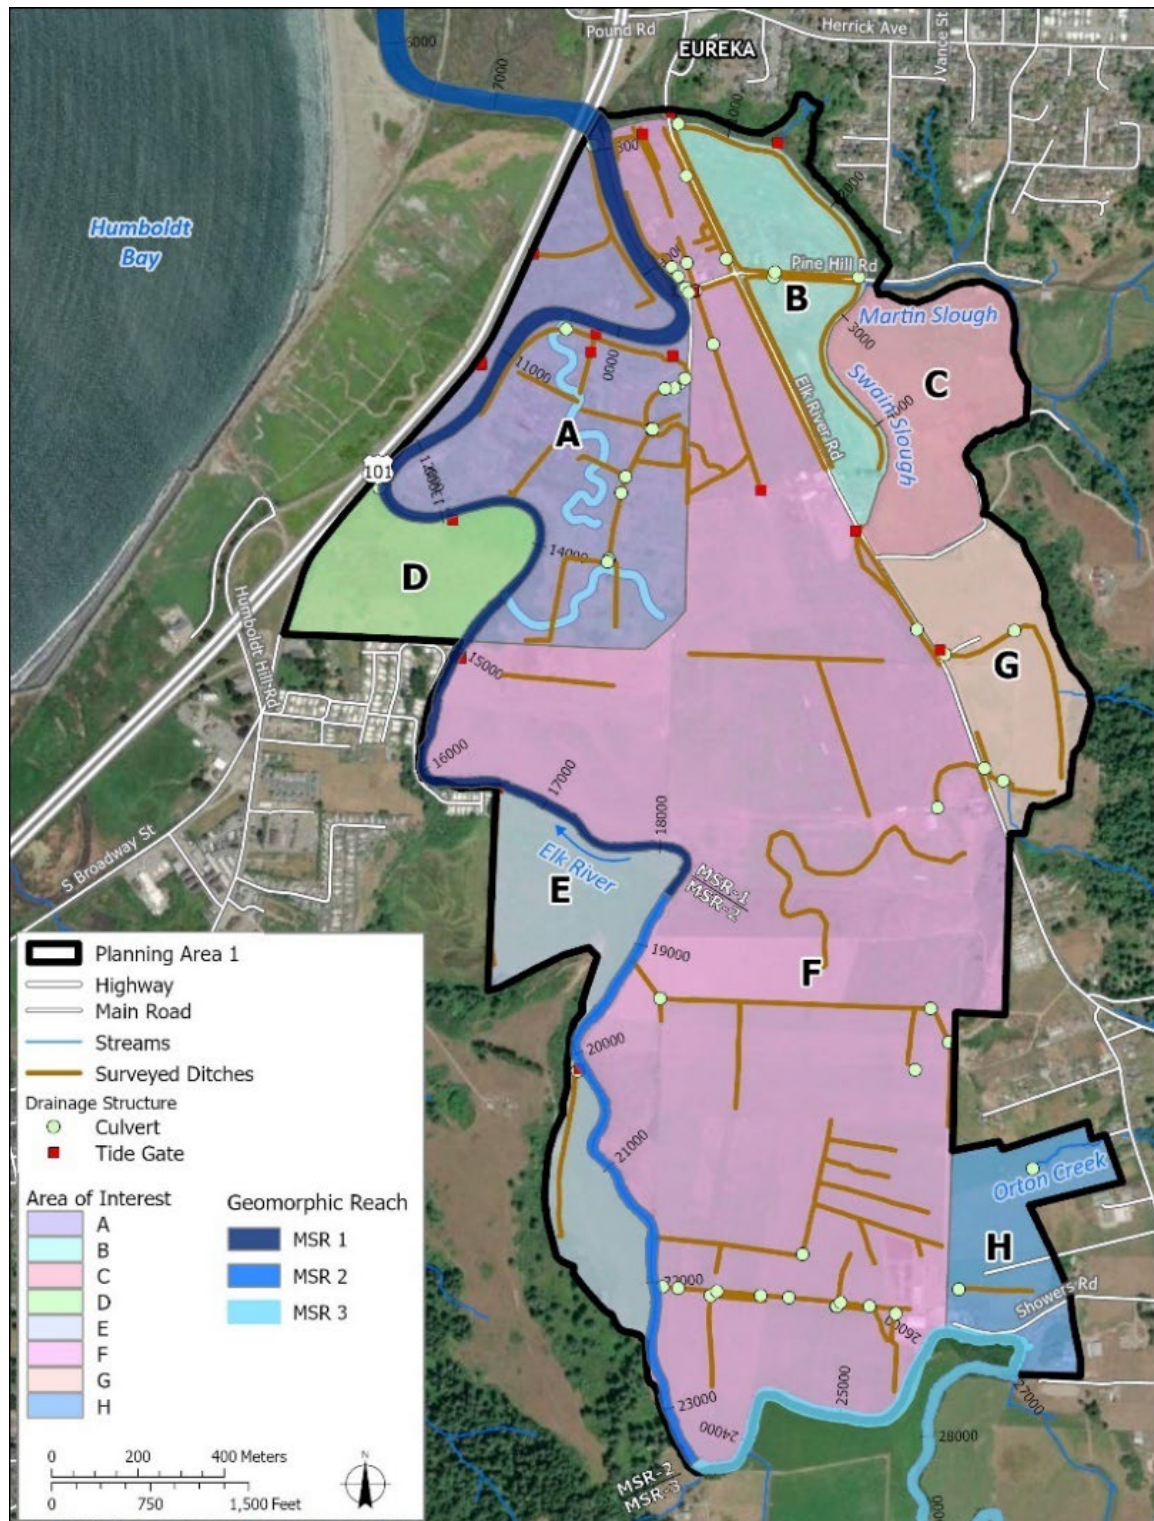
Figure 3-22. Overview of the Planning Area 1 project site, including Areas of Interest (AOI), geomorphic reaches (MSR) and surveyed drainage infrastructure.

This summary provides a brief overview of a 2-dimensional (2D) hydraulic model constructed to simulate a range of habitat and peak-flood flows through a ~19,000-ft reach of the Elk River within the Recovery Program Planning Area 1 (PA-1; Figure 3-22). The goal of the modeling exercise was to simulate existing conditions (EG) and 10% design conditions (DG) to evaluate the hydraulic impacts of proposed design actions. The design conditions model incorporated a suite of design concepts, including:

The following sections provide an overview of the hydraulic model results for both the existing and design conditions scenarios. Results will generally be summarized in the context of different areas of interest (AOIs)—as well as the three key geomorphic reaches in the project area (Figure 3-22). As evidenced by section 2.4.6 in Appendix F, the model calibrated quite well to observed in-channel and floodplain highwater marks (i.e., correlation coefficients > 0.98, percent biases < 4% and Nash-Sutcliffe Coefficients > 0.8 at all monitoring locations in PA-1; see section 2.4.6 in Appendix F). Additionally, the model was qualitatively validated via consultation with local landowners whose long-term observations of flooding and drainage characteristics corroborated model results.

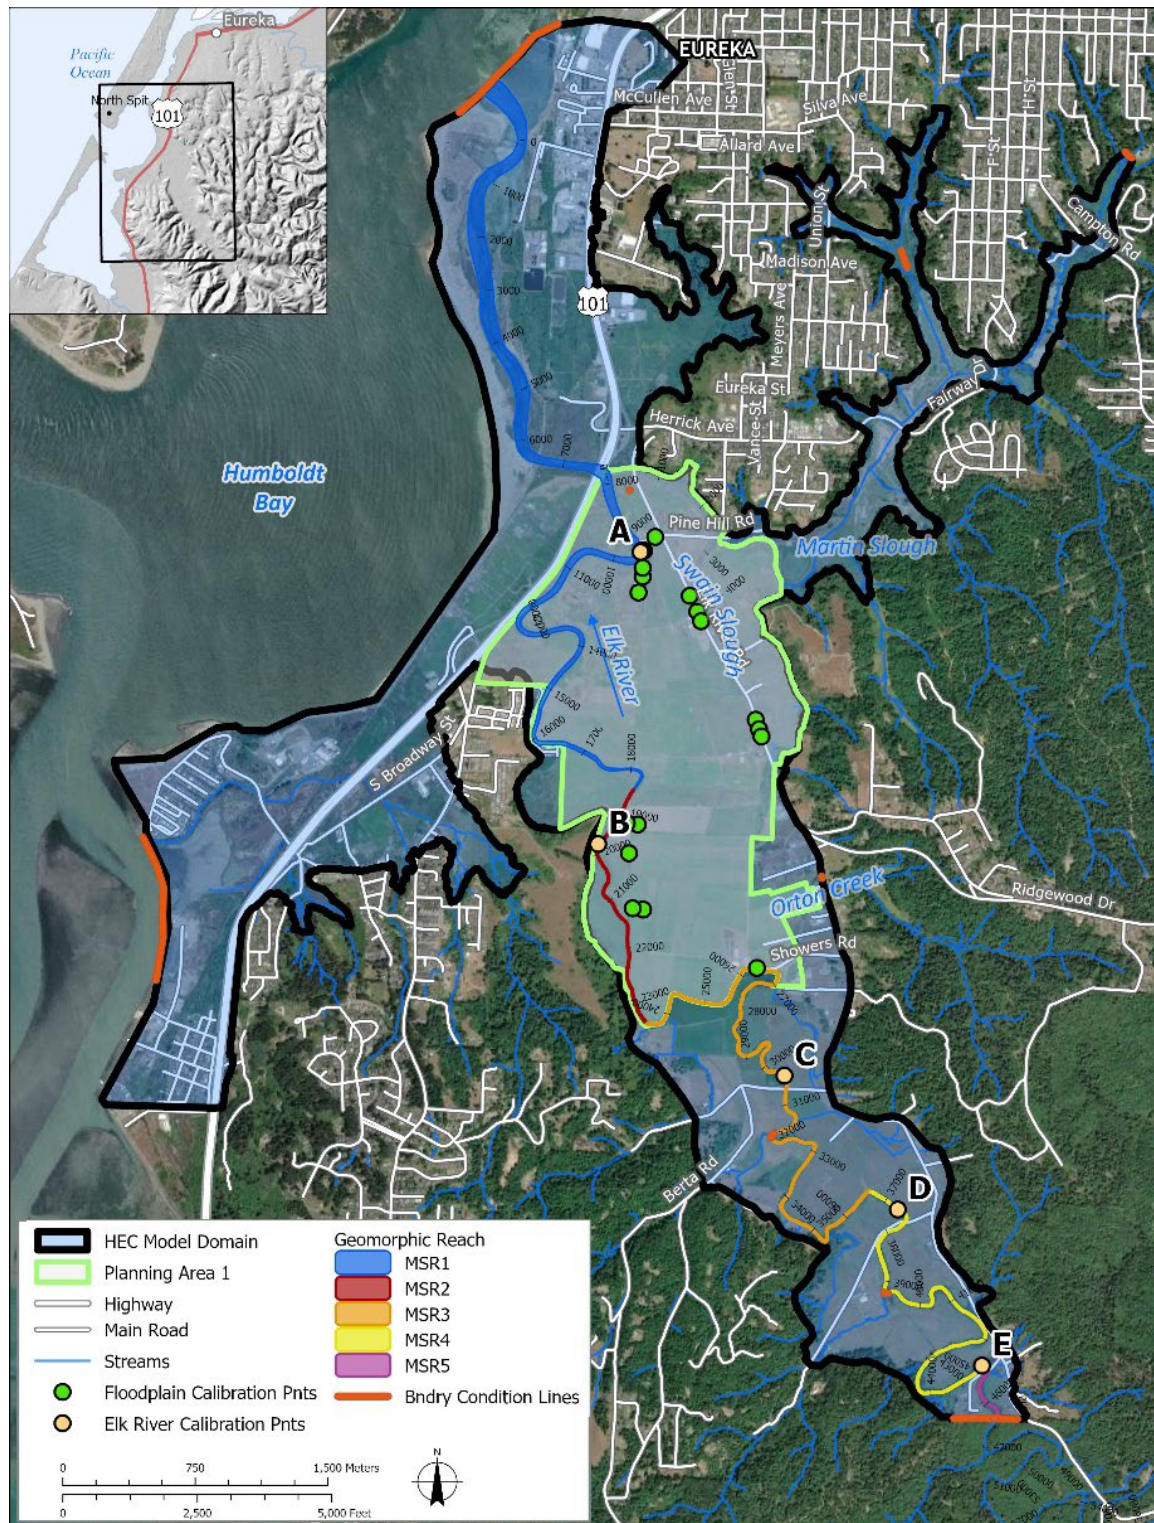
Figure 3-23. Model domain illustrating the location of continuous in-channel calibration points, discrete high water mark calibration points on the floodplain and boundary condition lines.

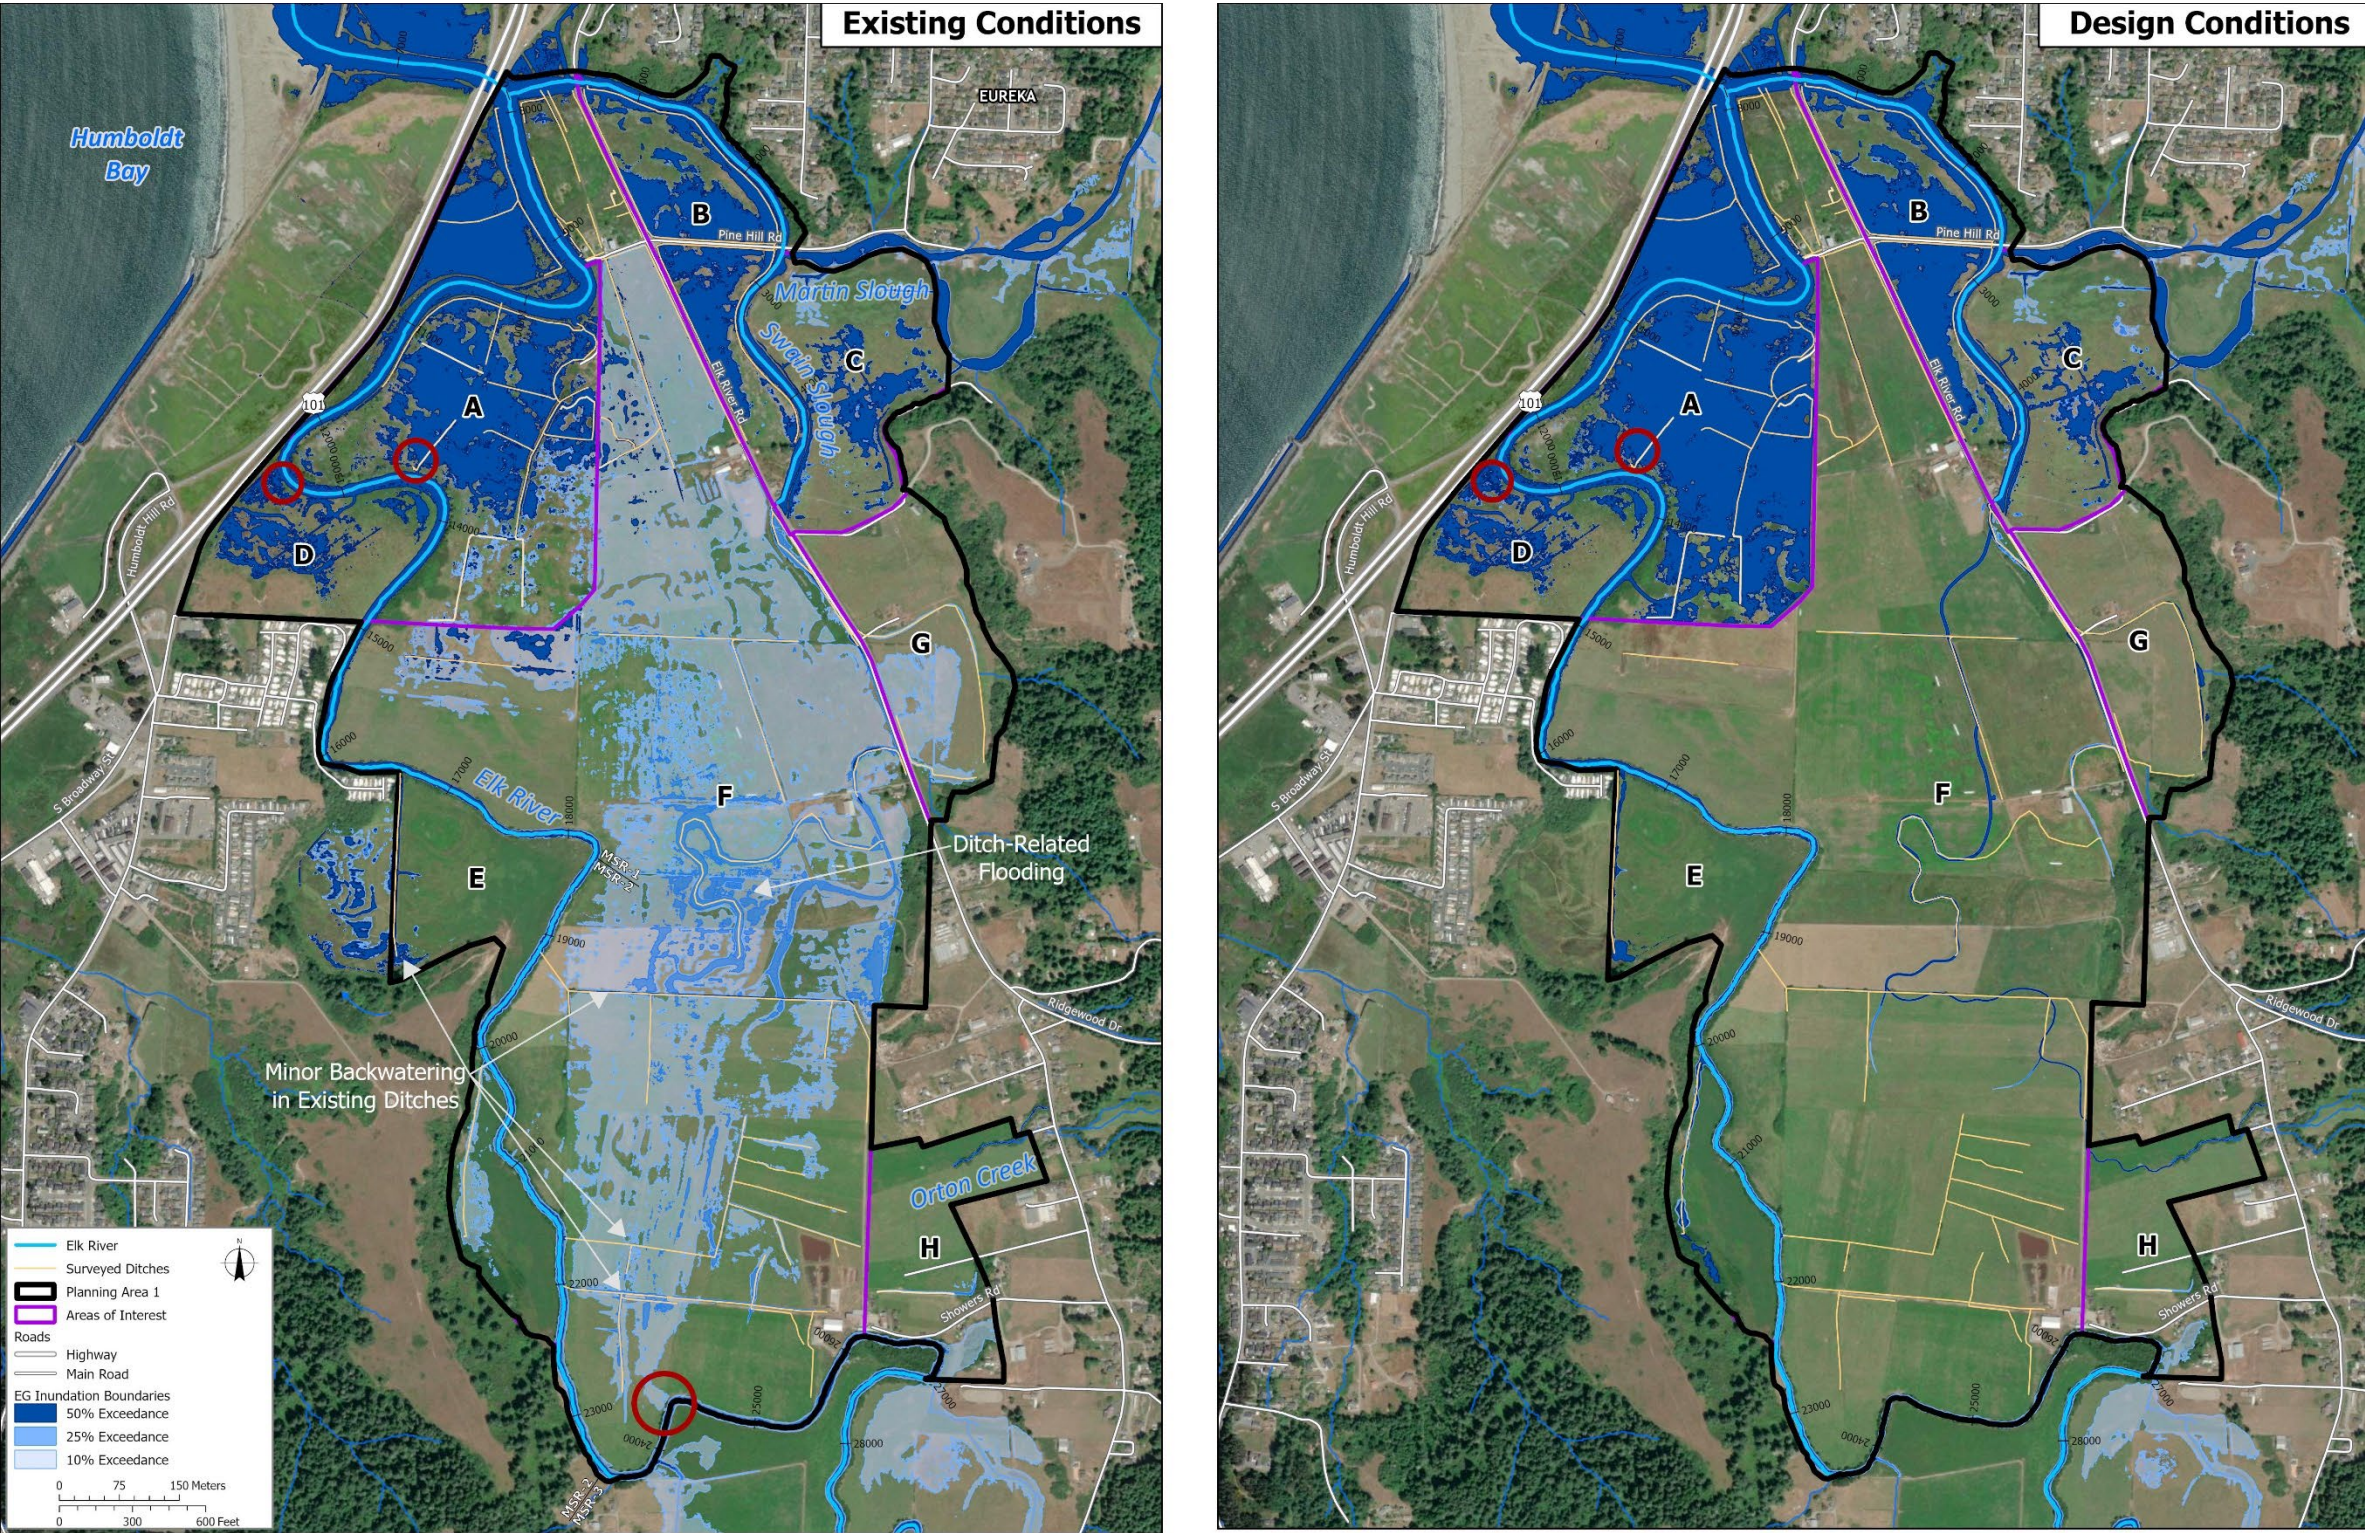
Figure 3-24. Inundation boundaries for 10%, 25% and 50% exceedance flows under existing and design conditions. Shallow, broad existing areas of inundation throughout most of PA-1 are reduced significantly under design conditions.

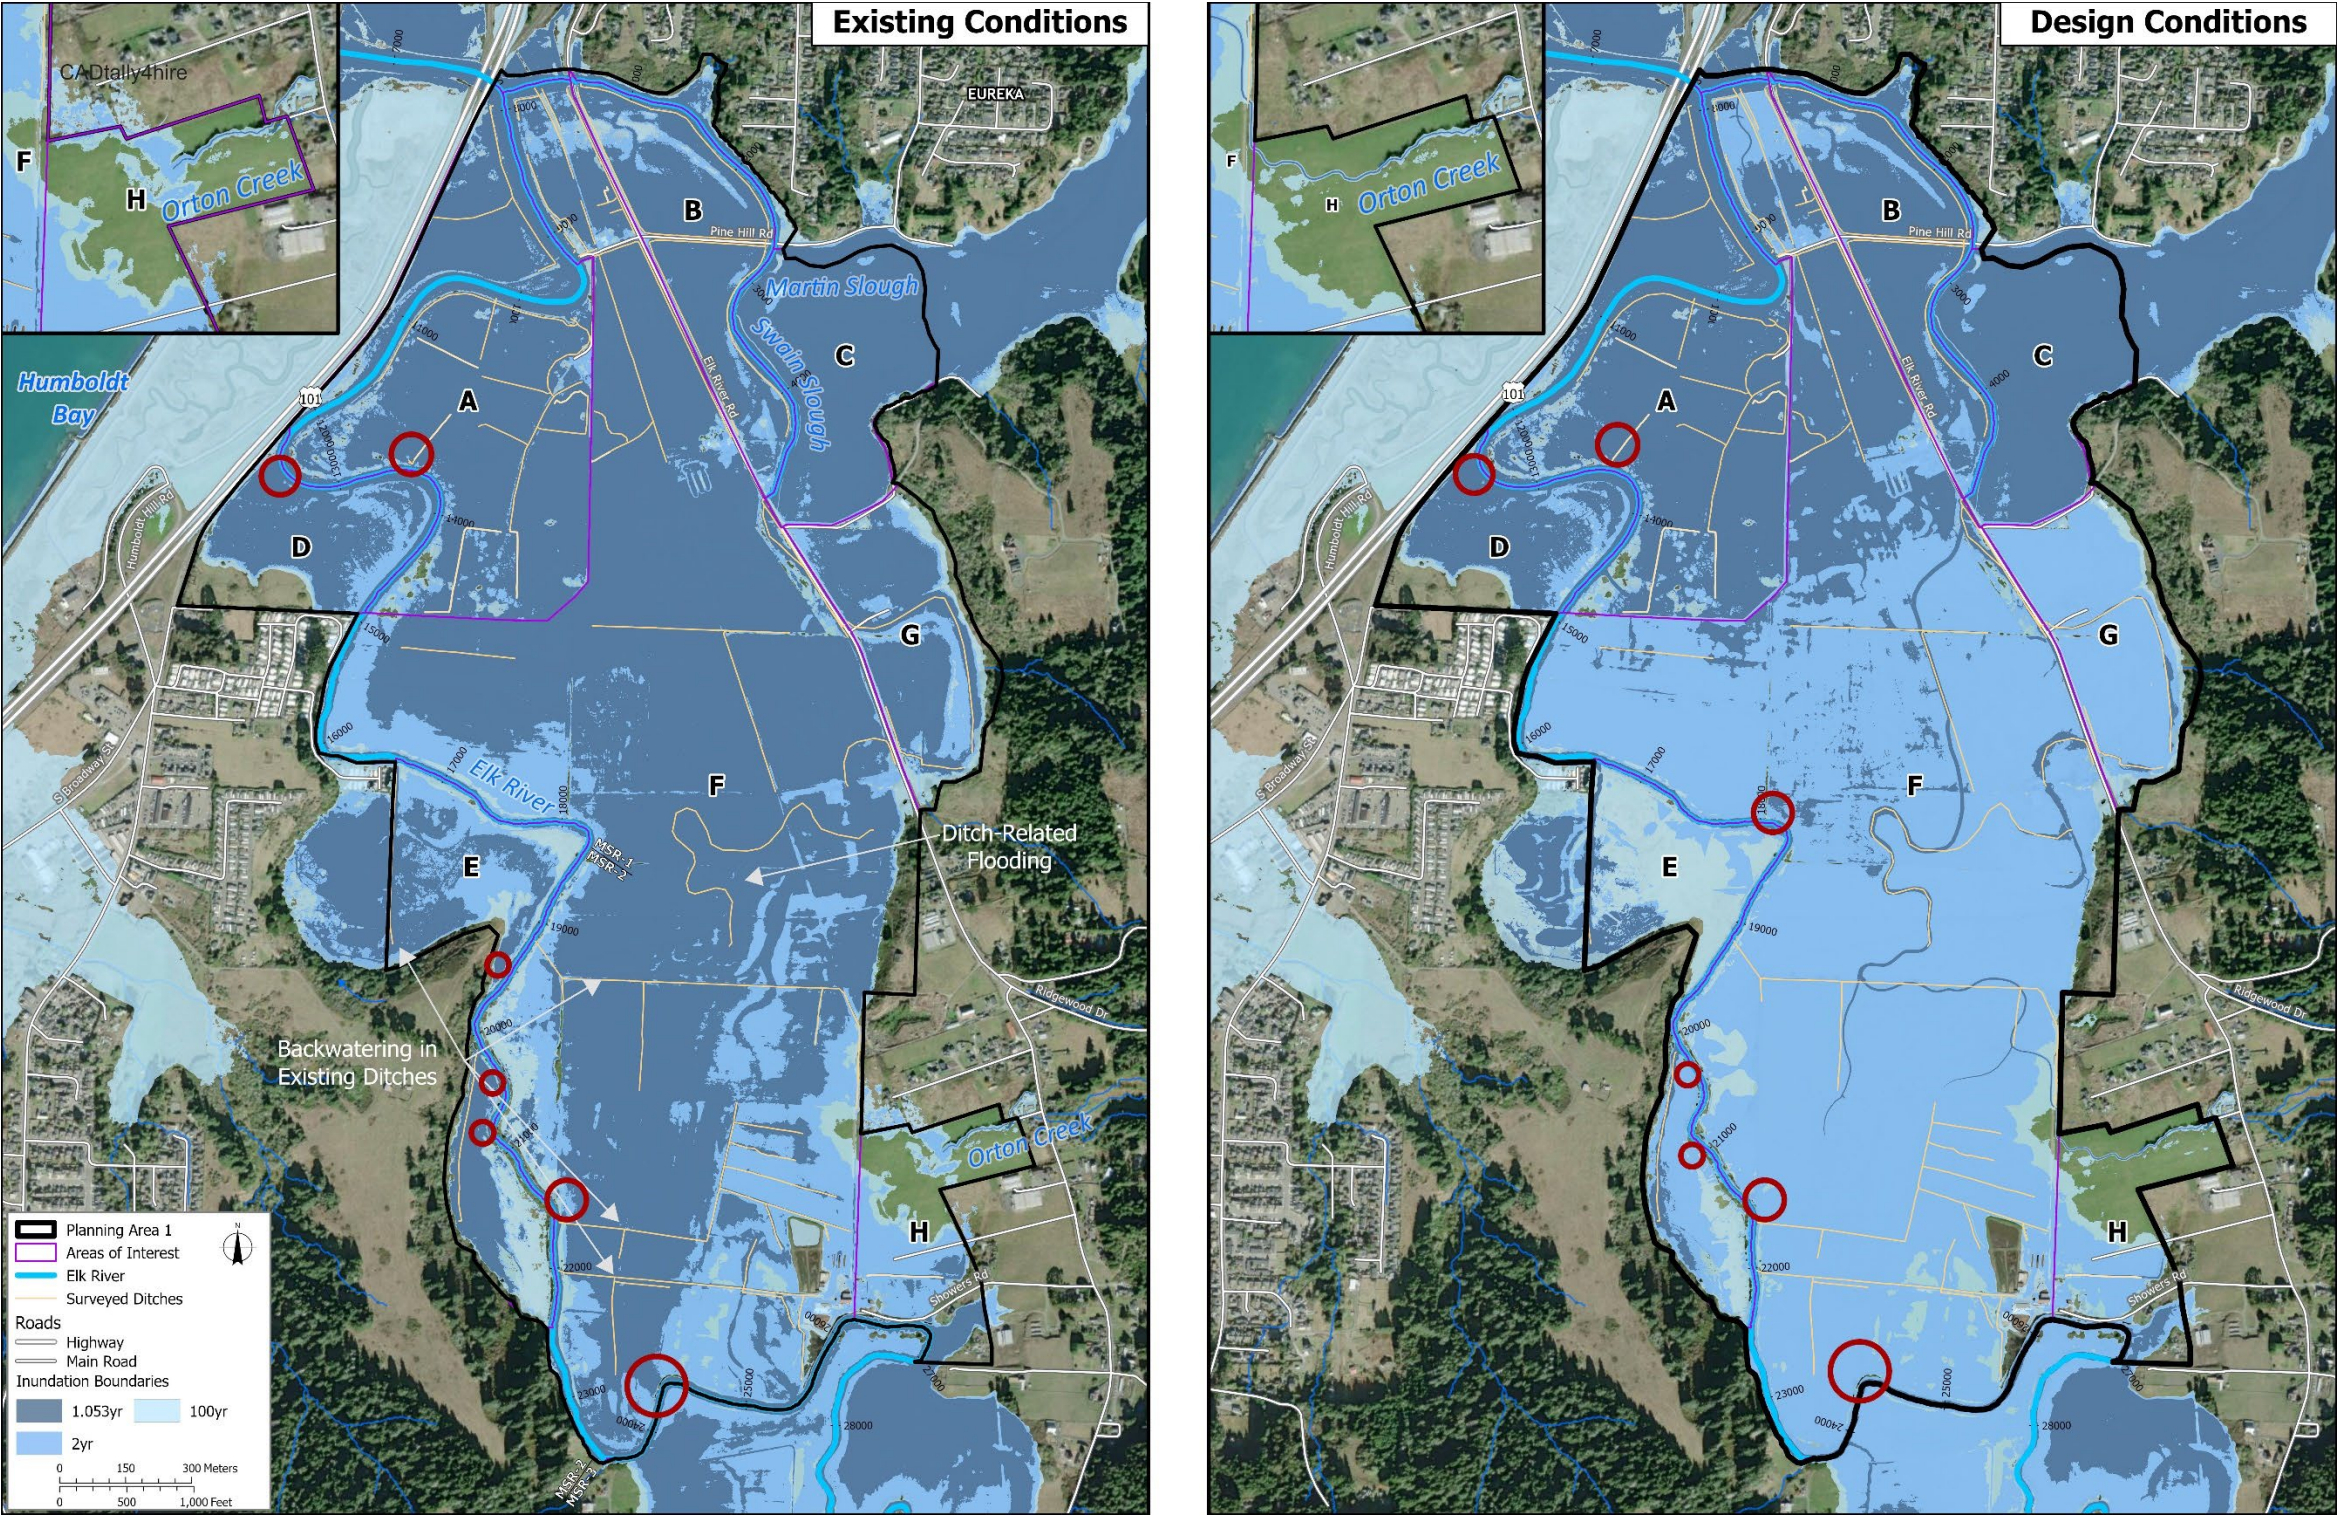
Figure 3-25. Inundation boundaries for 1.053-year, 2-year and 100-year peak flows indicating whether any cell was wet during the simulation under existing and design conditions

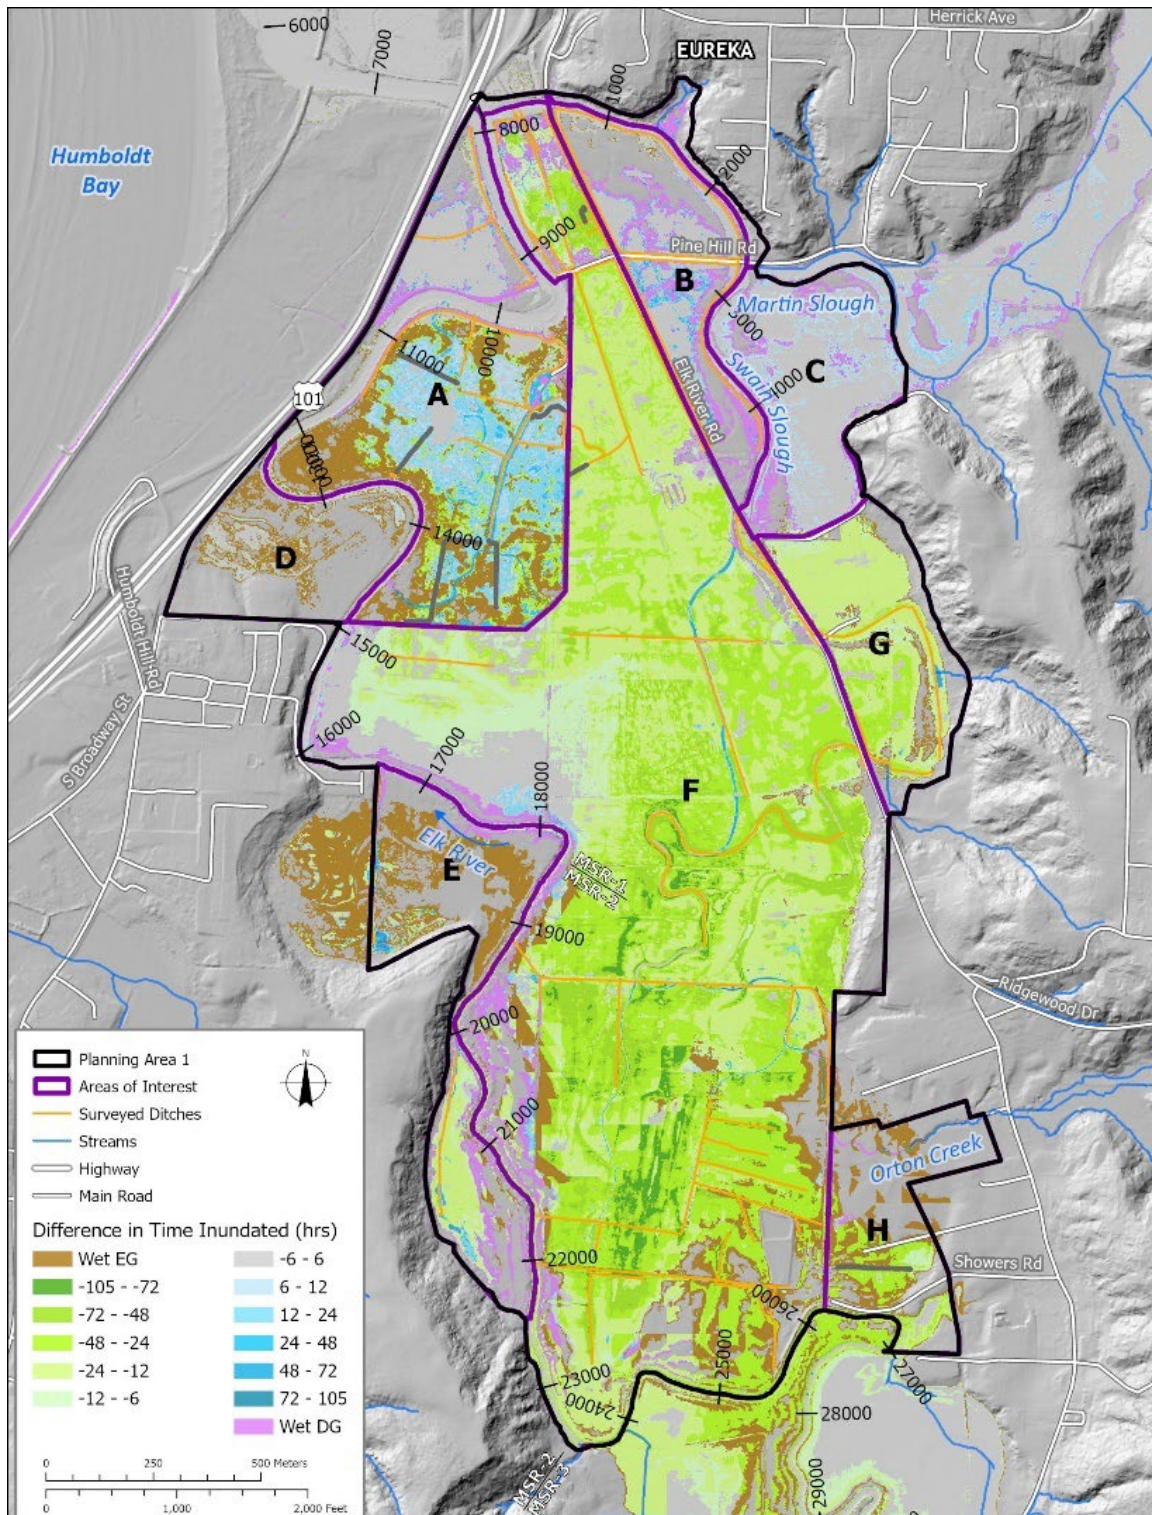
Figure 3-26. Differences in design vs. existing condition time of inundation (hrs). Positive values indicate increased time of inundation for design conditions. Wet EG and wet DG represent cells that were wet only under EG vs. DG conditions, respectively.

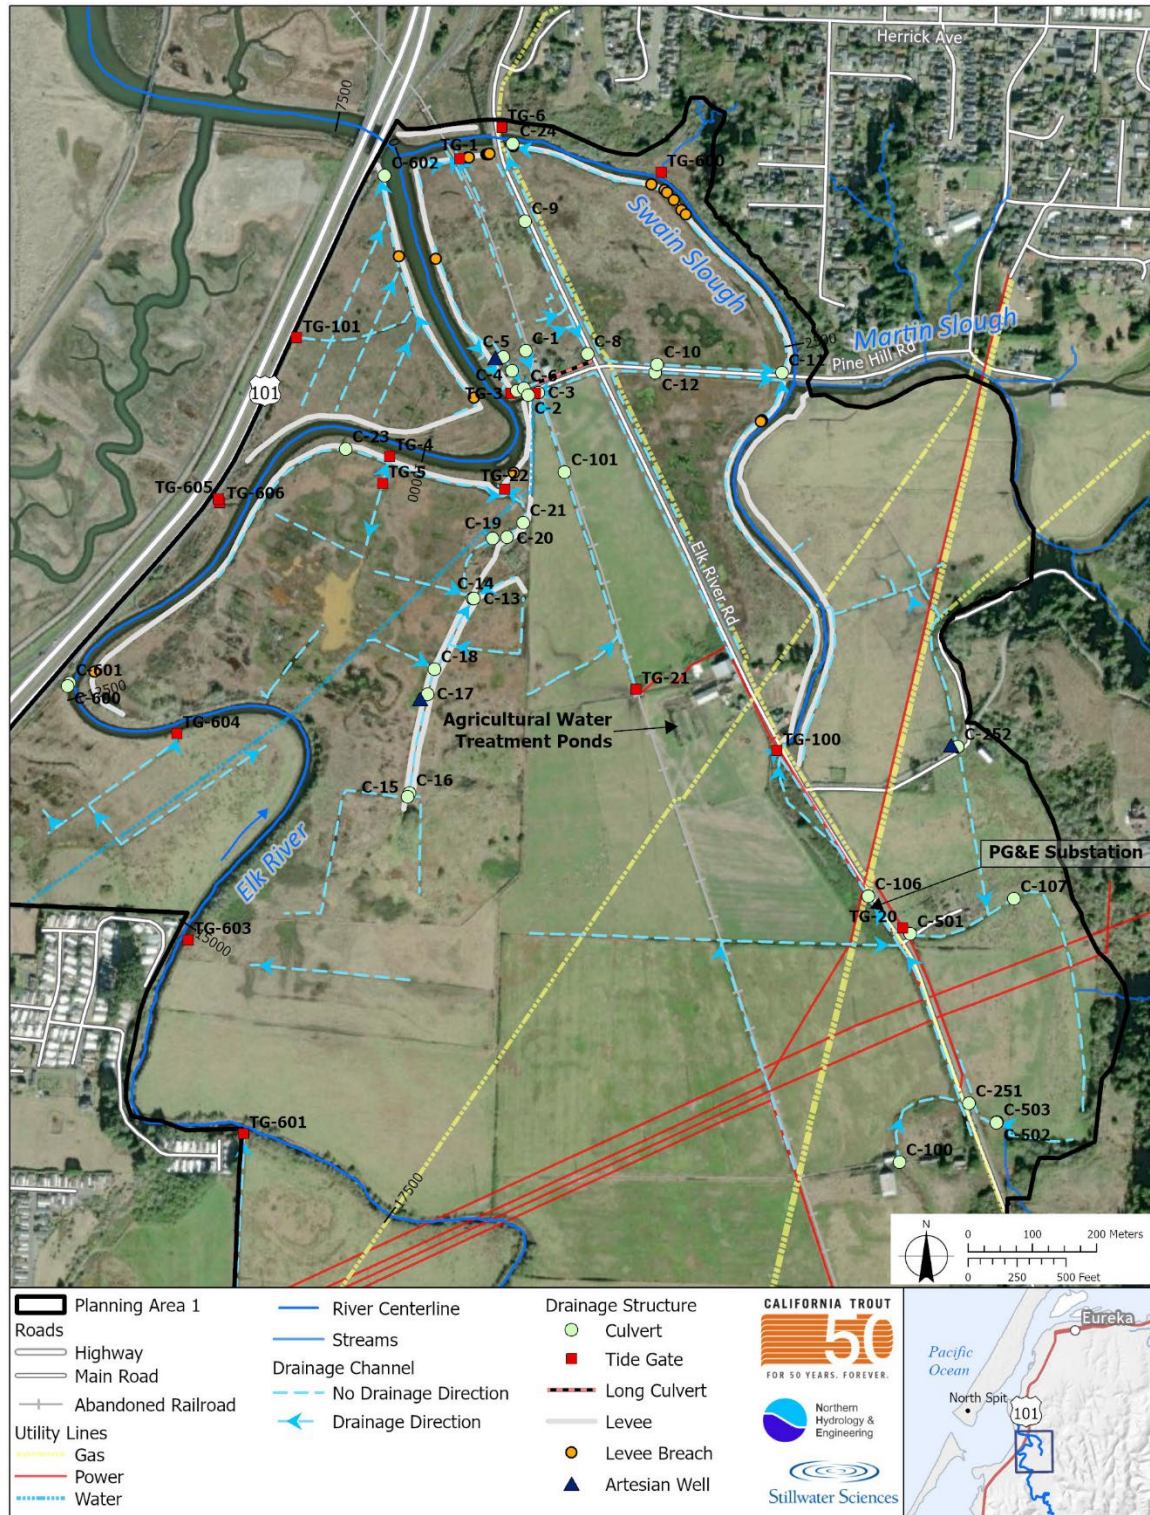
Figure A-1. Planning Area 1 infrastructure from Hwy 101 to Elk River STA 17,500.

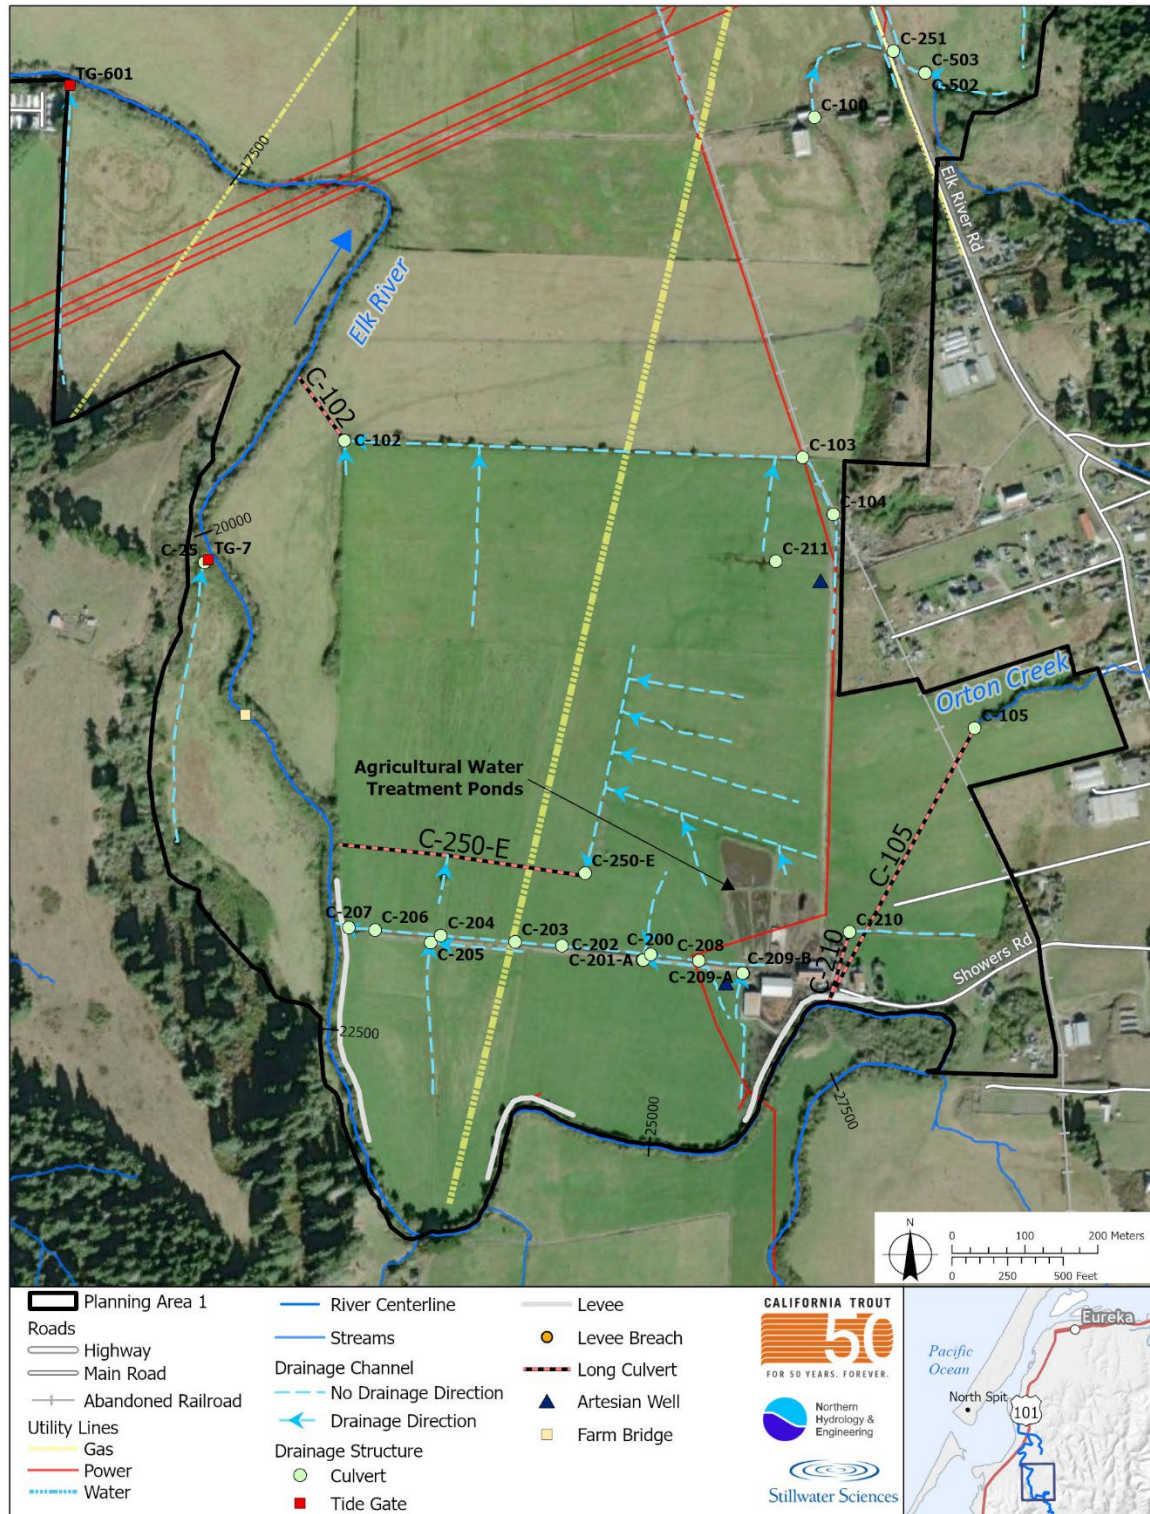
Figure A-2. Planning Area 1 infrastructure from STA 17,500 to Showers Road.

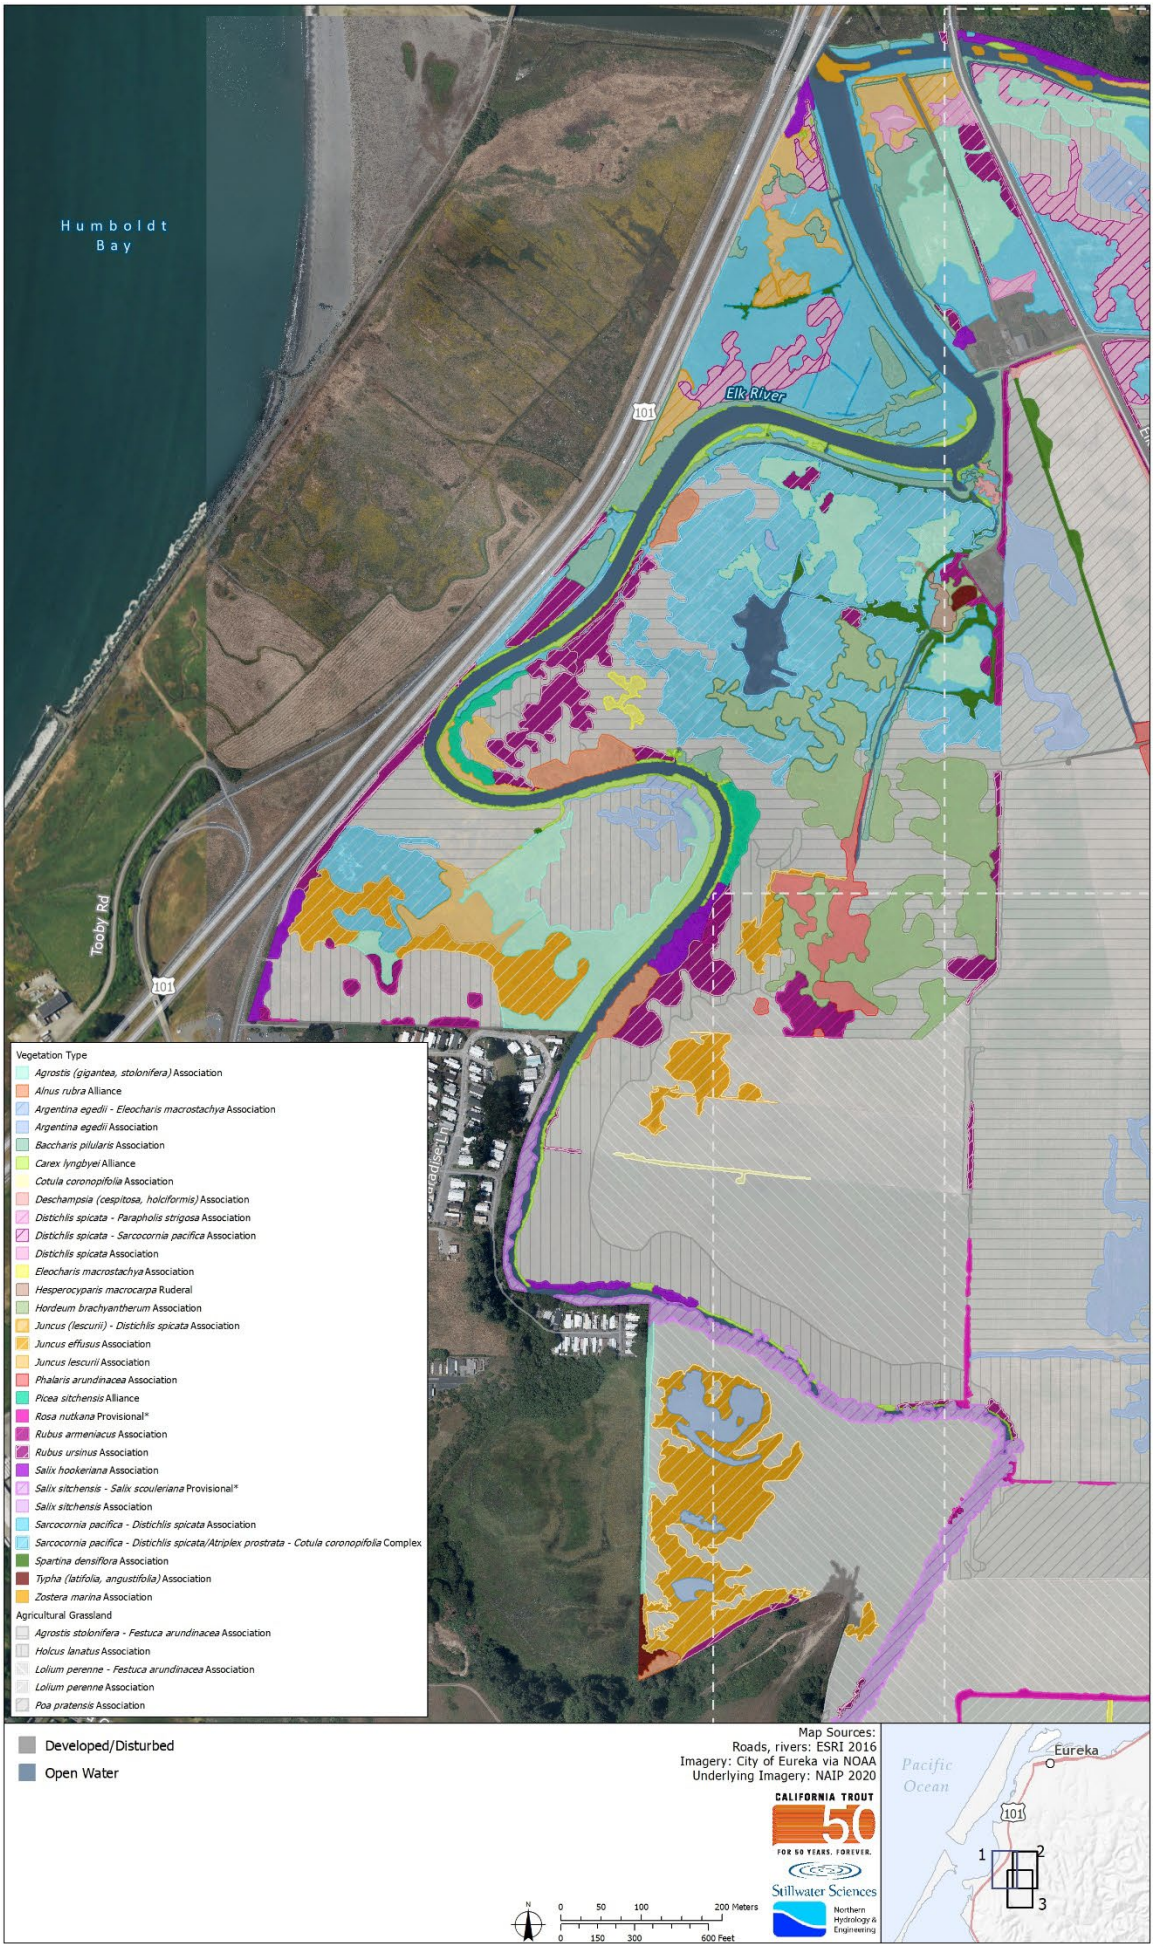
Figure B-1. Vegetation cover types within the Elk River Planning Area 1, Tile 1 of 3.

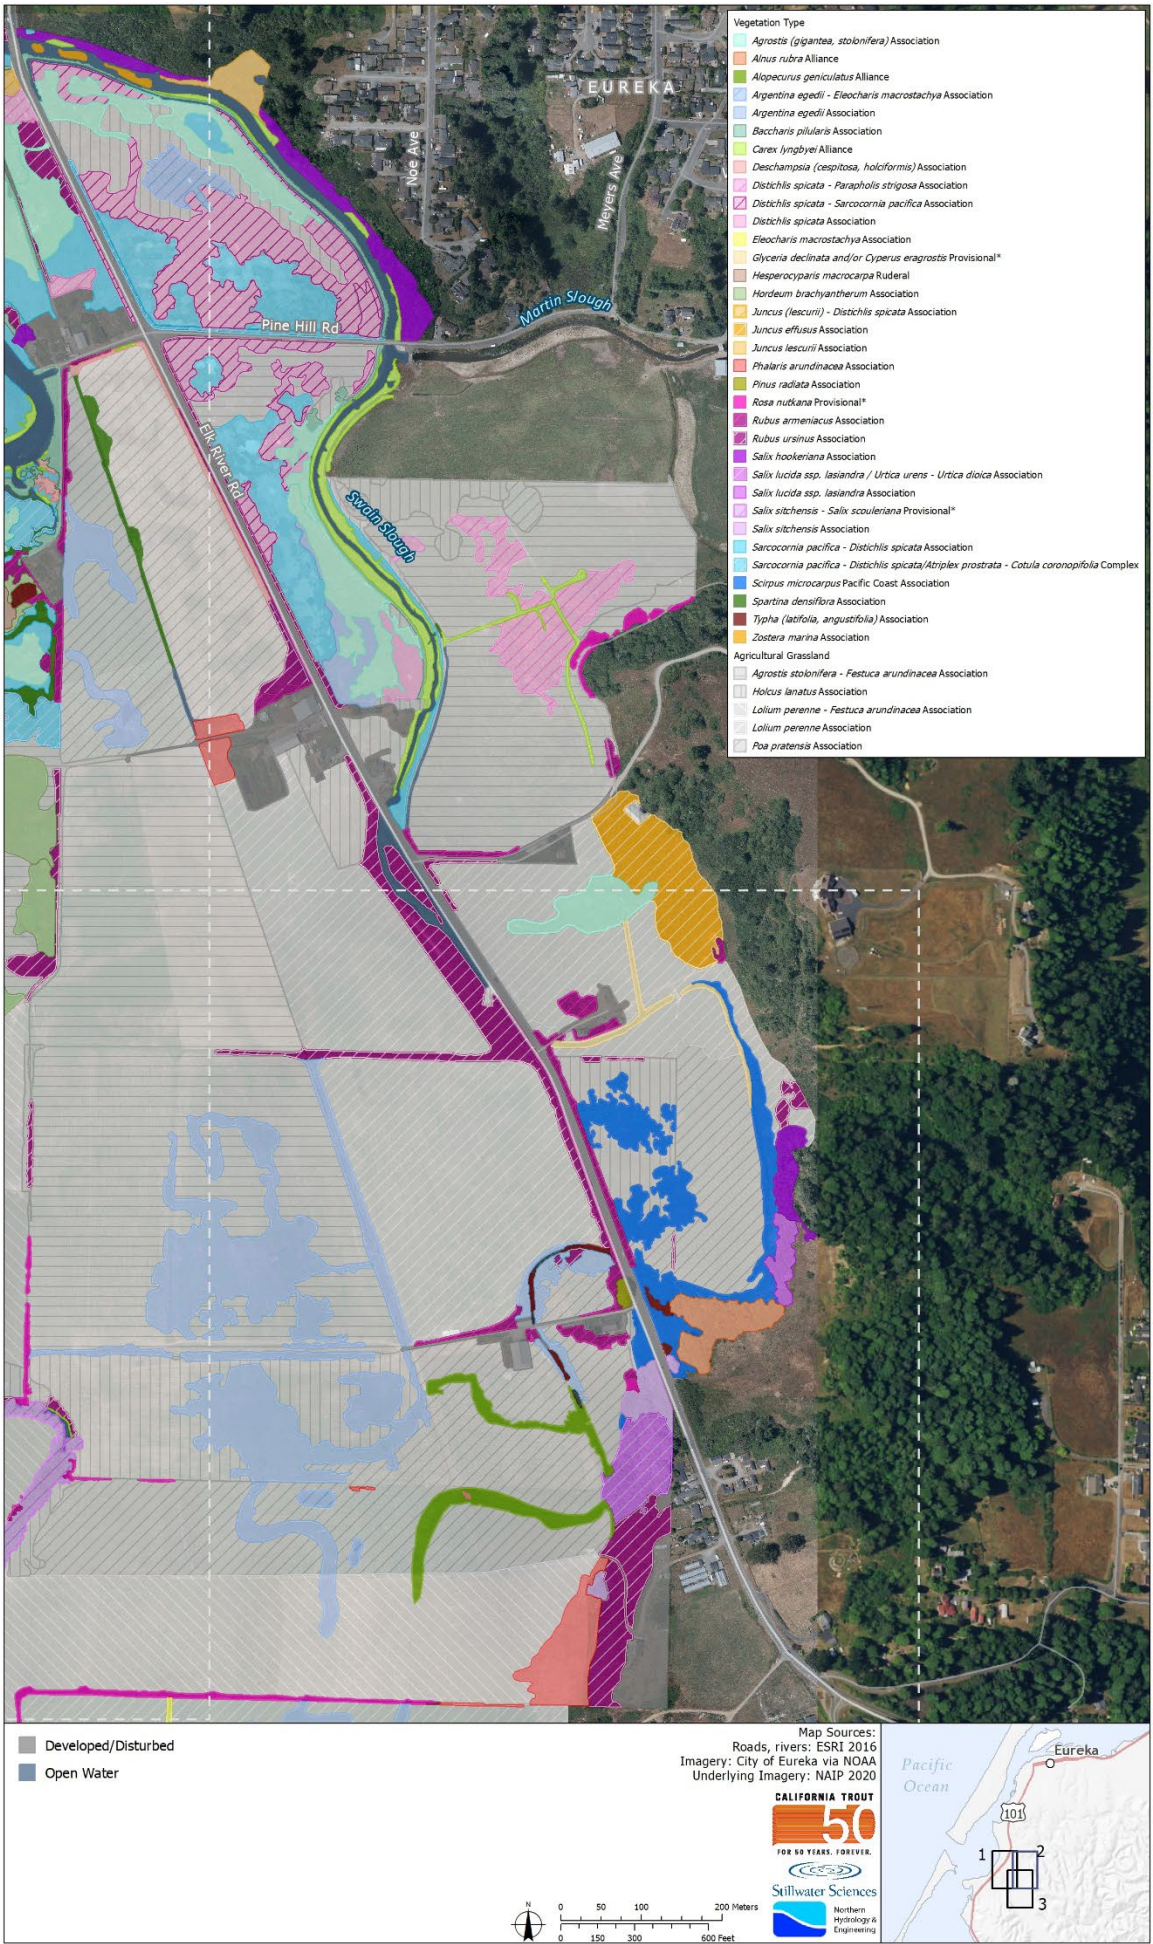
Figure B-2. Vegetation cover types within the Elk River Planning Area 1, Tile 2 of 3.
