FINAL REPORT • MAY 2023

Elk River Planning Area 1: 10% Design Report

Northern Hydrology and Engineering
P.O. Box 2515
McKinleyville, CA 95519

Stillwater Sciences
850 G Street, Suite K
Arcata, CA 95521

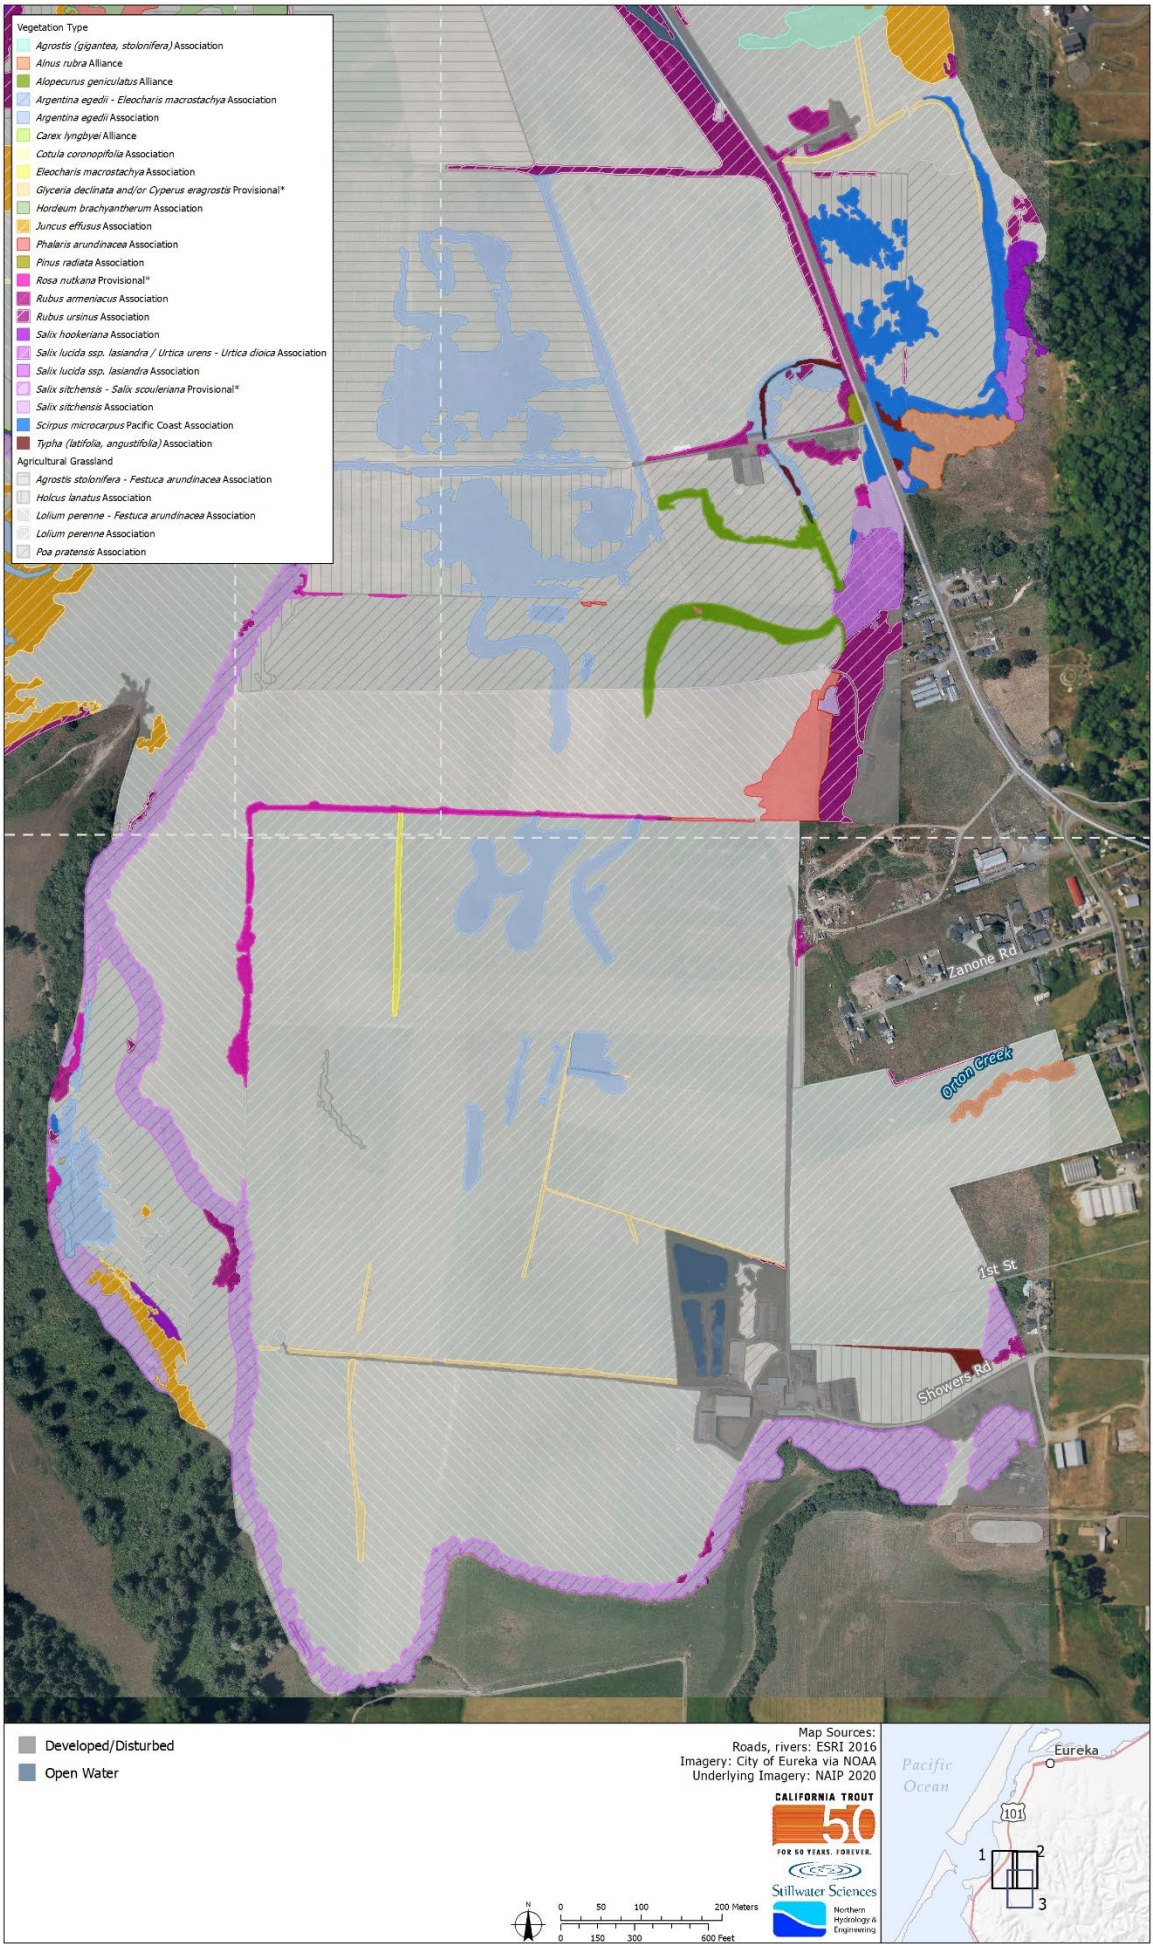
Figure B-3. Vegetation cover types within the Elk River Planning Area 1, Tile 3 of 3.

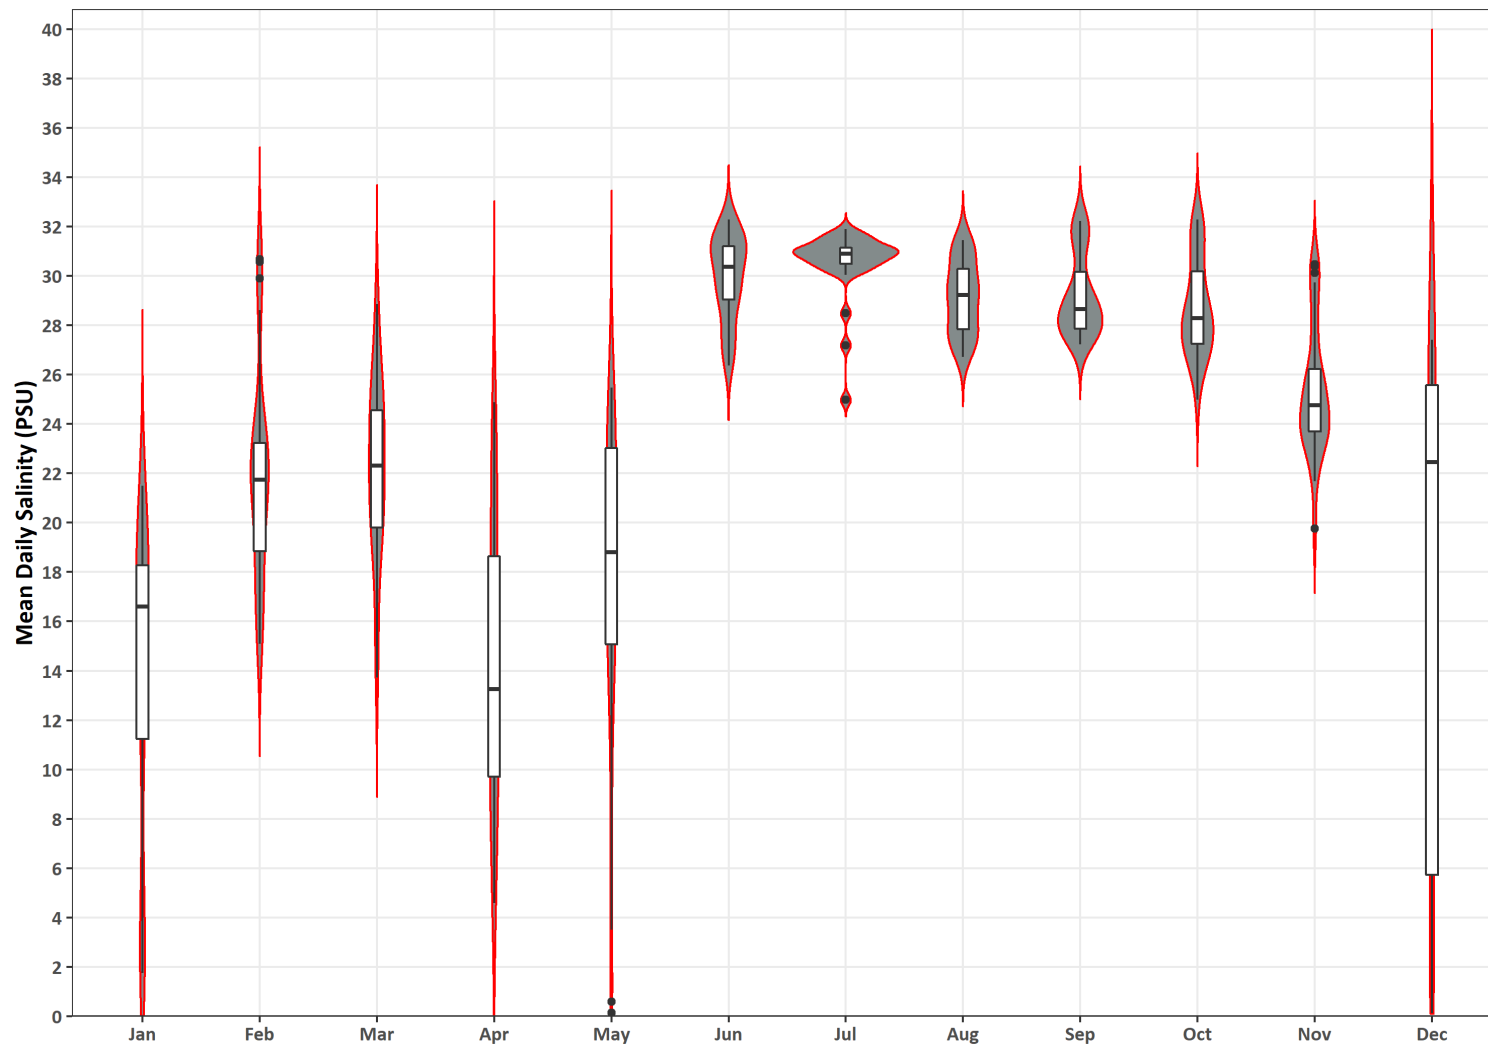
Figure D-1. Violin plot of monthly salinity data at ER-1.

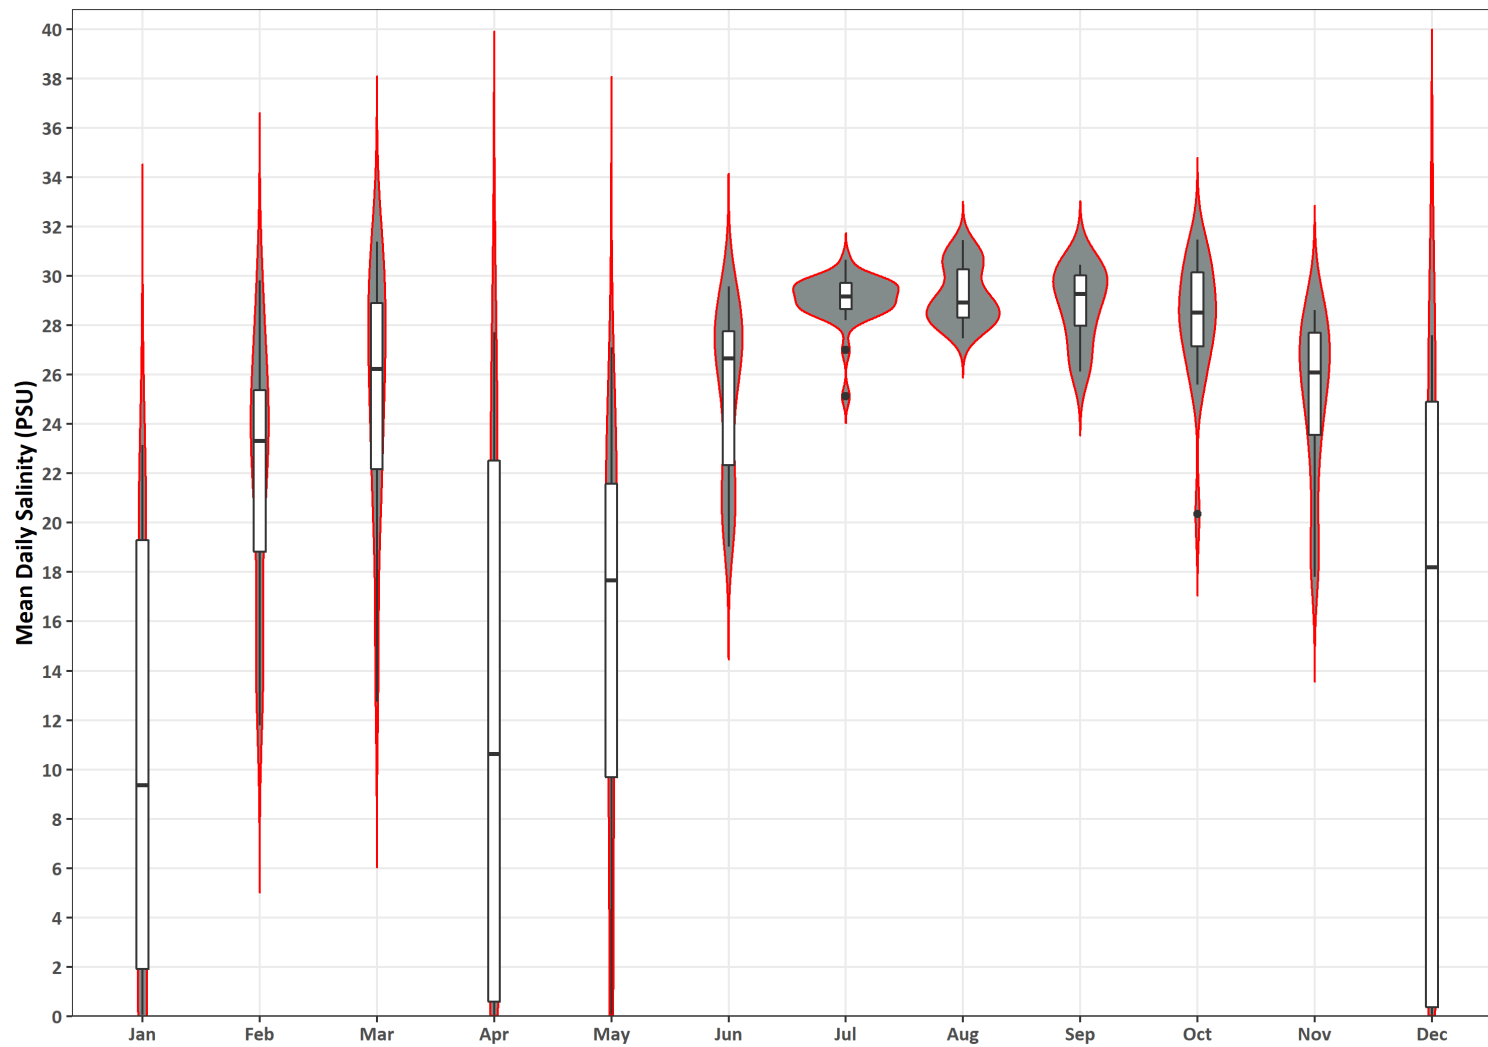
Figure D-2. Violin plot of monthly salinity data at ER-2.

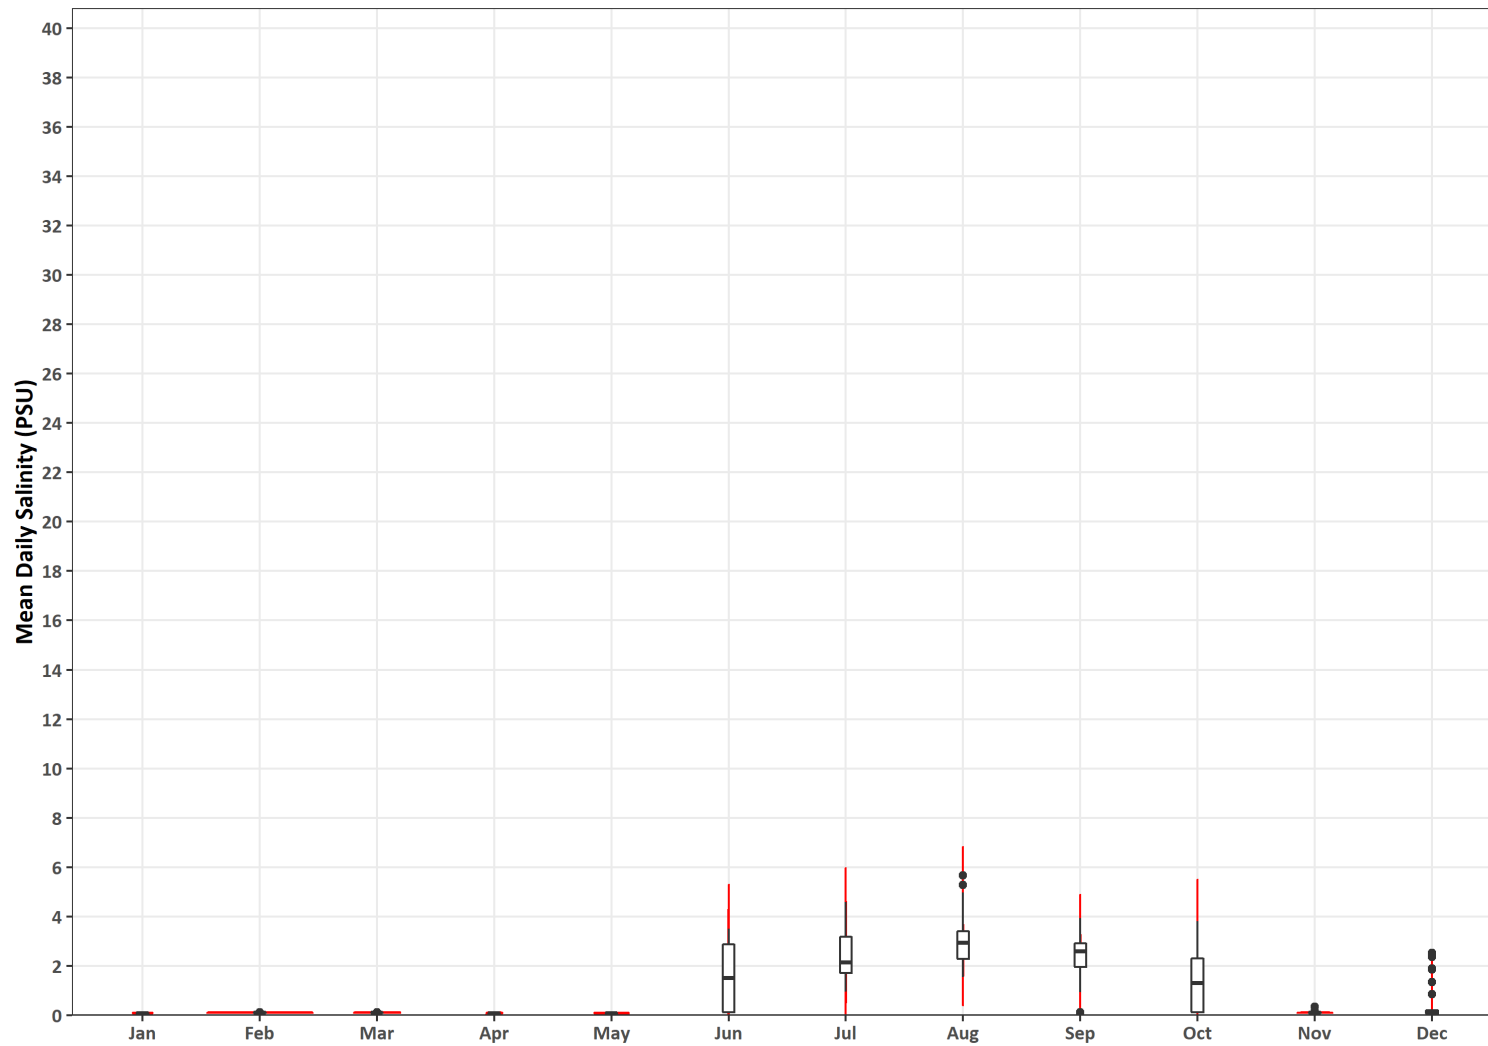
Figure D-3. Violin plot of monthly salinity data at ER-3.

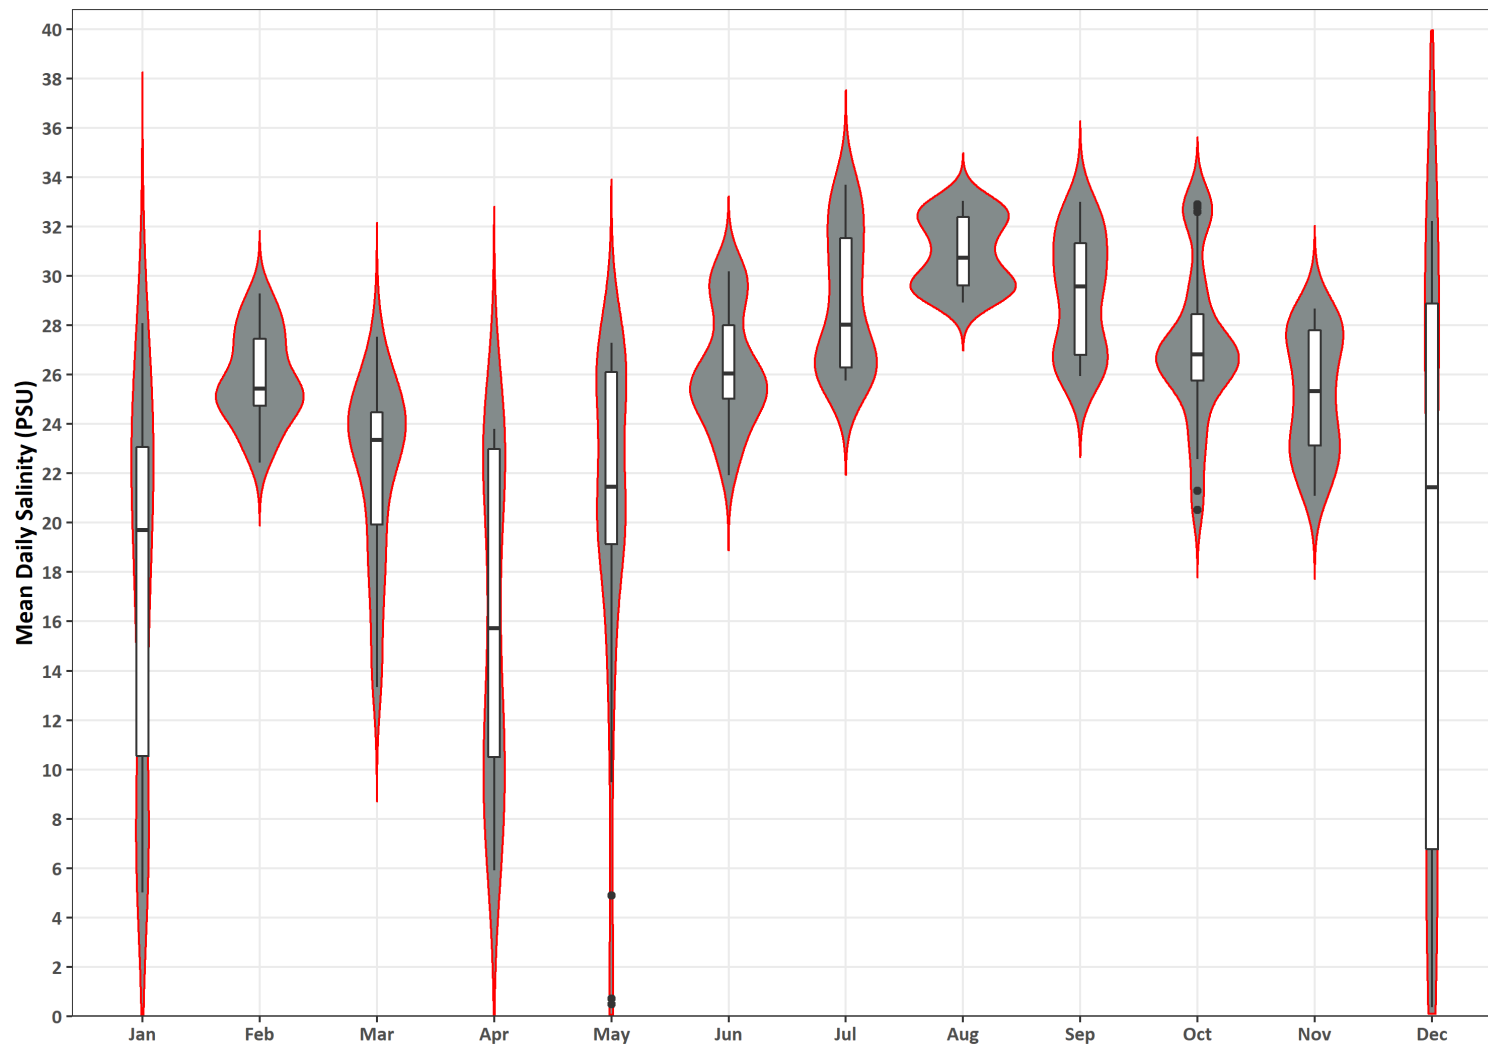
Figure D-4. Violin plot of monthly salinity data at SS-1.

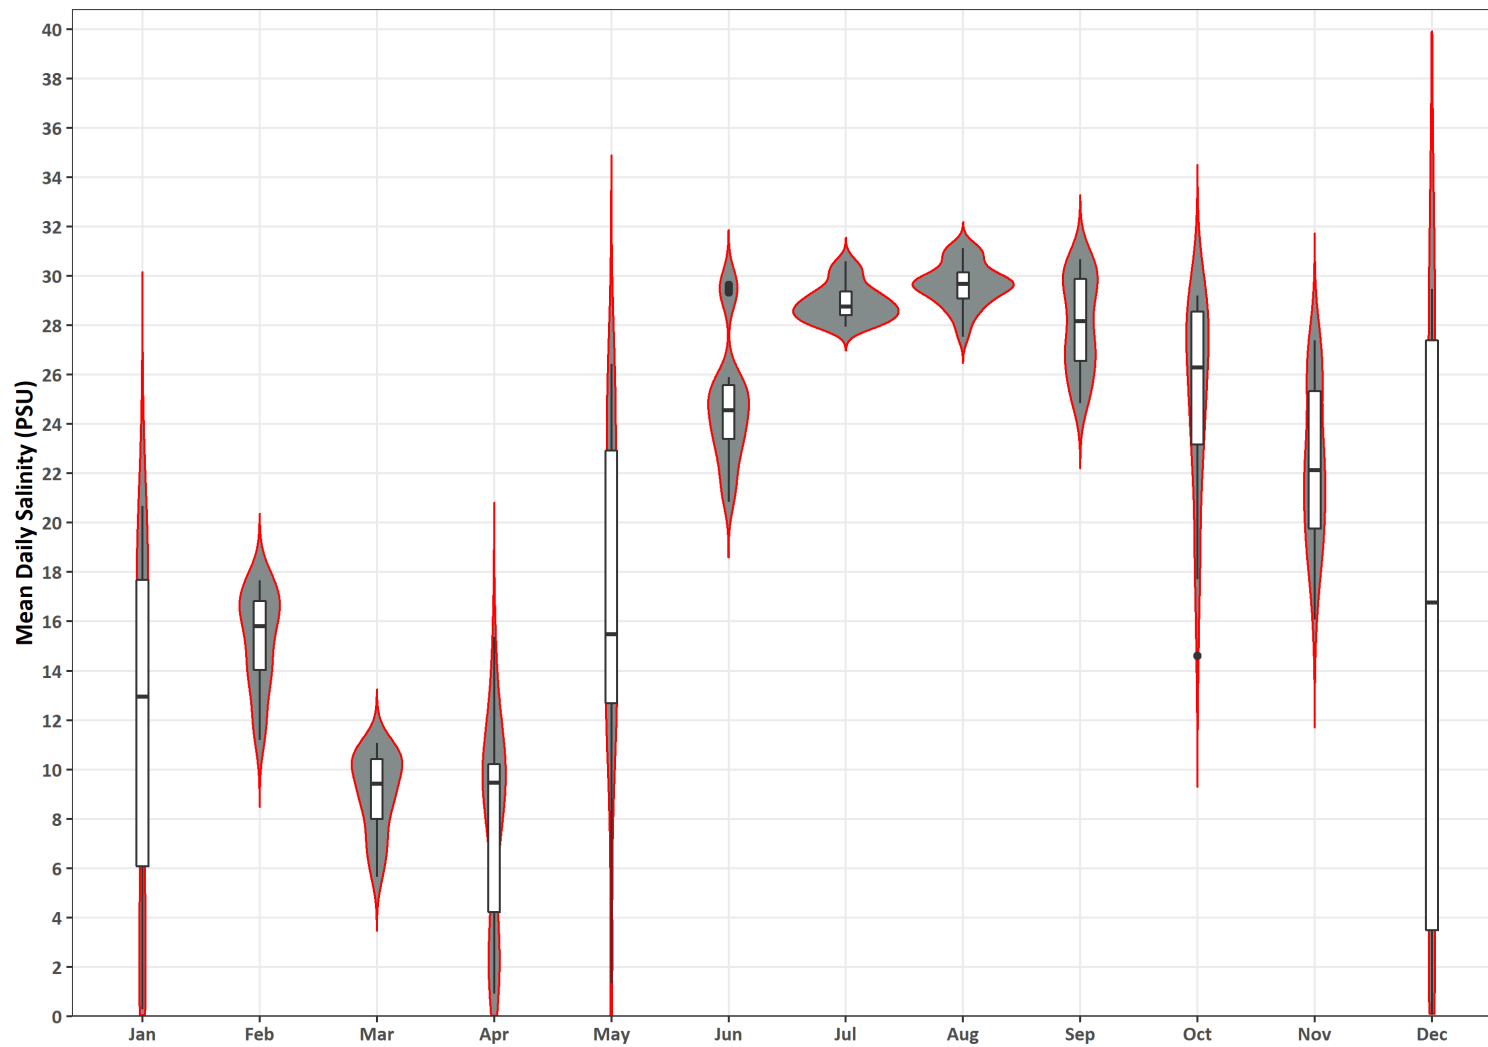
Figure D-5. Violin plot of monthly salinity data at SS-2.

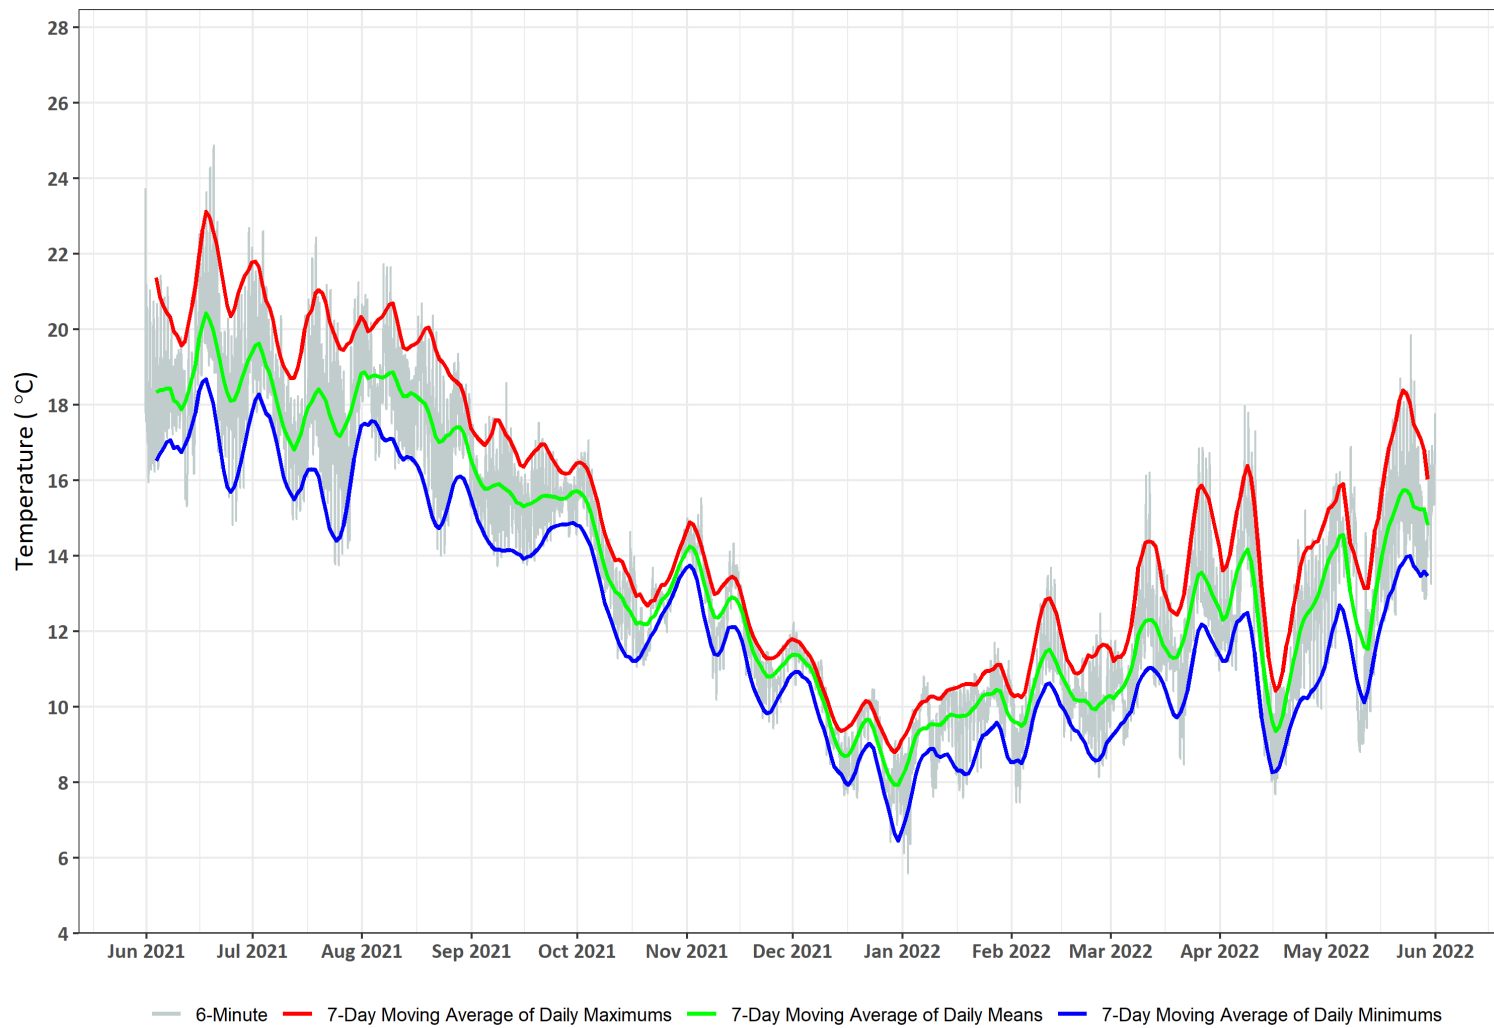
Figure D-6. Six-minute and 7-day average maximum, mean, and minimum temperatures at ER-1.

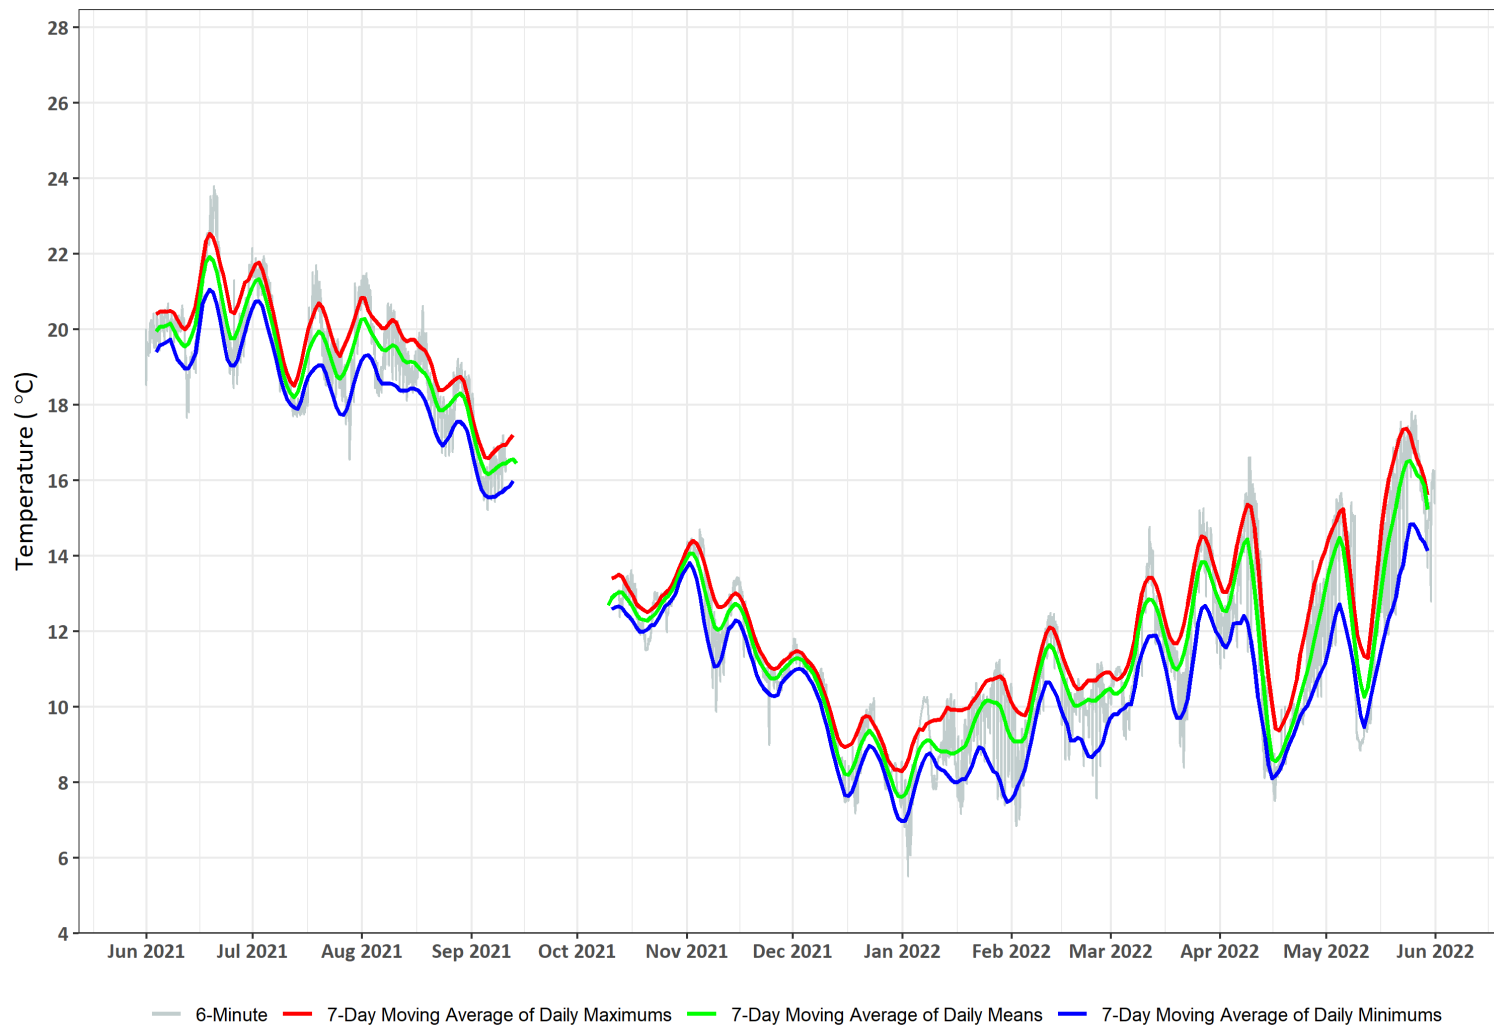
Figure D-7. Six-minute and 7-day average maximum, mean, and minimum temperatures at ER-2.

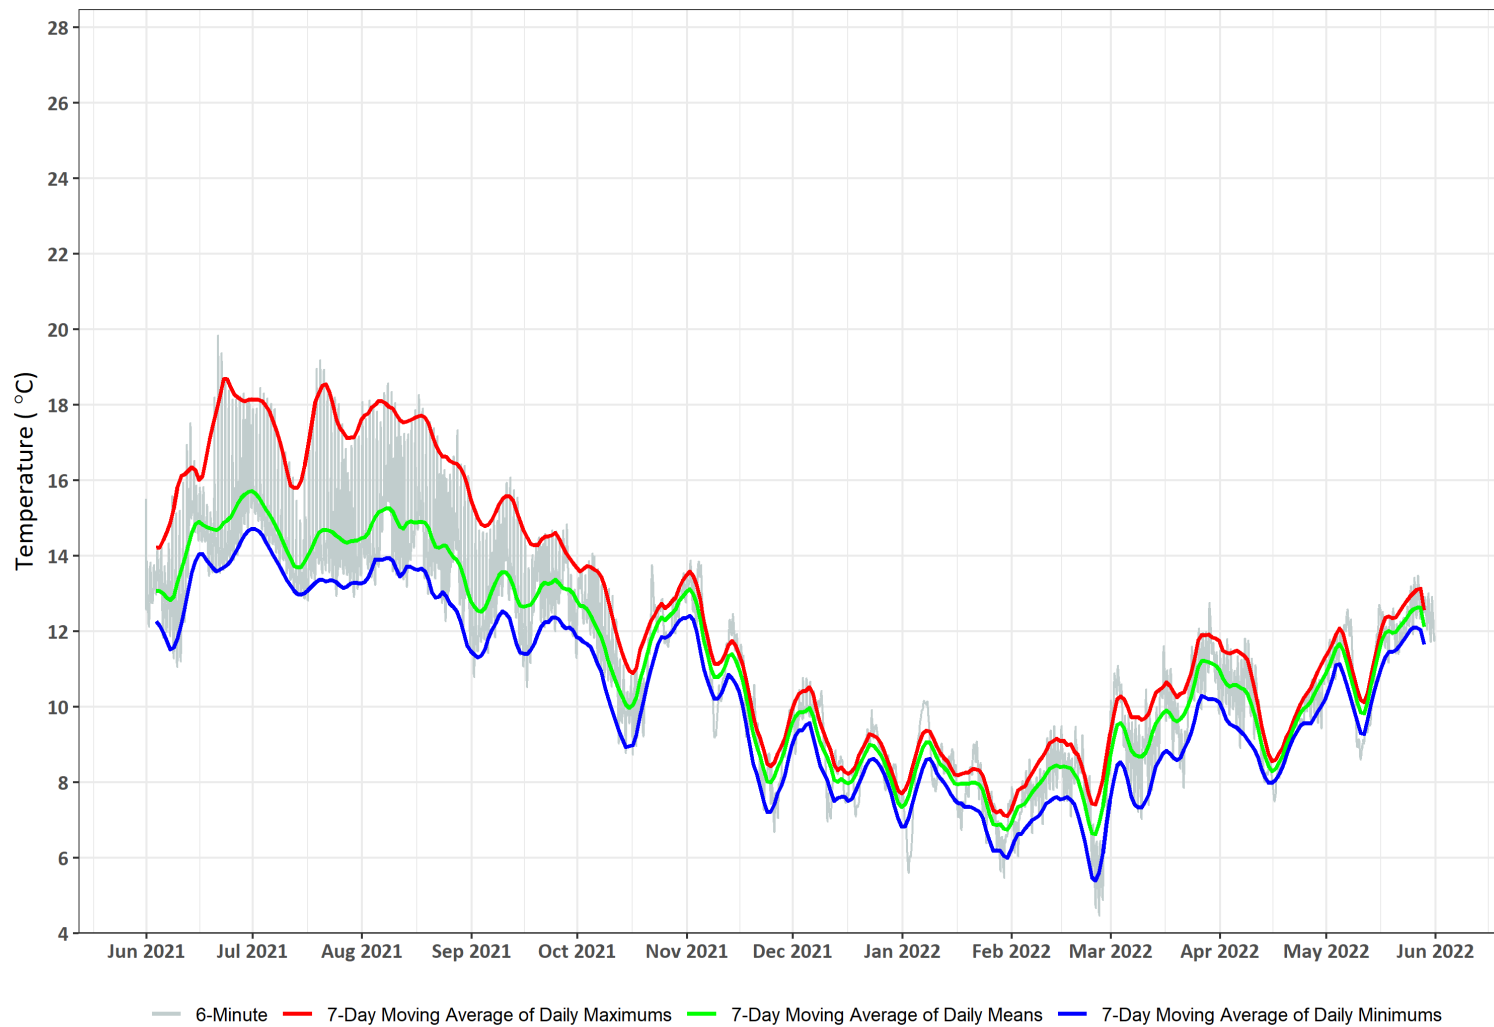
Figure D-8. Six-minute and 7-day average maximum, mean, and minimum temperatures at ER-3.

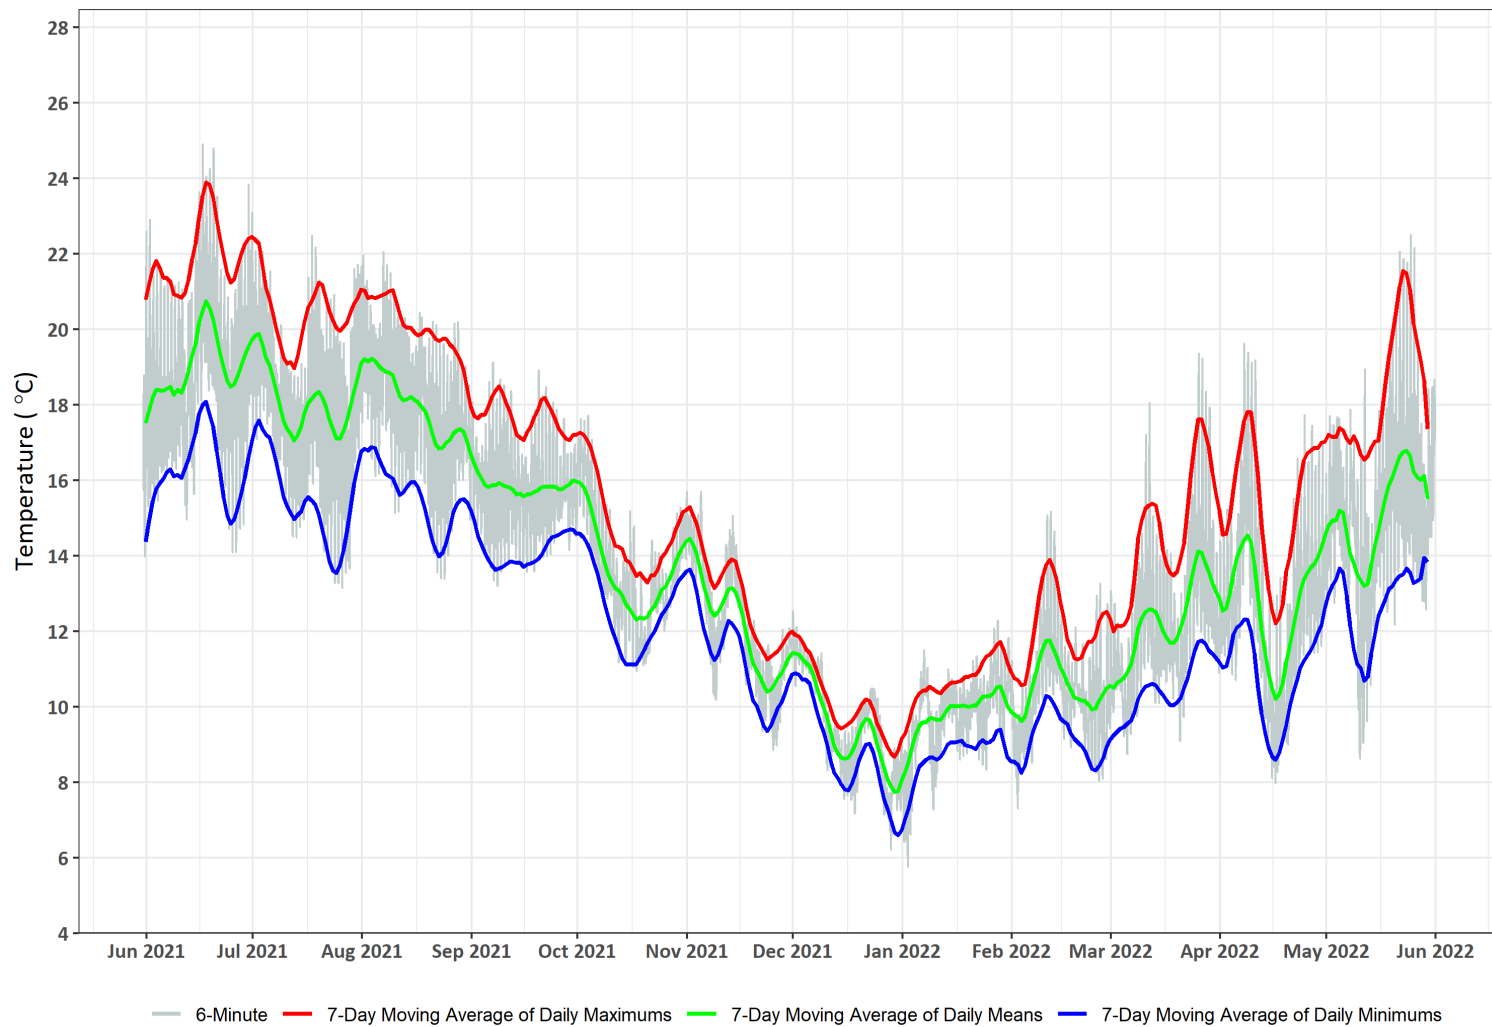
Figure D-10. Six-minute and 7-day average maximum, mean, and minimum temperatures at SS-1.

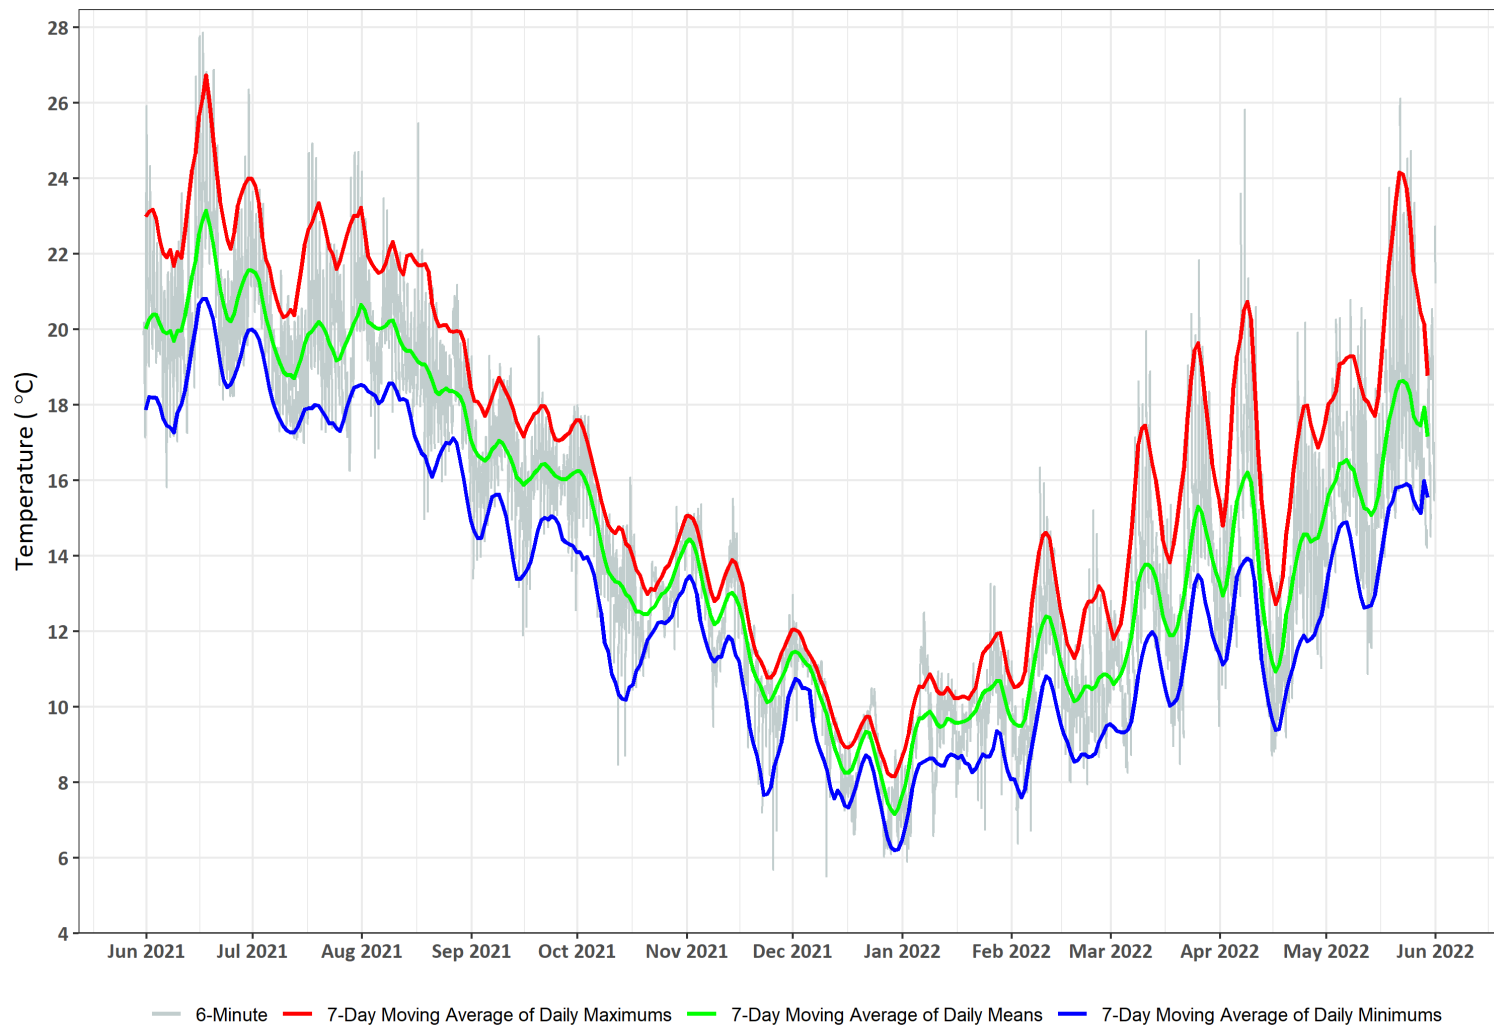
Figure D-11. Six-minute and 7-day average maximum, mean, and minimum temperatures at SS-2.

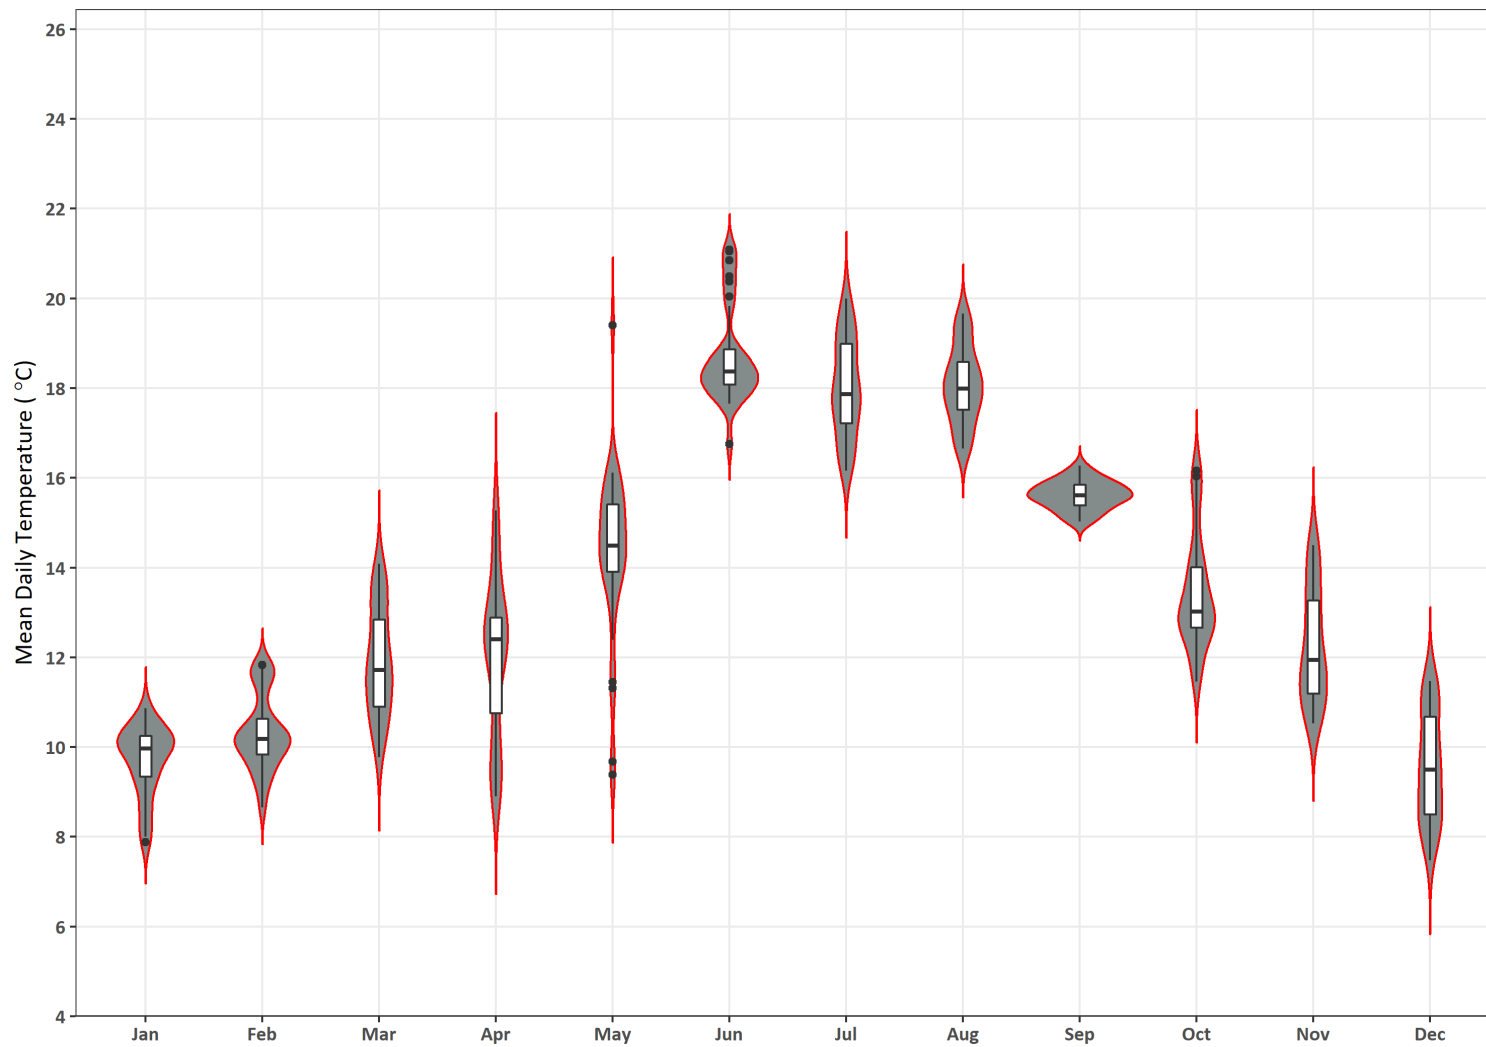
Figure D-12. Violin plot of mean daily temperature summarized by month at ER-1.

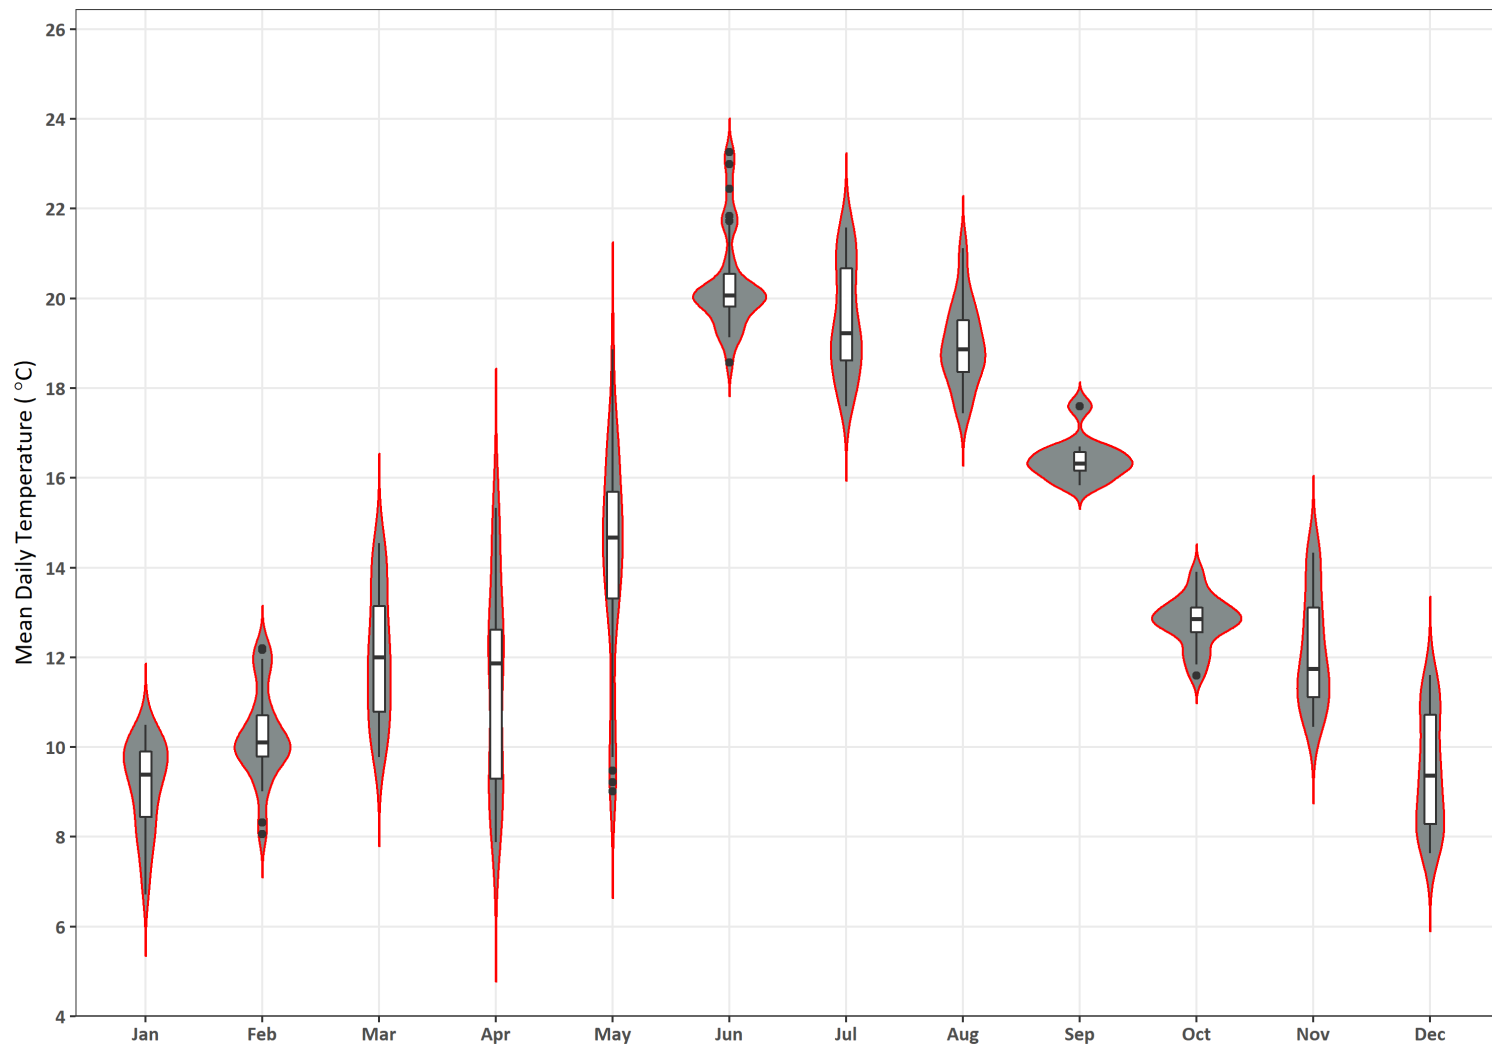
Figure D-13. Violin plot of mean daily temperature summarized by month at ER-2.

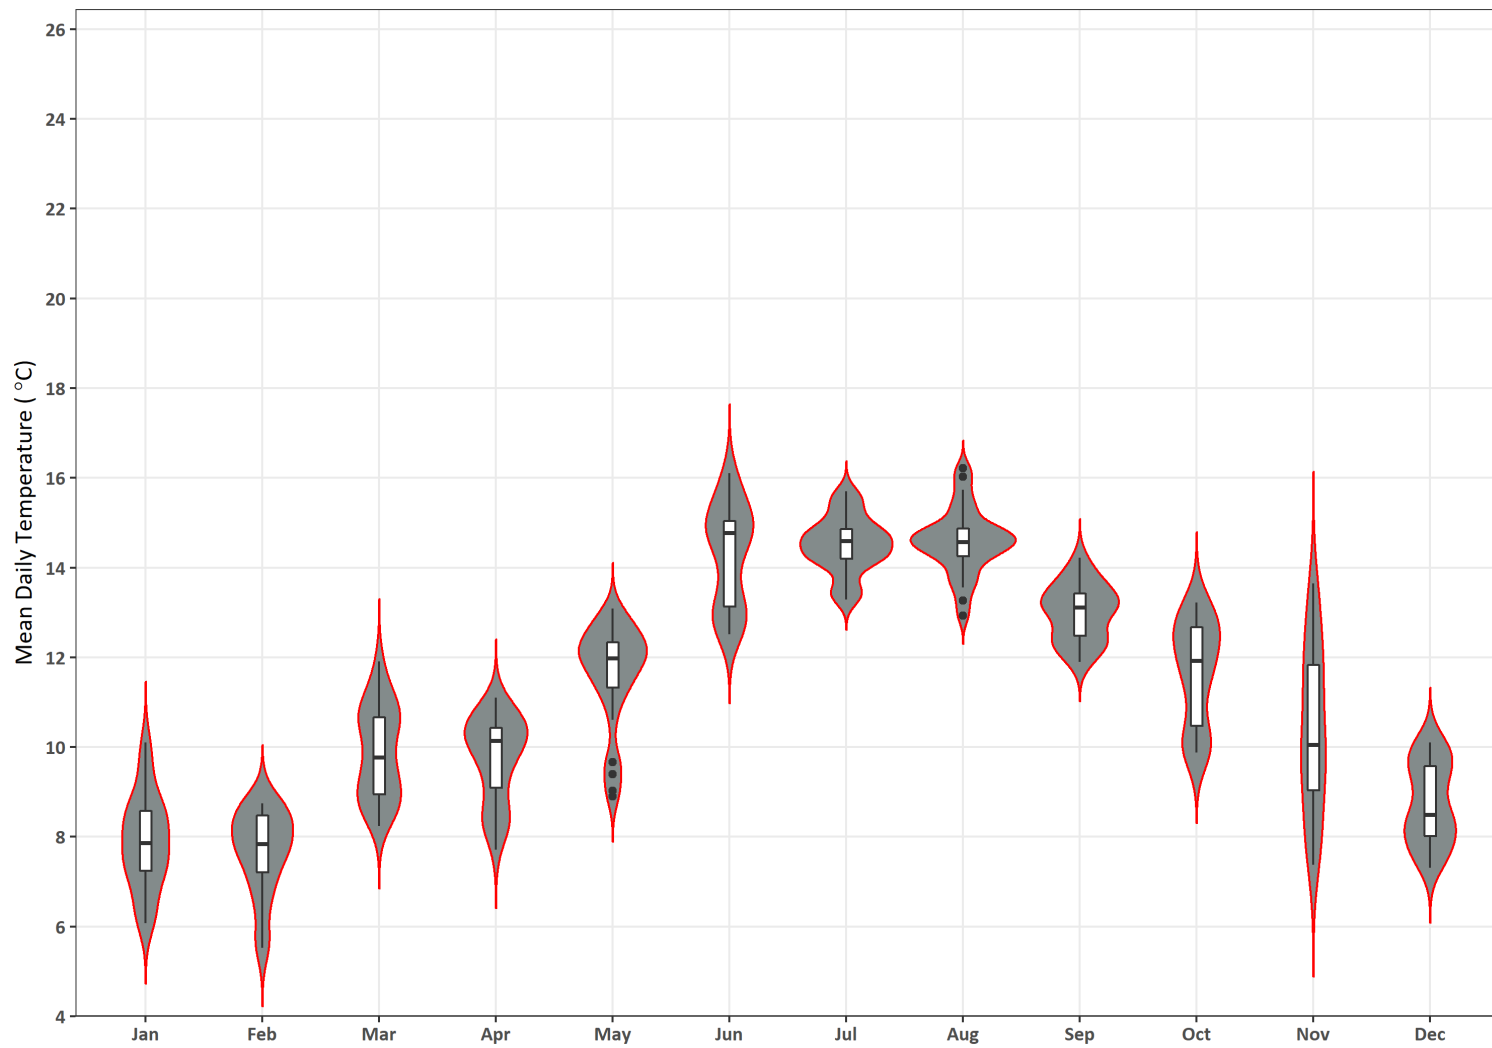
Figure D-14. Violin plot of mean daily temperature summarized by month at ER-3.
