FINAL REPORT • MAY 2023

Elk River Planning Area 1: 10% Design Report

Northern Hydrology and Engineering
P.O. Box 2515
McKinleyville, CA 95519

Stillwater Sciences
850 G Street, Suite K
Arcata, CA 95521

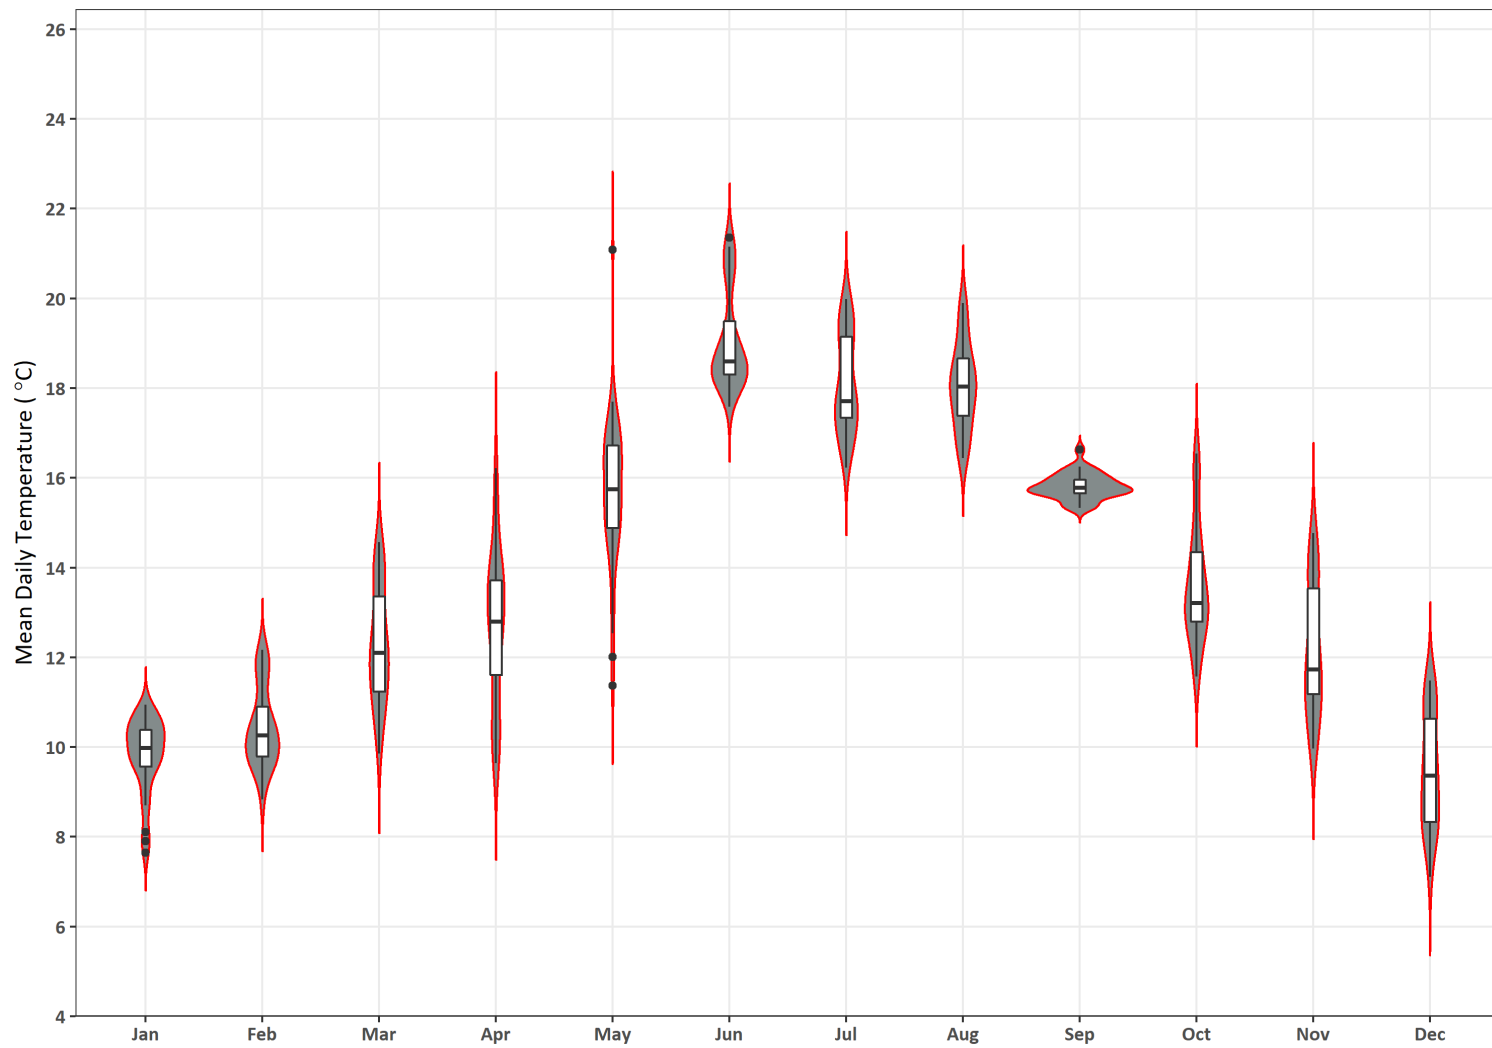
Figure D-15. Violin plot of mean daily temperature summarized by month at SS-1.

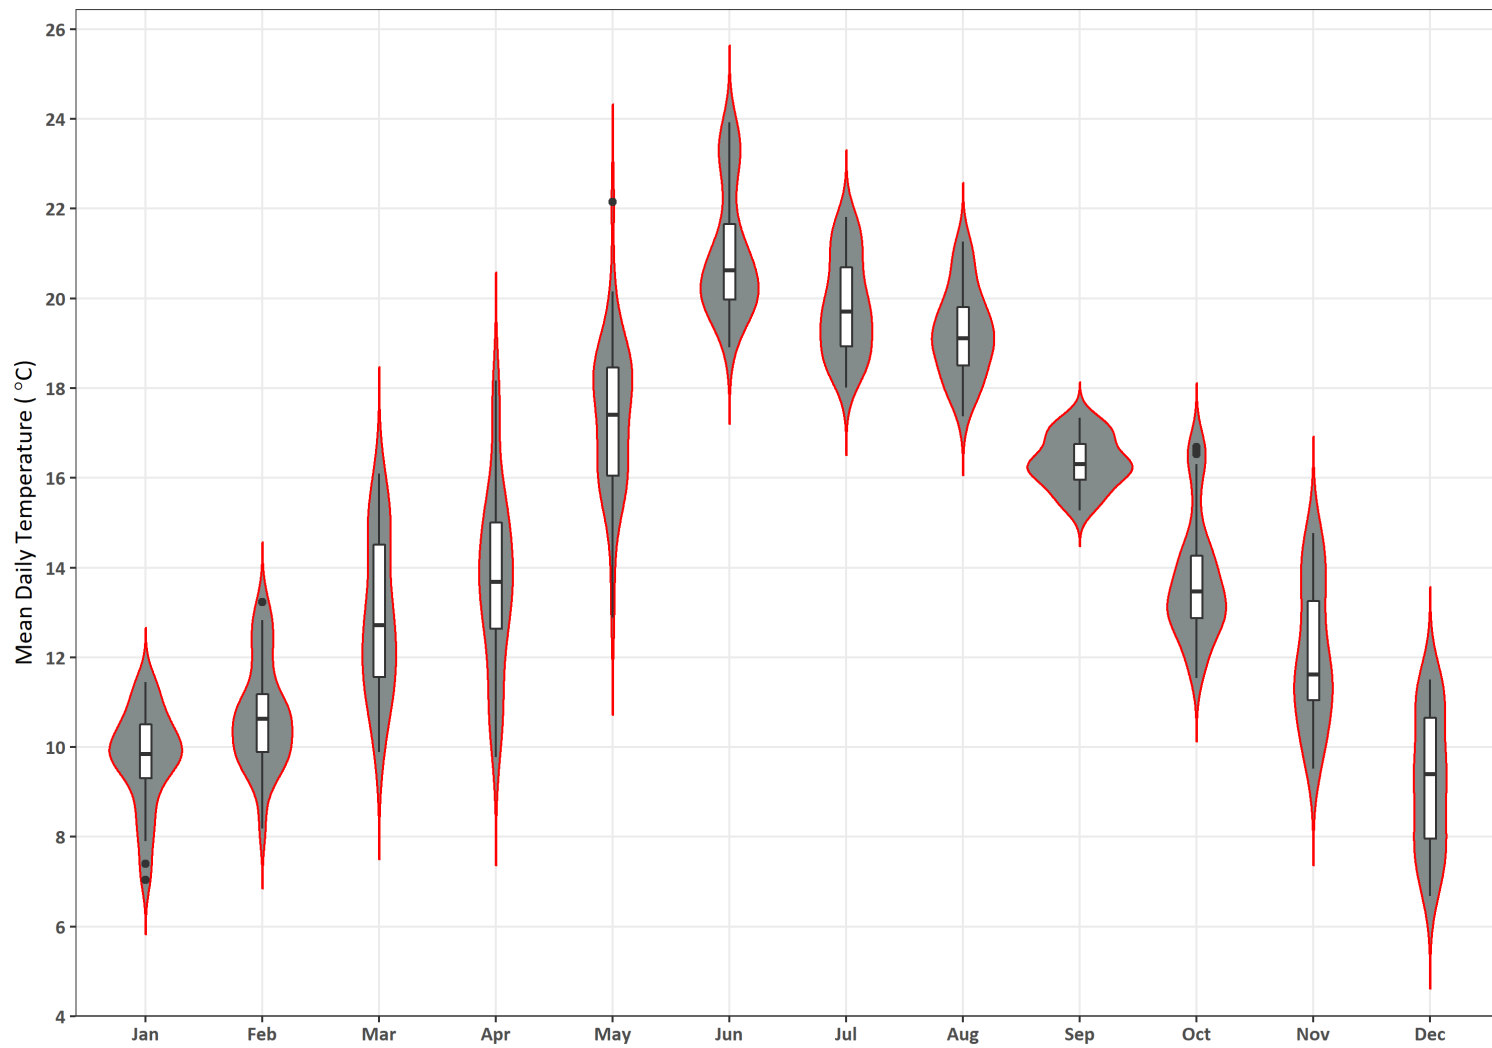
Figure D-16. Violin plot of mean daily temperature summarized by month at SS-2.
