## Lower Eel River – Historical Survey

River Planform changes from 1922 to 2017 documented using aerial photographs from USGS , Belcher's Humboldt County Atlas, and GPS survey.

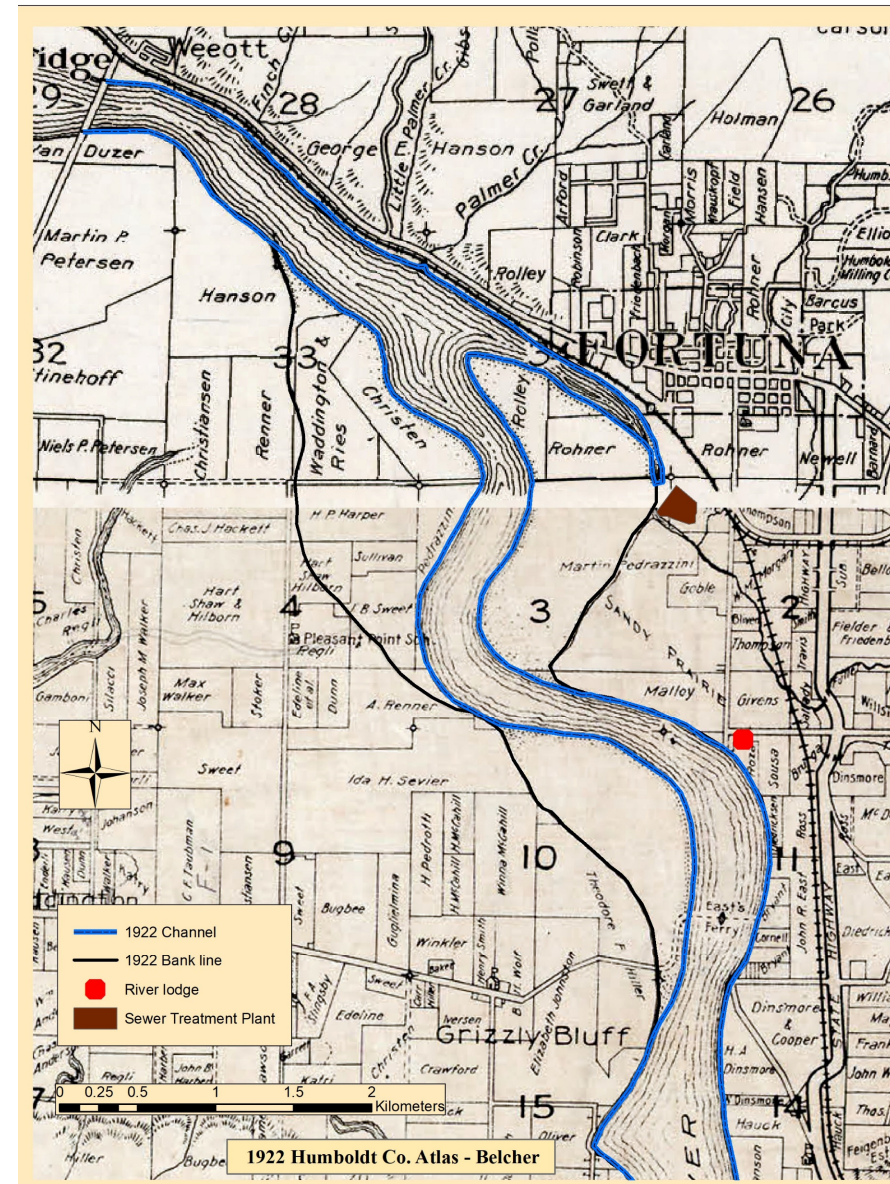
- 1) Erosion of the meander between Pleasant Point and Sandy Prairie Point  
-ends with construction of Fortuna levee 1959

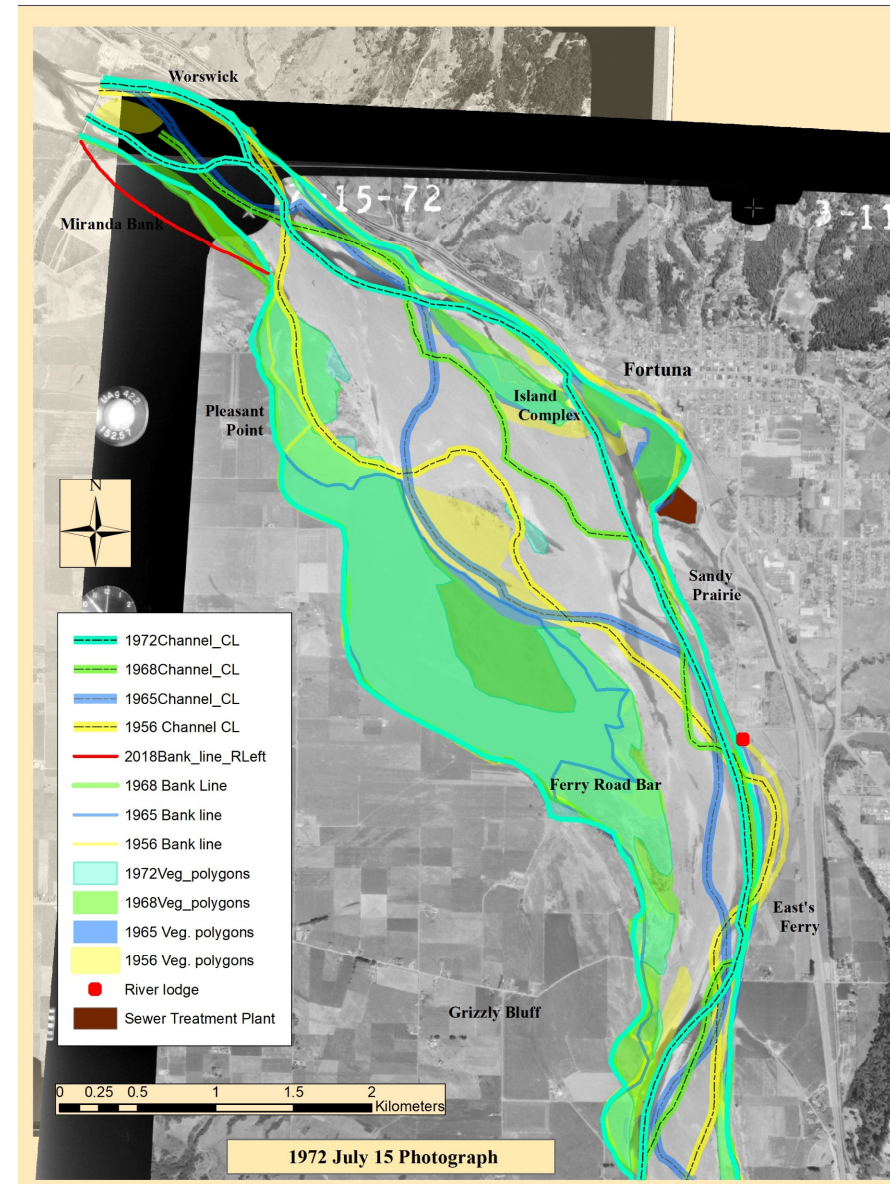
1) Erosion of the meander between Pleasant Point and Sandy Prairie Point

- ends with construction of Fortuna levee 1959
- 1940 image shows loss of Sandy Prairie Point and Pleasant point
- 1956 image shows erosion of Fortuna Bank

2) The second era goes through the mid 1970's as the river chokes with sediment from the 1964 and subsequent events

- The channel is highly braided
- The channel gradually moved to the outside of the bend

3) The final era continues to the present with the river settled into its new configuration entering the corner east of the Old Island then crossing to the Miranda Bank side, eroding it.

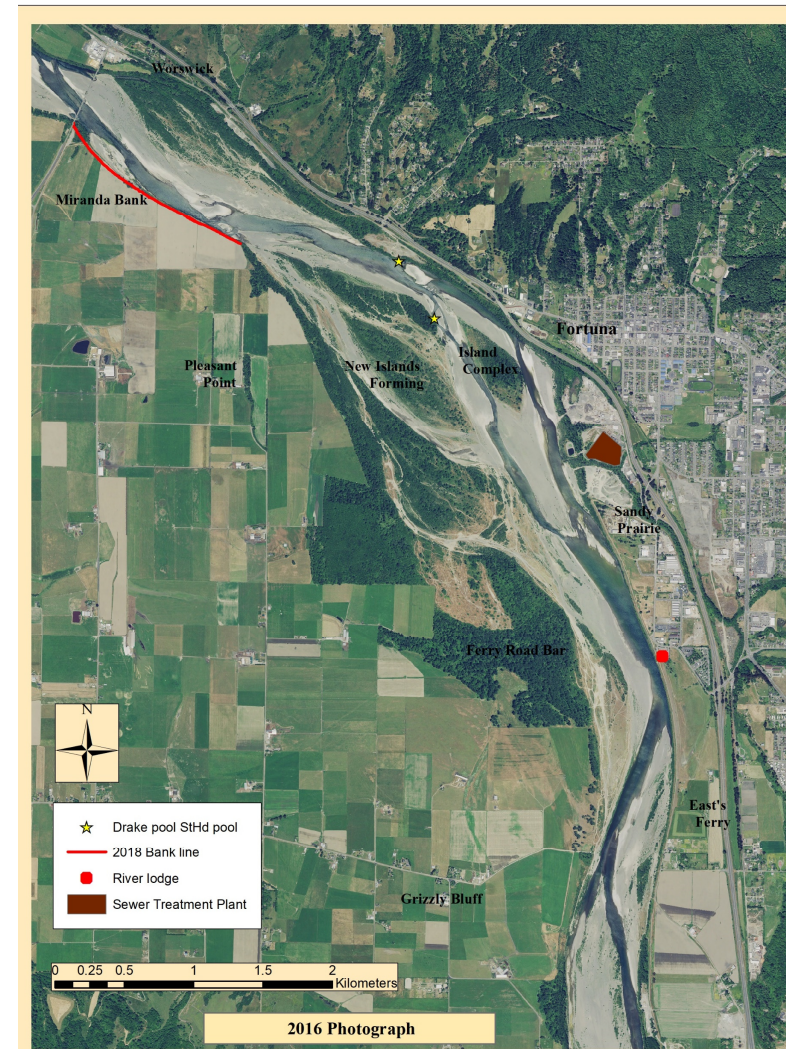
- 1) The Miranda Bank continues to erode.
- 2) On the Worswick Bar and the Island Complex the riparian vegetation continues to expand in area and density.
- 3) The sediment plug in the lower river has filled all the holding water for migrating fish between tide water and the 12<sup>th</sup> street pool.
